Examining Wood Tie Failure

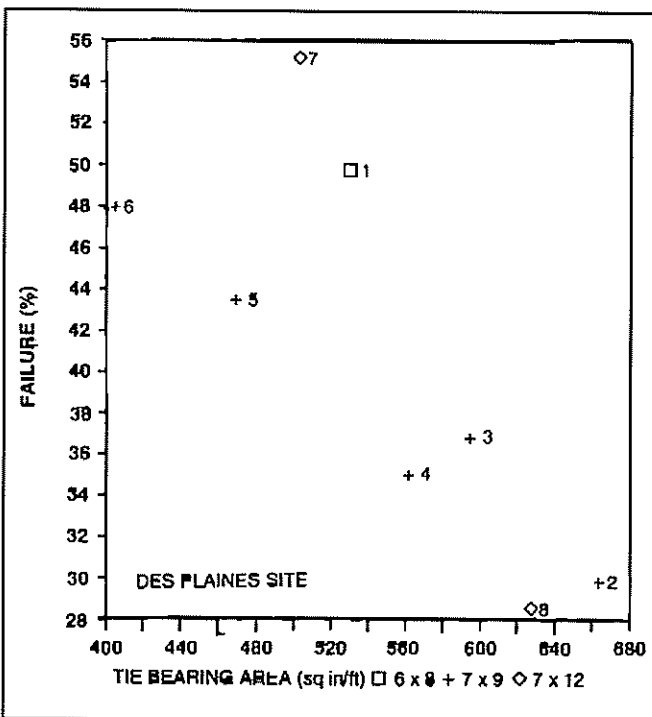
Figure 1 — Failure rate vs. tie bearing area

Increasing tie width and length enlarges, in turn, the bearing area of the tie. Figure 1 shows that the rate of tie failure decreases in direct relation to the increase in the bearing area.

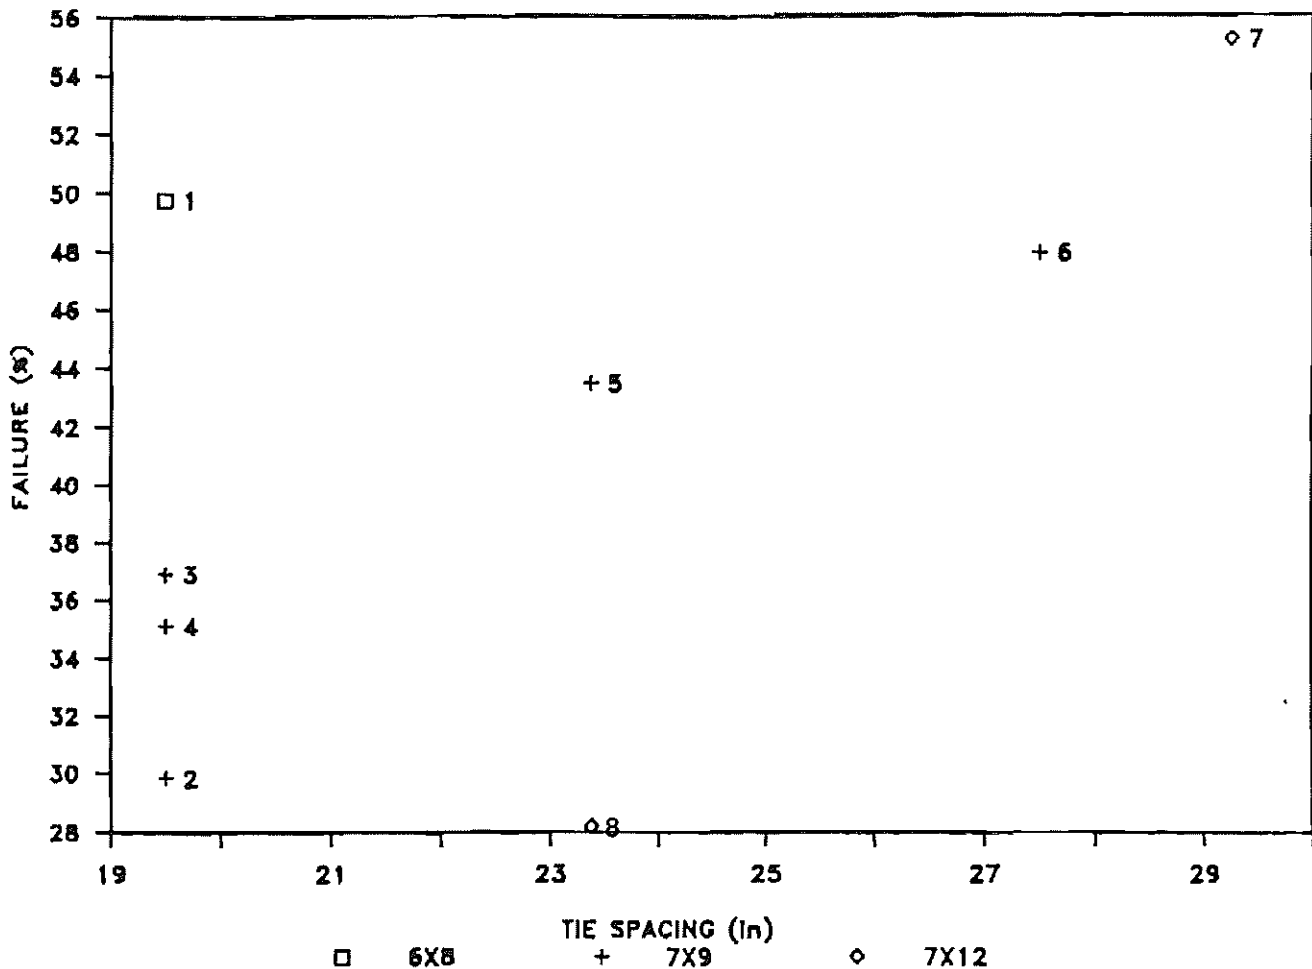
Figure 2—Failure rate vs. tie spacing

Finally, with examination of the effect of tie spacing, there was found a direct correlation between increased spacing and an increased percentage of failed ties. This trend held for 7-inch by 9-inch and 7-inch by 12-inch

cross sections, and is illustrated by Figure 2.
