MISSISSIPPI STATE
UNIVERSITY[™]

DEPARTMENT OF SUSTAINABLE BIOPRODUCTS

Tenth Annual Evaluation of Phase II MSU/RTA Alternative Preservative Study

July 11, 2022

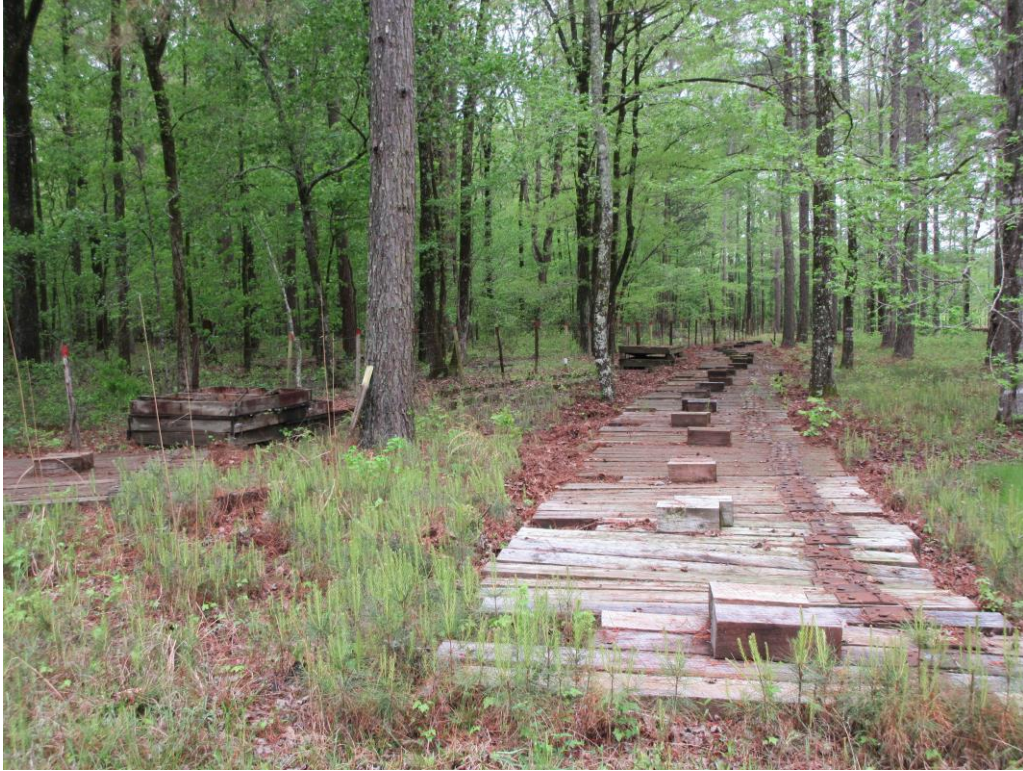
Ties at Site 1 are definitely more moist/wet due to the increased shade and leaf litter at this site and thus more signs of decay were noted at this site.

Figure A - Site 1 (MSU Dorman Lake Test Site) at the time of inspection.

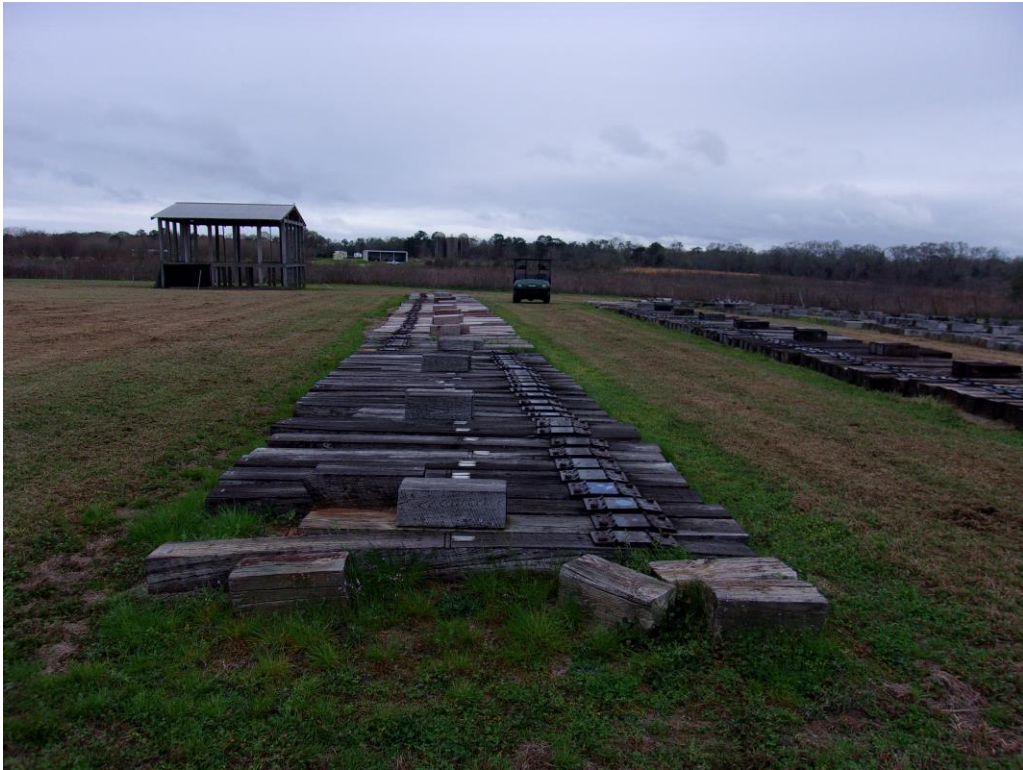
No unexpected results were found. Biological activity is progressing in the untreated ties as expected indicating virulent fungi activity and active termites at both sites. As noted in previous reports, Site 2 ties appeared to be a drier probably due to more direct sunlight exposure allowing for more checking. Formosan termite activity at this site continues to increase.

Figure B - Site 2 (MSU Formosan Termite Research Facility) at the time of inspection.

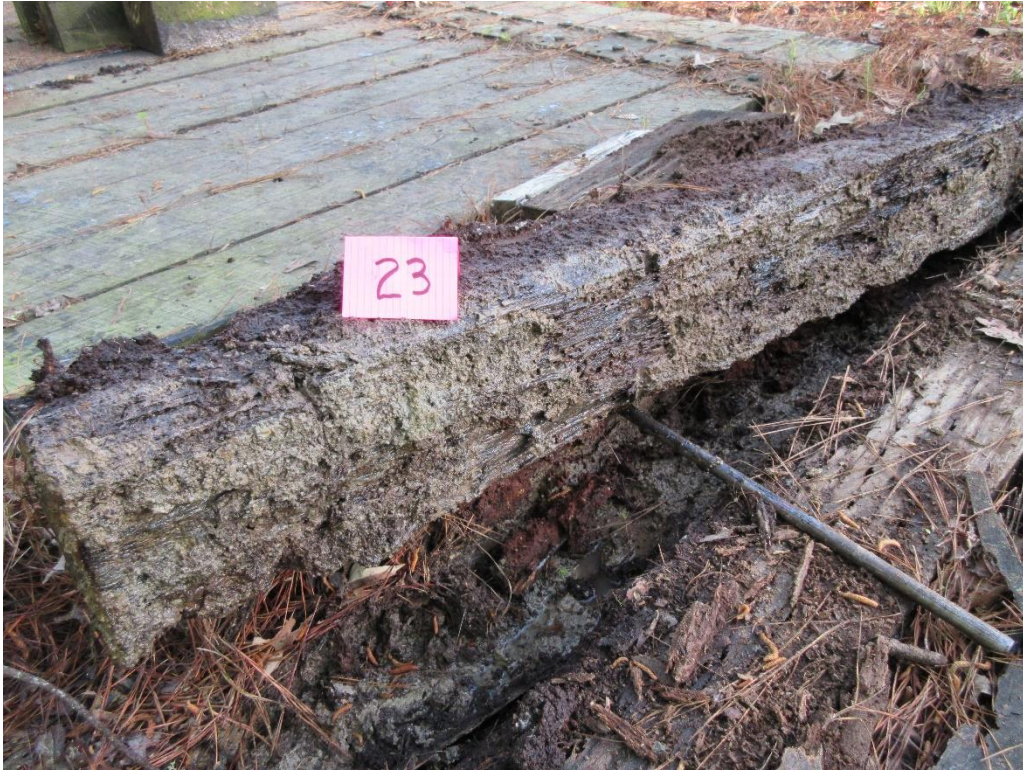
Figure 5 – Tie #23 untreated red oak with heavy decay and moderate termite damage.

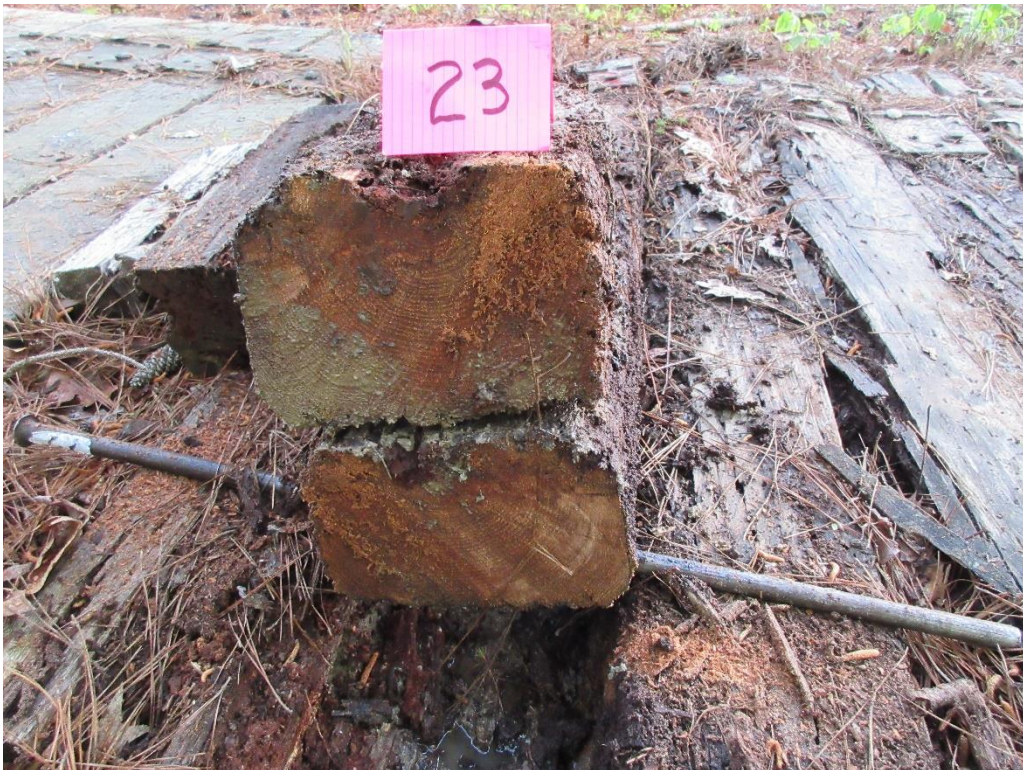
Figure 6 – Tie #23 untreated red oak with extensive decay and moderate termite damage.

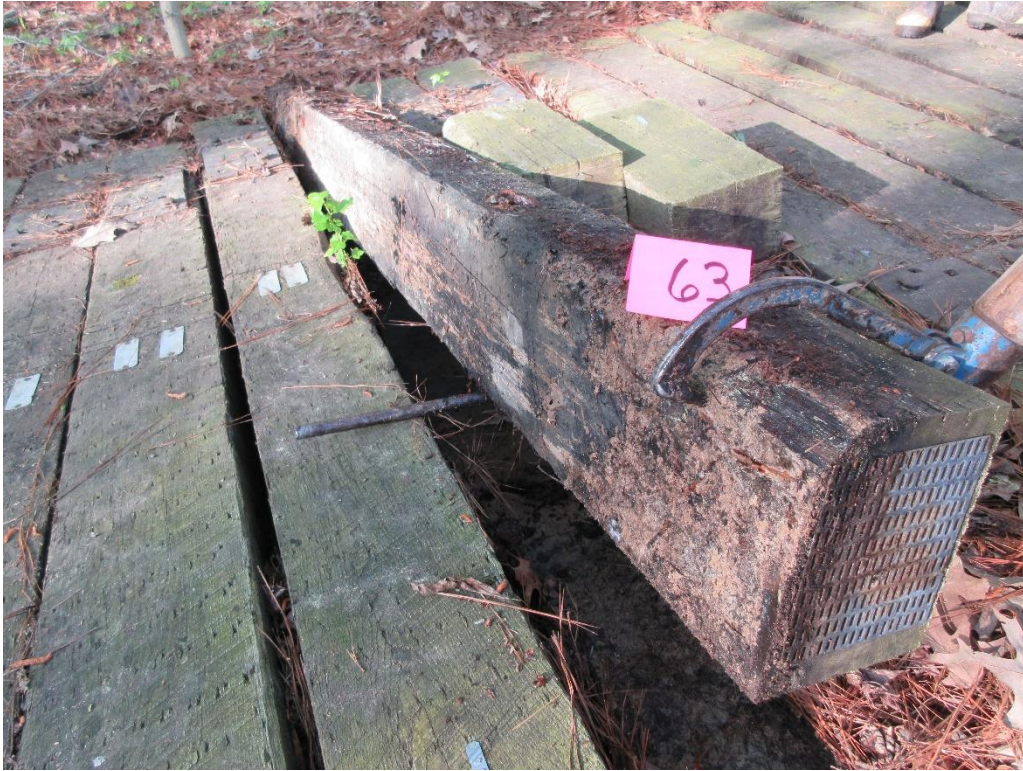
Figure 13 - Tie #63 red oak/1 step creosote borate with trace decay (Stella Jones).

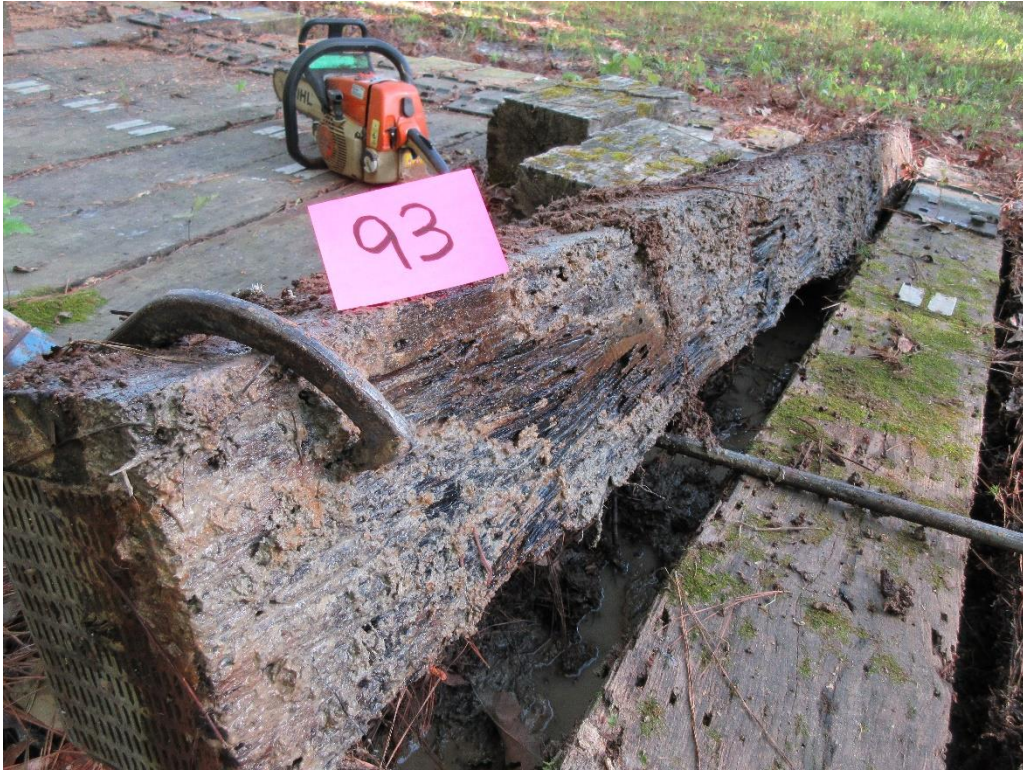
Figure 19 – Tie # 93 untreated white oak width moderate decay and termite damage.

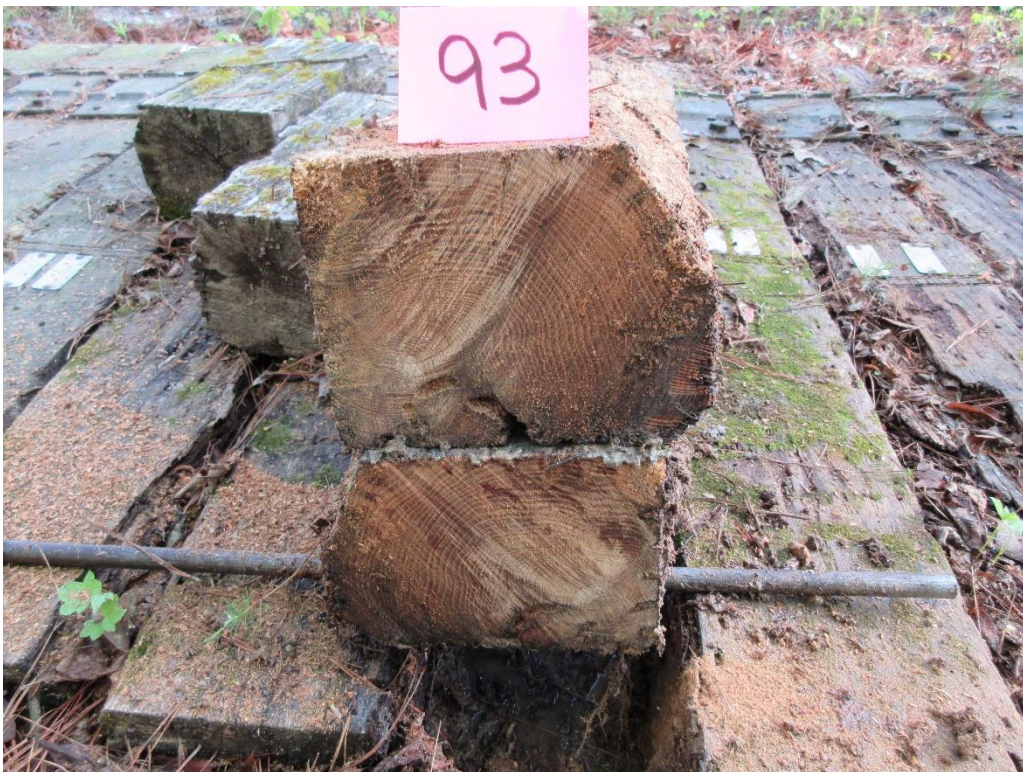
Figure 20 – Tie #93 untreated white oak with obvious decay visible.

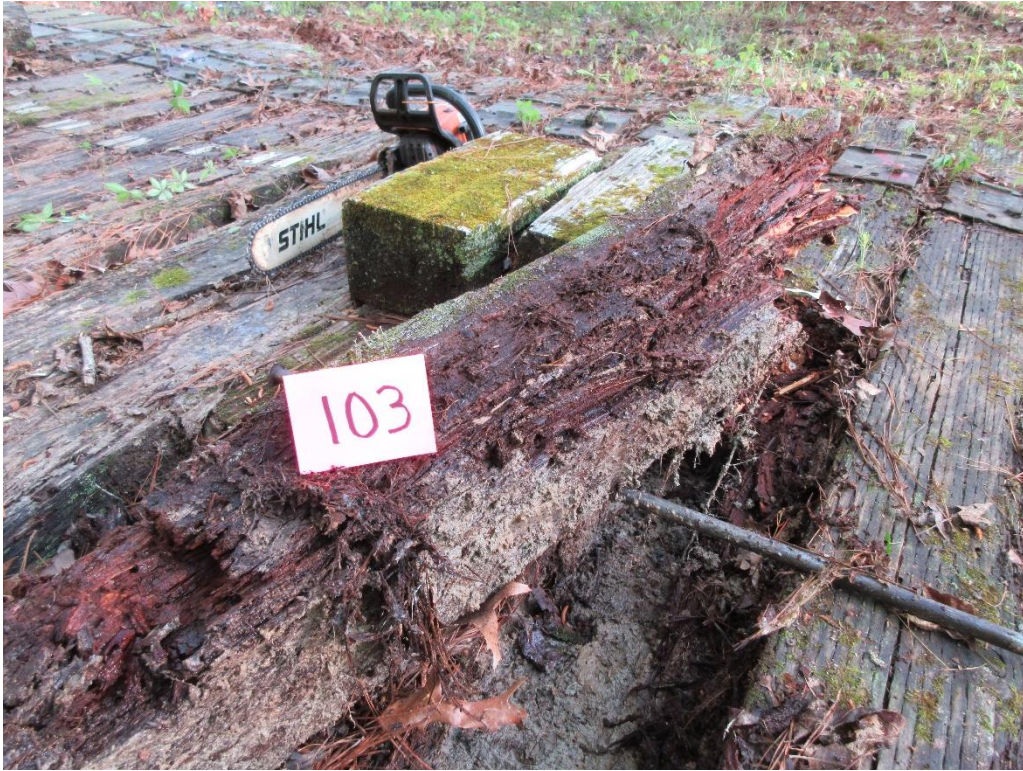
Figure 21 – Tie #103 untreated Douglas fir which failed due to decay.

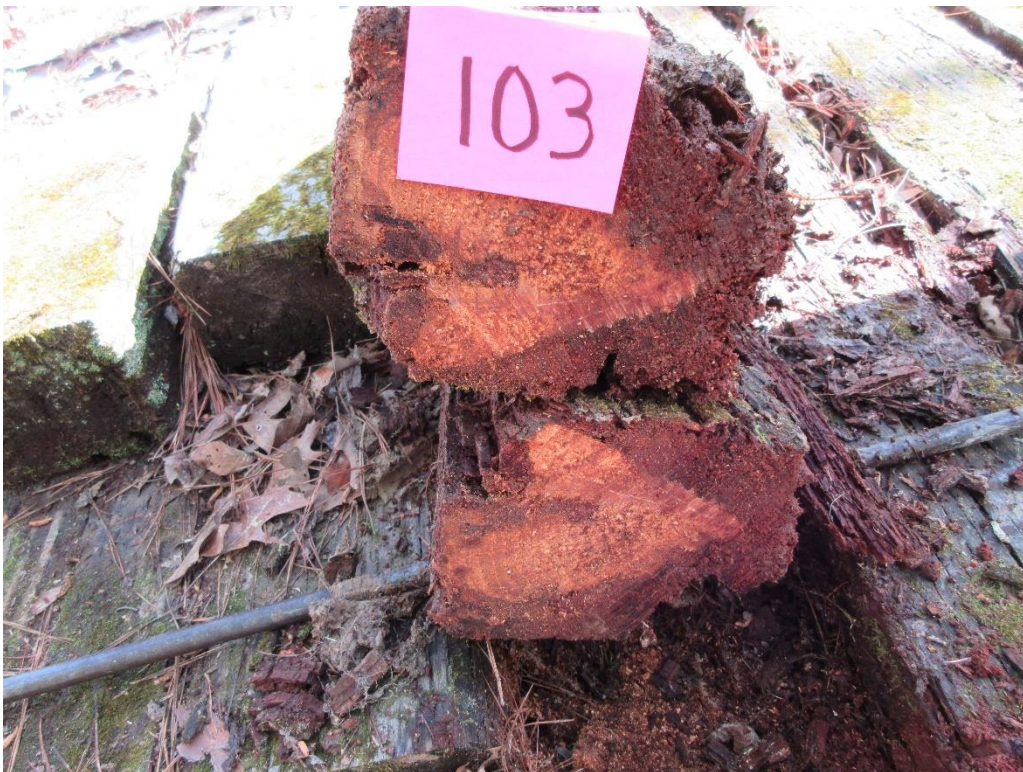
Figure 22 - Tie #103 severely decayed untreated Douglas fir.

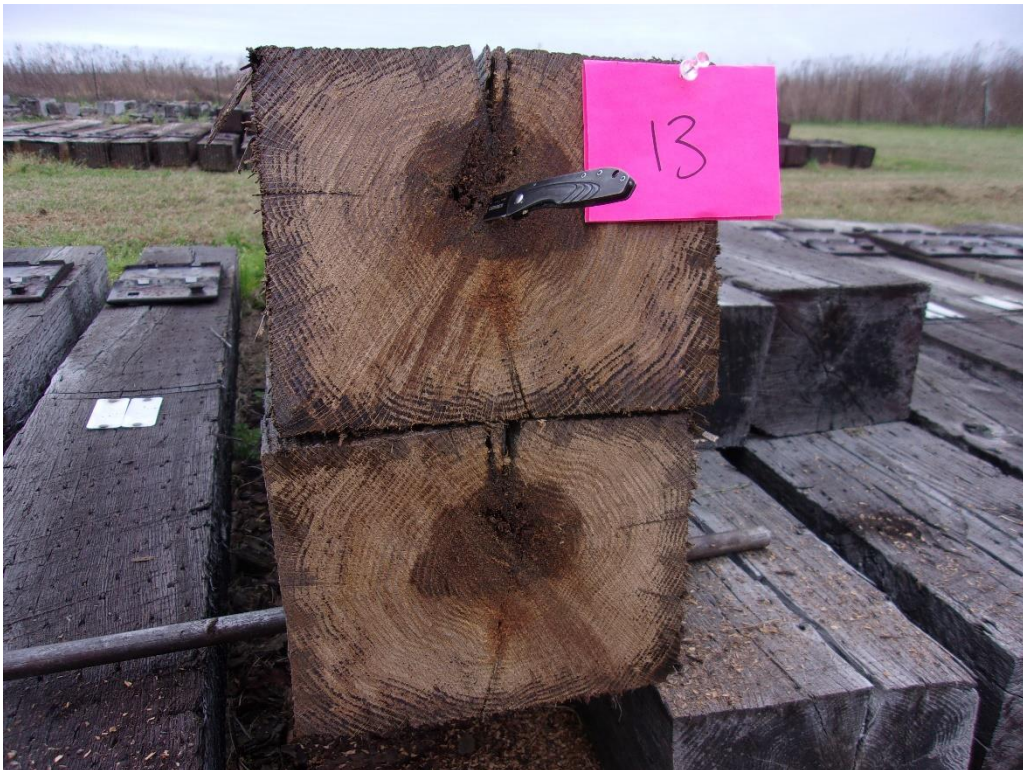
Figure 56 - Tie #13 red oak/one step creosote borate with decay in cross-section (Stella jones).

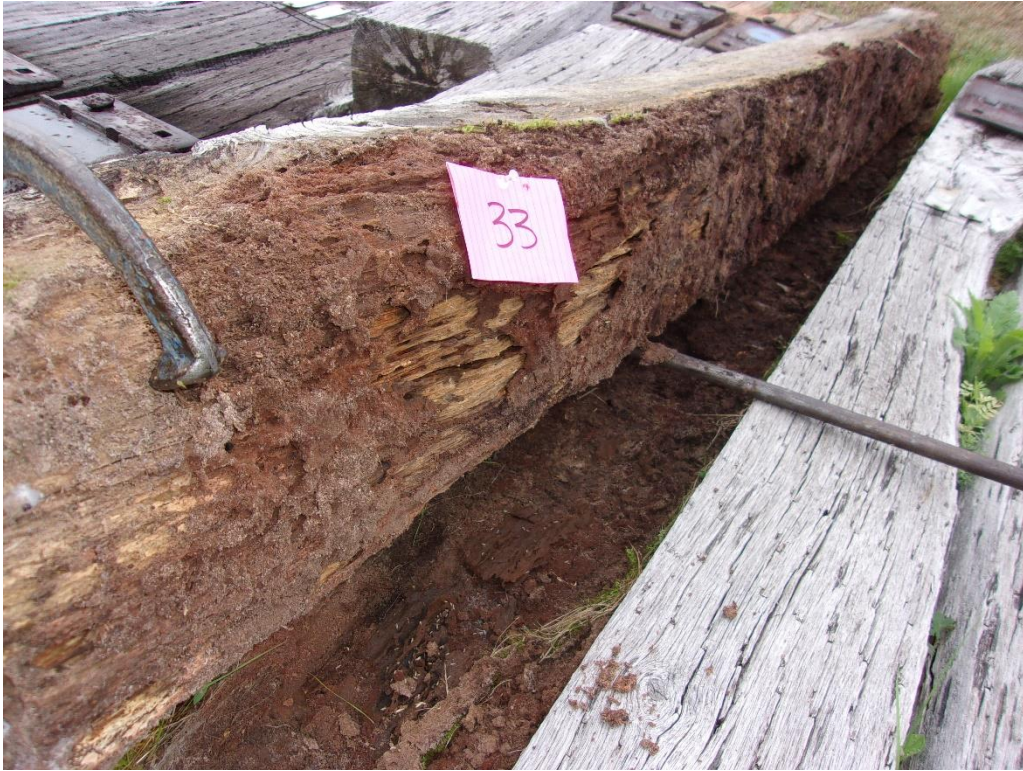
Figure 59 – Tie #33 untreated white oak with decay and termite damage.

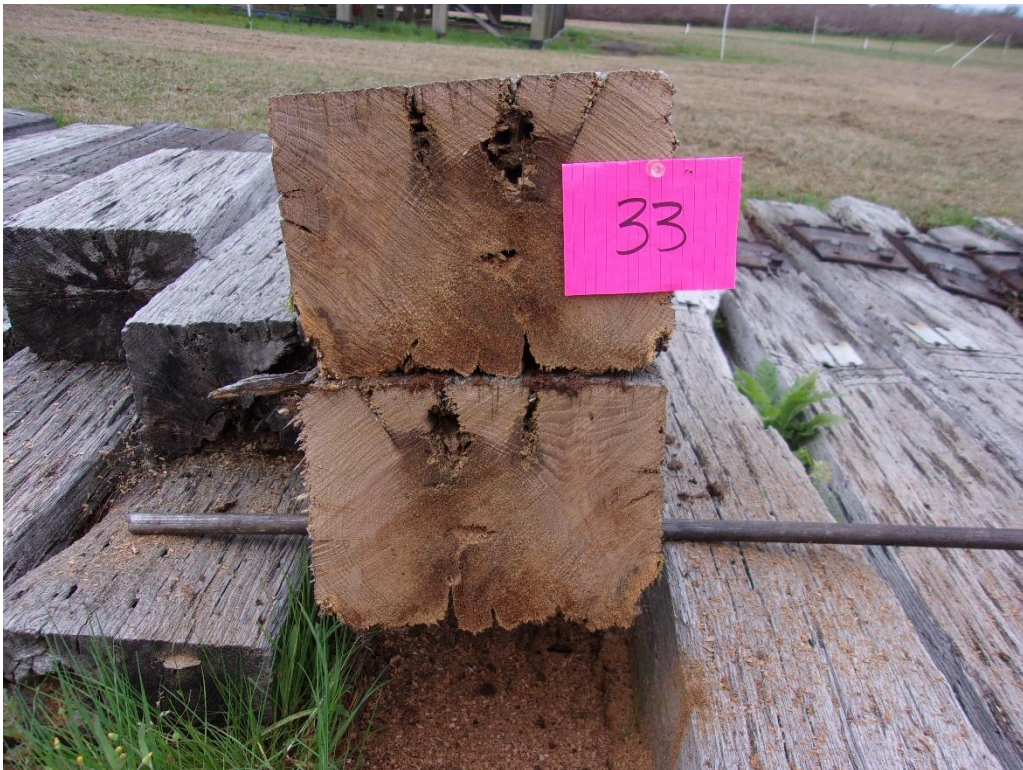
Figure 60 - Tie #33 untreated white oak with decay visible in cross-section.

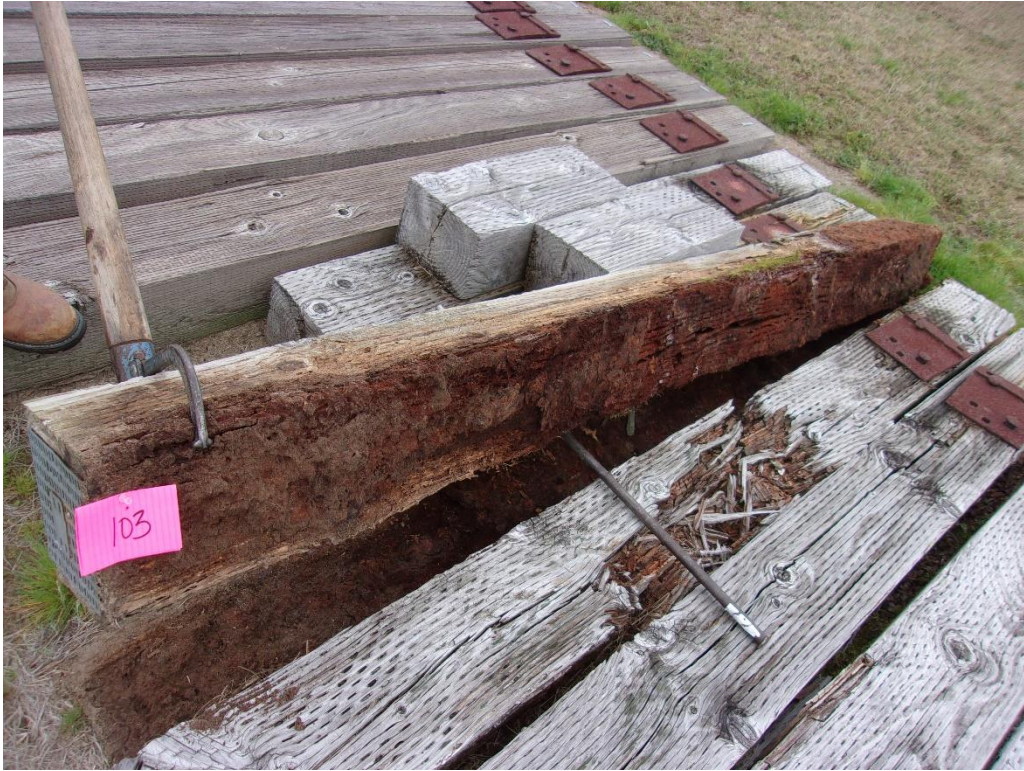
Figure 73 – Tie #103 untreated Douglas fir with decay and termite damage.

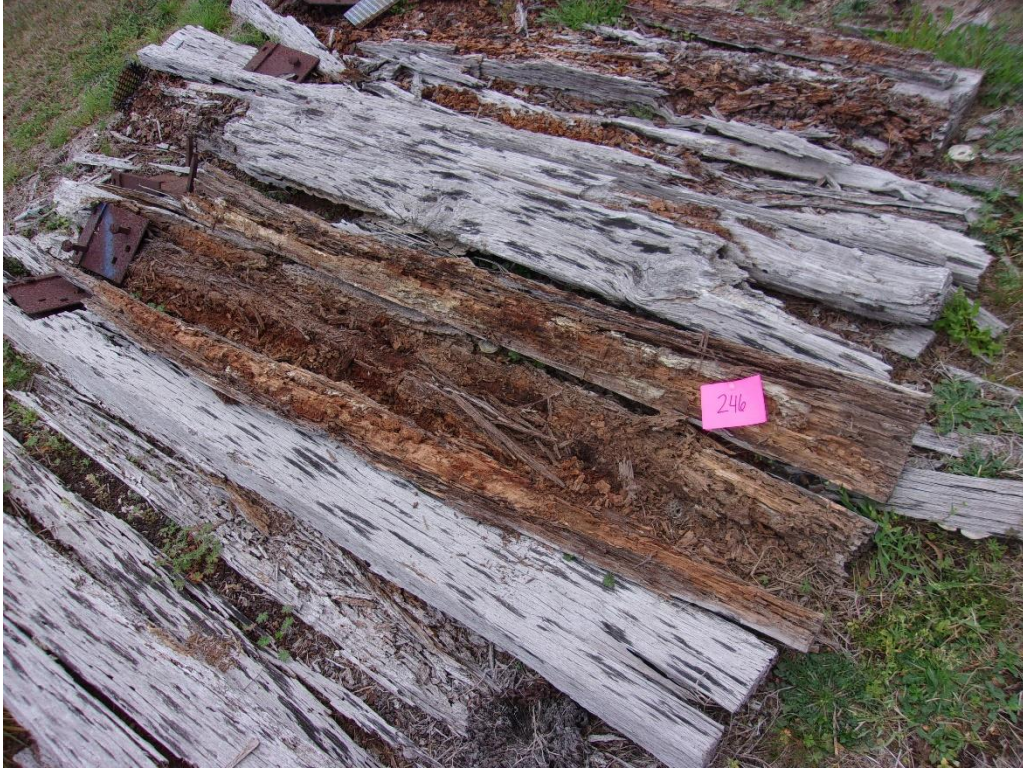
Figure 103 – Tie #246 untreated red oak with failed due to decay and Formosan termites.
