FOREST AND WILDLIFE RESEARCH CENTER

DEPARTMENT OF SUSTAINABLE BIOPRODUCTS

Sixth Annual Evaluation of Phase II MSU/RTA Alternative Preservative Study

May 16, 2018

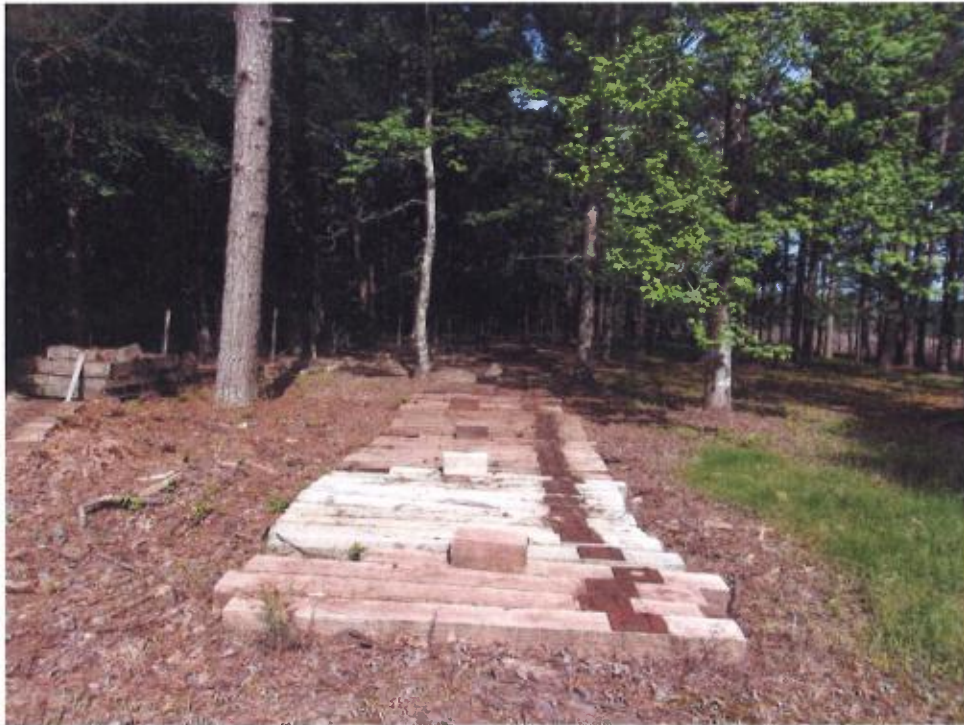
Figure 1 - Site 1 (MSU Dorman Lake Test Site) at the time of inspection.

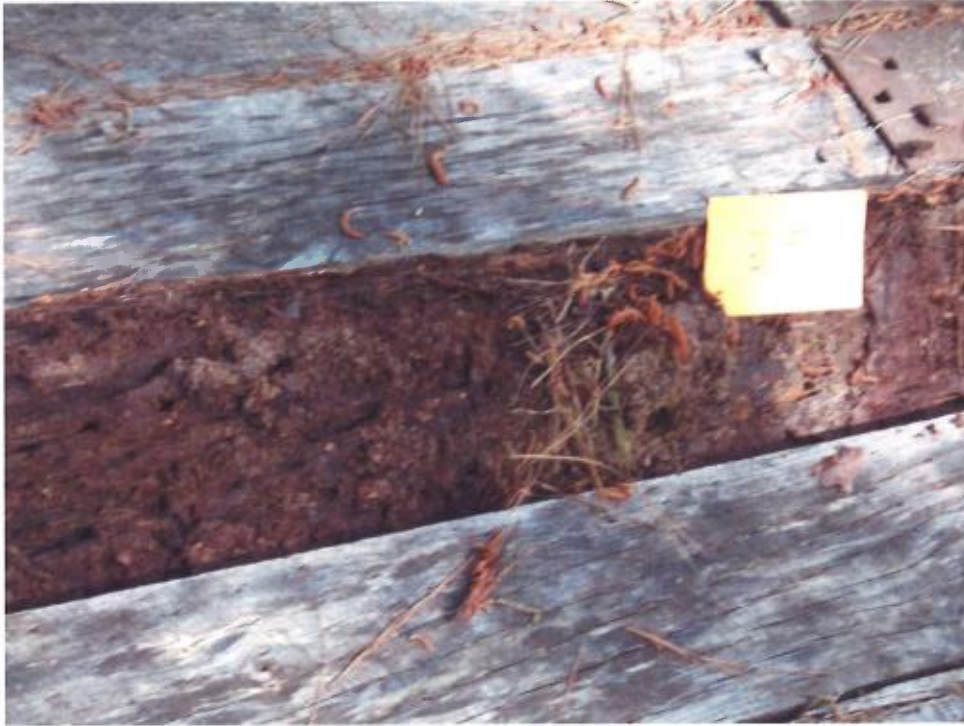
Figure 2 - Tie #25 with decay and beetle damage.

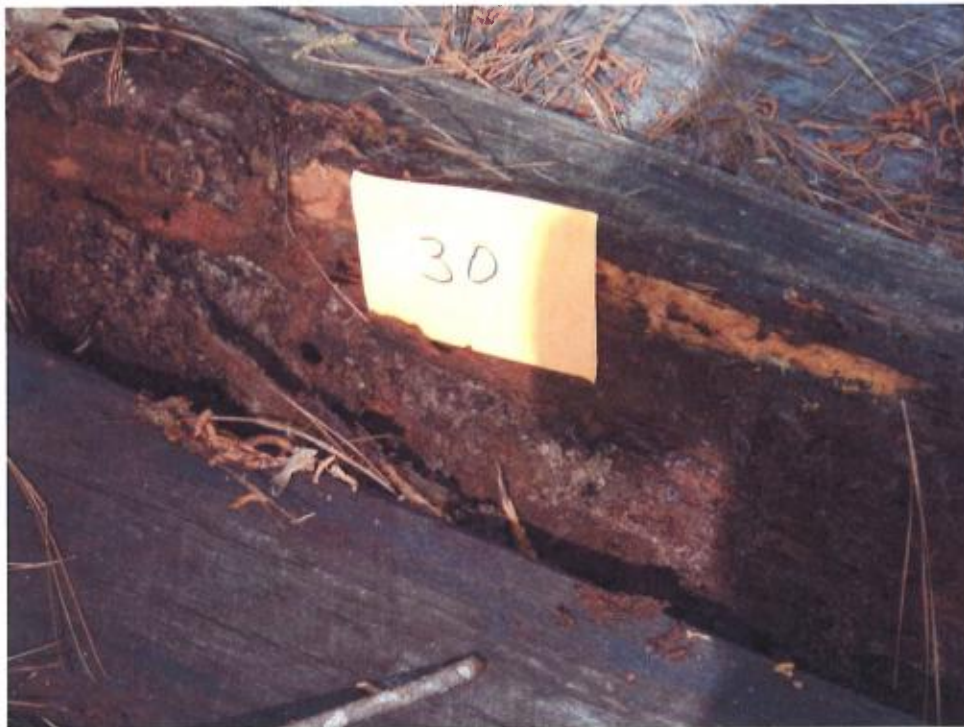
Figure 3 - Tie #30 with decay damage.

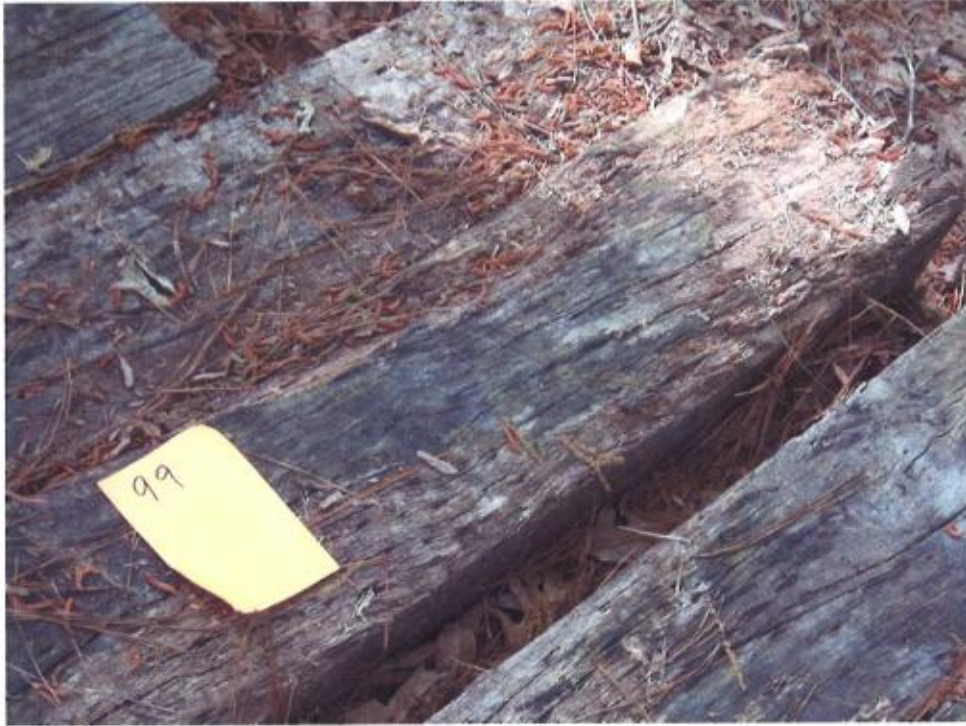
Figure 4 - Tie #99 with decay on upper surface.

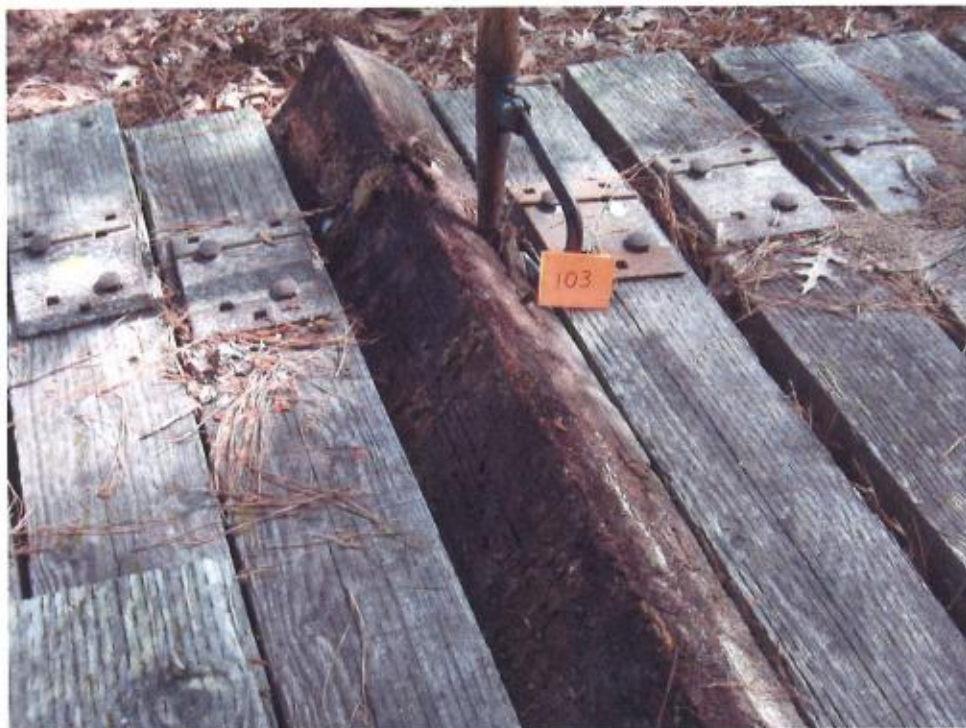
Figure 5 - Tie #103 with moderate decay.

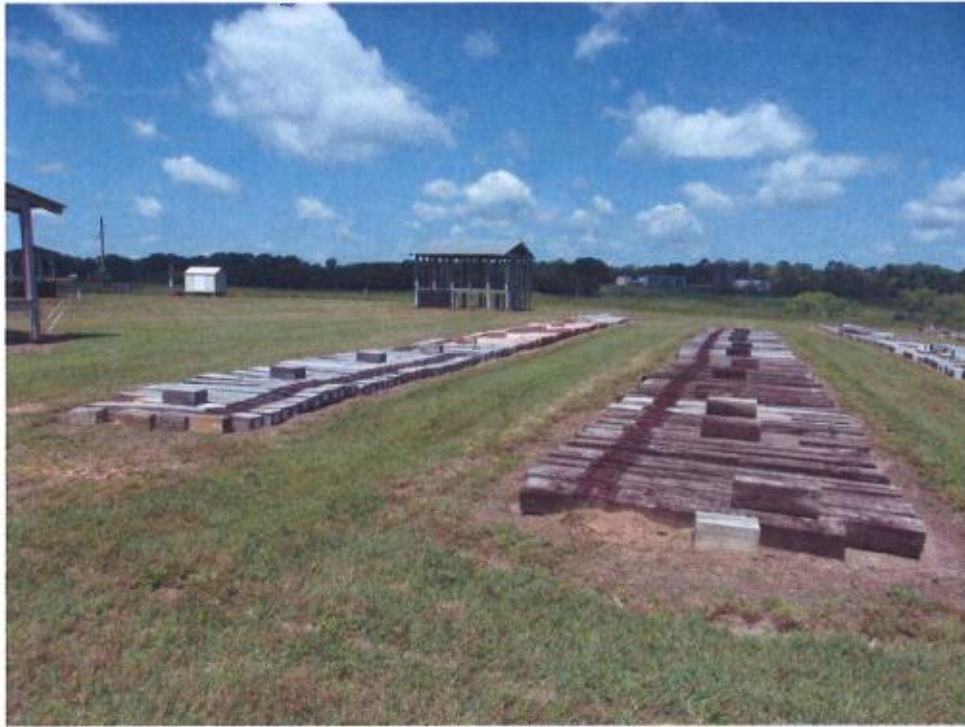
Figure 6 - Site 2 at the time of inspection.

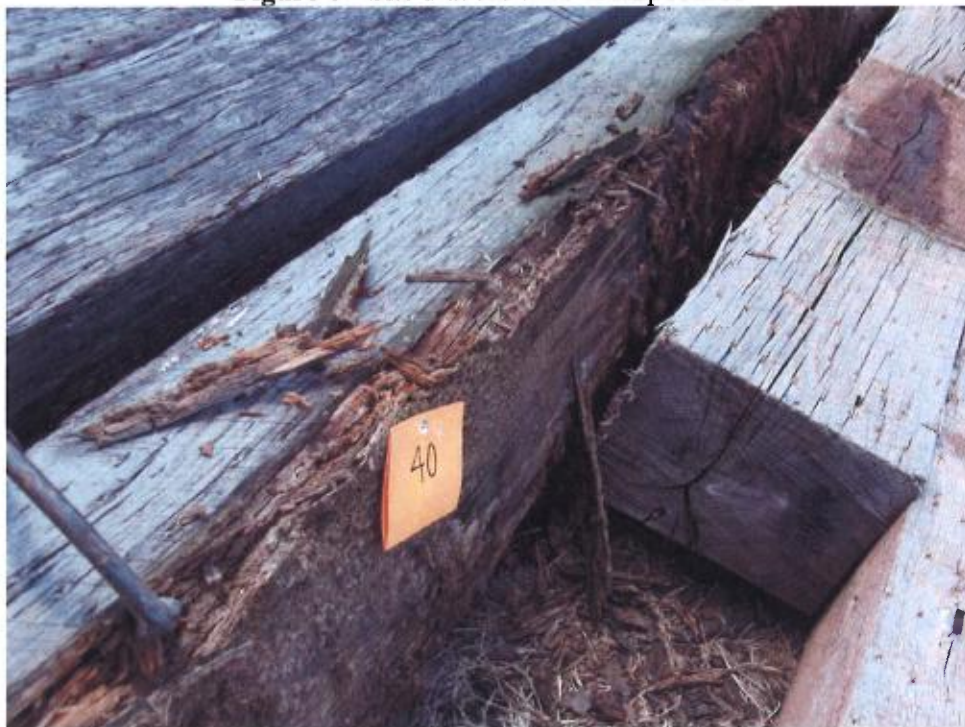
Figure 7 - Tie #40 with decay.

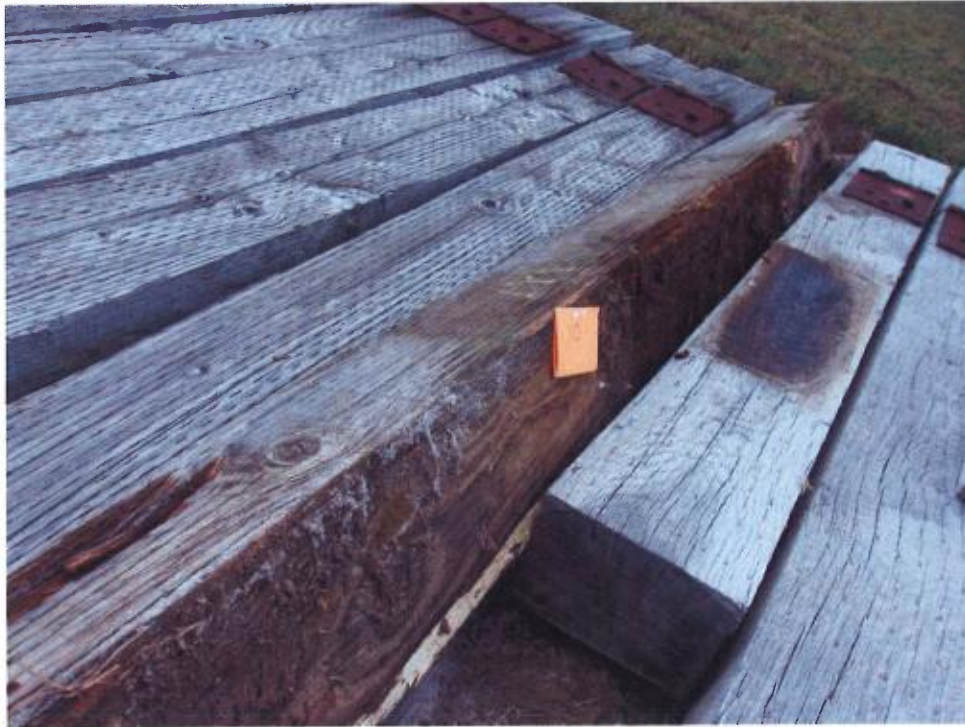
Figure 8 - Tie #110 with decay and trace termite attack.

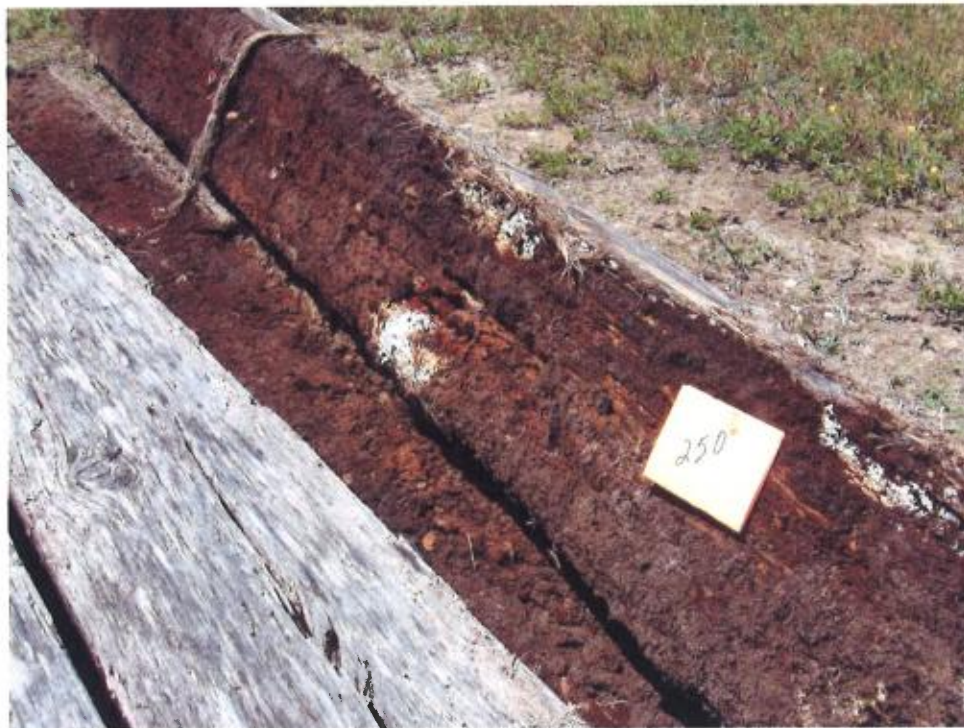
Figure 9 - Tie #250 with heavy decay and trace termite damage.
