ASSOCIATION OF AMERICAN RAILROADS
RESEARCH AND TEST DEPARTMENT

EVALUATION OF NAIL PLATES AS AN
ANTI-SPLITTING DEVICE FOR
TIMBER TIES

REPORT NO. R-542

January, 1983

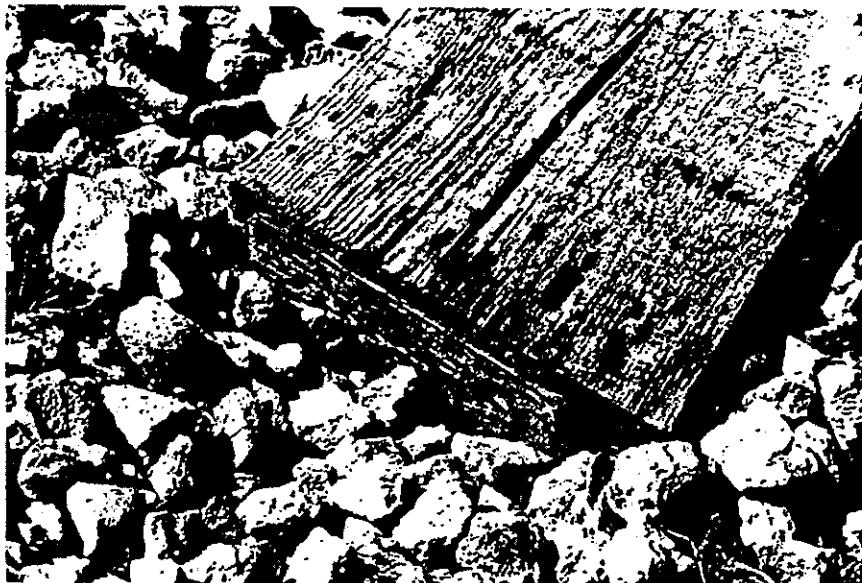
Figure 2. South End of Tie Number 70, Showing the Typical Restraining Action of a Nail Plate in Arresting the Growth of a Check and Potential Split.

- a. 14 control ties had checks enlarged to more than 1/4 inch;
- b. 27 control ties had checks enlarged to 1/4 inch or less;
- c. 3 control ties had splits that had enlarged, in one case from 1/8 inch to 2-1/4 inch;
- d. Of the nail-plated ties that had checks, none were larger than 3/8 inch;
- e. Of special interest was the fact that for all of the checks in the nail-plated ties, the check appeared to stop at the edge of the plate area and did not progress beyond. In the case of Tie No. 70 (Figure 2), the nail plates appears to have halted the progress of a potential split;

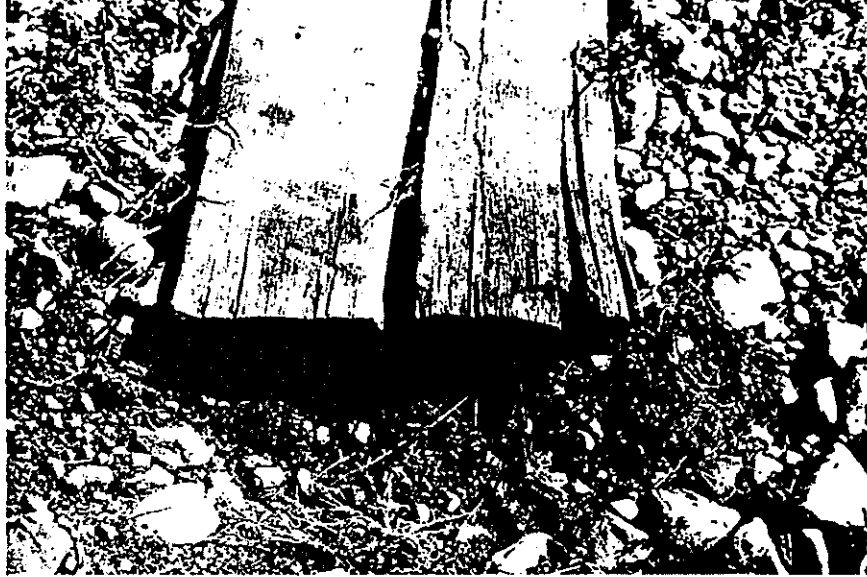
Figure 3. South End of Control Tie Number 7, Showing a Typical Split that was Only 1/16 Inch Wide at the Time of Installation in 1964.

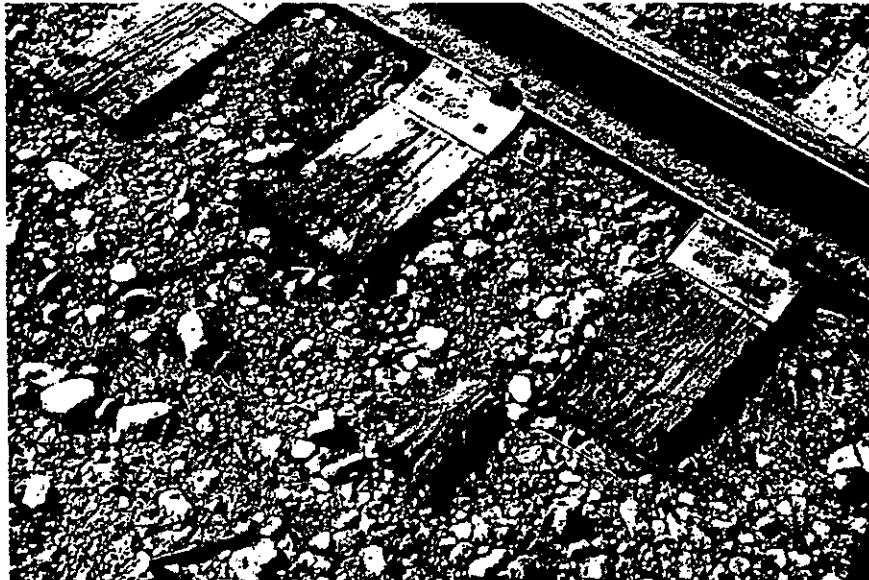
Figure 4. South Ends of Nail-Plated Tie Number 35 (Left), Control Tie Number 36 (Center), and Nail-Plated Tie Number 37 (Right), Showing a Split in the Control Tie and the Restraint to Splitting Caused by the Nail Plates.

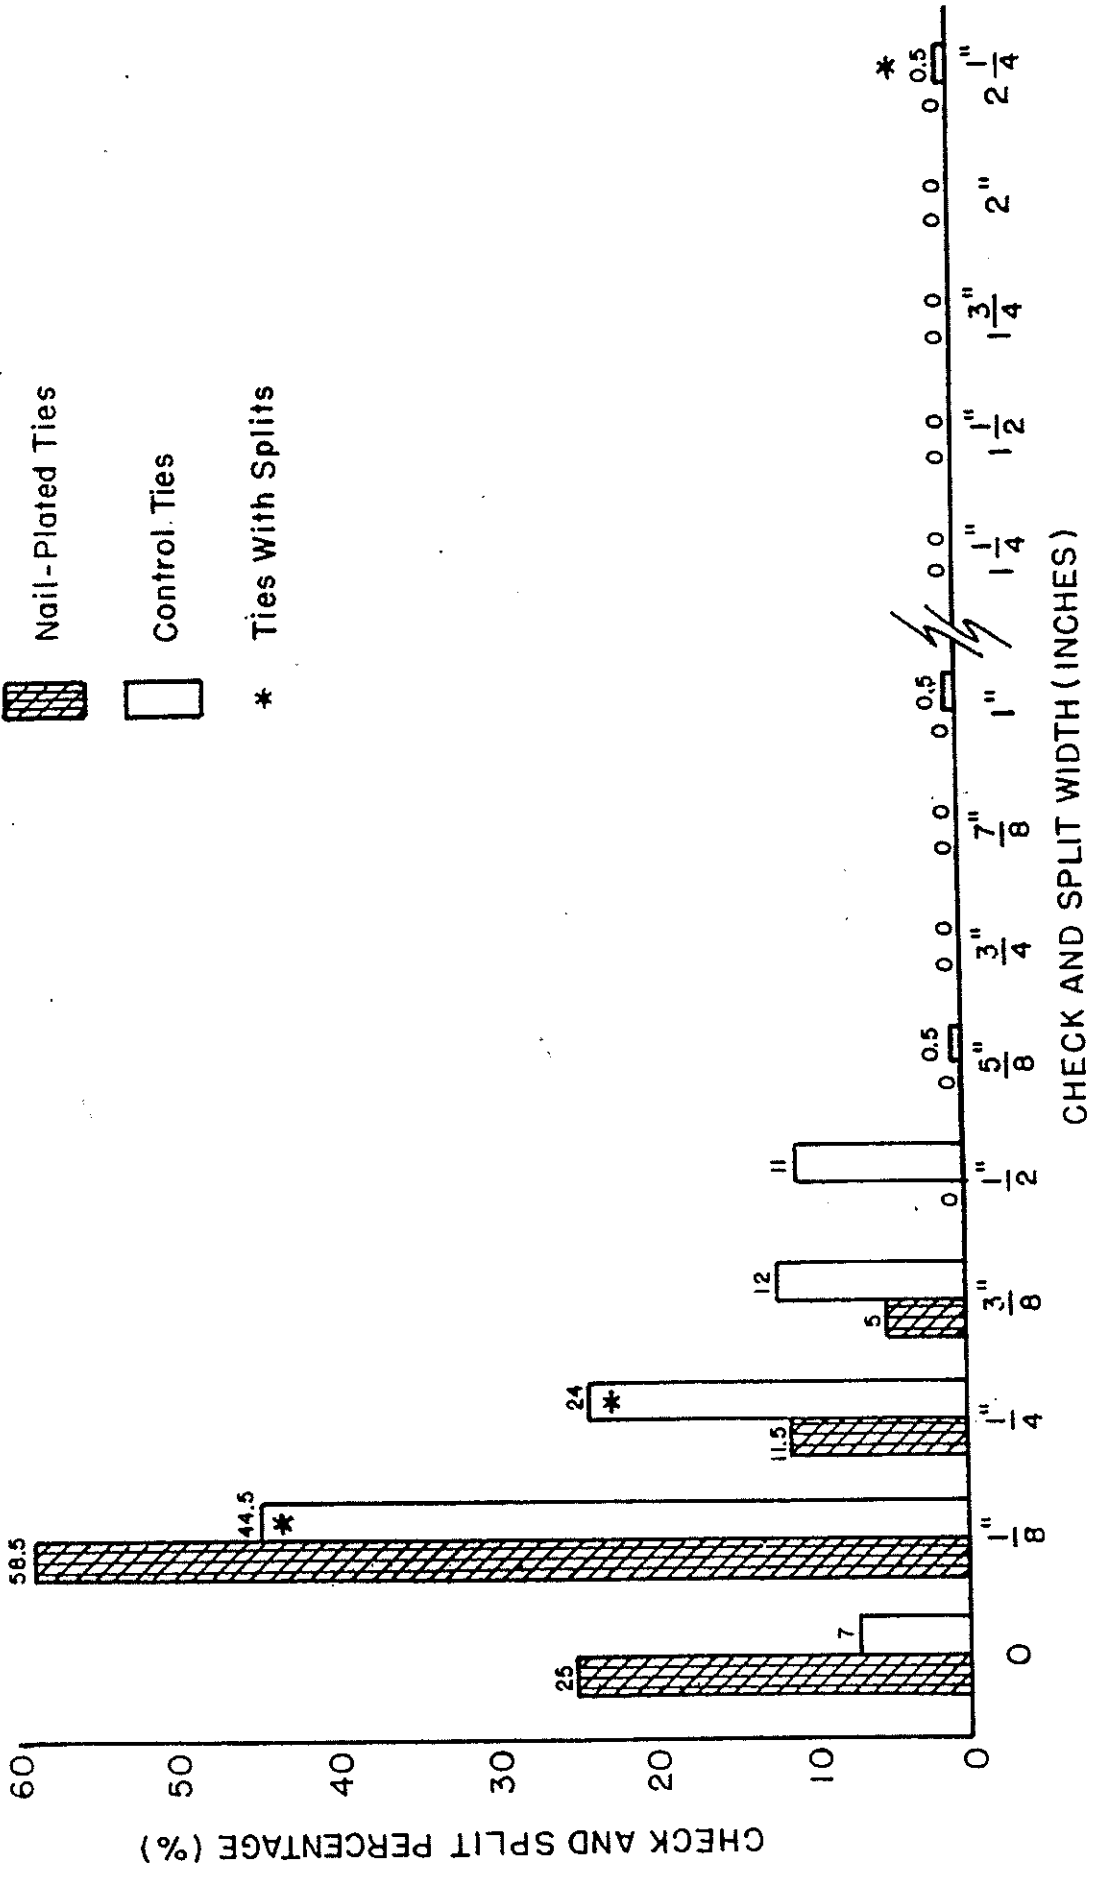
As shown in Figure 6, 25% of the nail-plated ties had no checks or splits; 58.5% had only 1/8 inch checks; 11.5% had 1/4 inch checks and 5% had 3/8 inch checks. None of the nail-plated ties had splits.

In contrast, only 7% of the control ties had no checks or splits; 44.5% had 1/8 inch checks (one with a split); 24% had 1/4 inch checks with one split; 12% had 3/8 inch checks; 11% had 1/2 inch checks; 0.5% had 5/8 inch checks; 0.5% had 1 inch checks and 0.5% had 2-1/4 inch checks, with one having a large split.

Figure 6. Summary of Test Results from the Sixth Inspection in July, 1981, Showing the Relative Percentages Versus Sizes of Test Tie Checks and Splits, After 17 Years of In-Track Service.
