ZETA-TECH
Associates, Inc.
900 Kings Highway N.
P.O. Box 8407
Cherry Hill, NJ
08002
(609) 779-7795
FAX: (609) 779-7436

AAR Research Review
December 1-2, 1998

Report to RTA

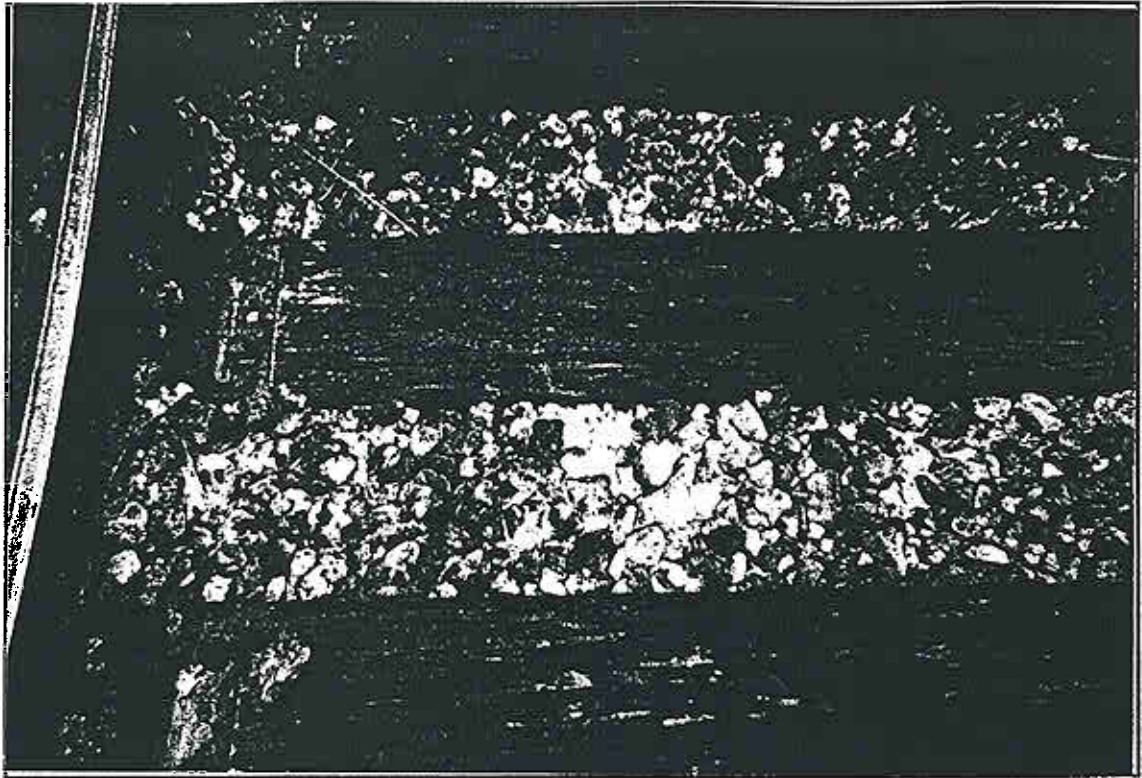
Photograph 1: Parallam Ties

- Gage retention performance of the Southern Yellow Pine laminated ties was comparable to Oak (under the premium trucks).
- The Parallam ties were reported as performing well with 165 MGT of tonnage. (Field inspection confirmed this, see attached Photo 1).

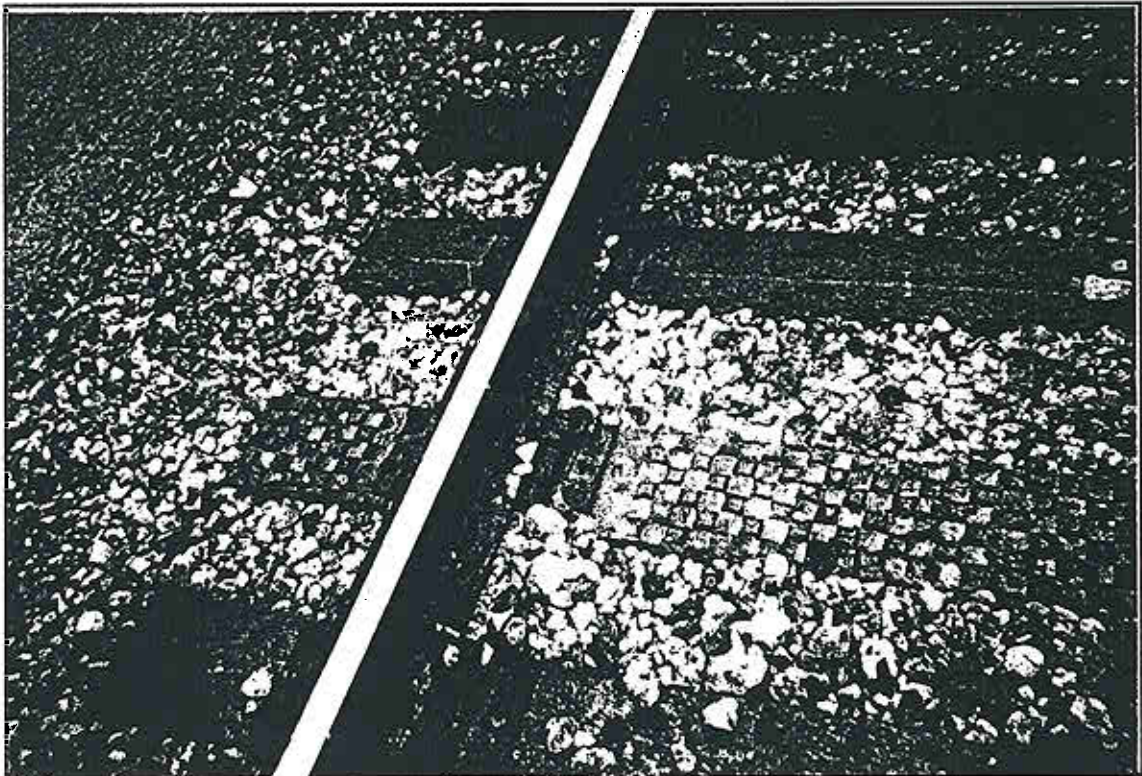
Photograph 2: Rough Surface Plastic Tie

- Lateral resistance tests of the plastic ties (single tie push tests) showed that the smooth sided ties had lower lateral resistance than typical wood ties. However, the roughened surface ties (see Photo 2) had a higher lateral resistance than the wood ties. This is illustrated in Figure 3. Note; all reported plastic ties were U.S. Plastics & Lumber (USP&L). There were also several proprietary plastic ties in track, but no information was provided about these other ties.

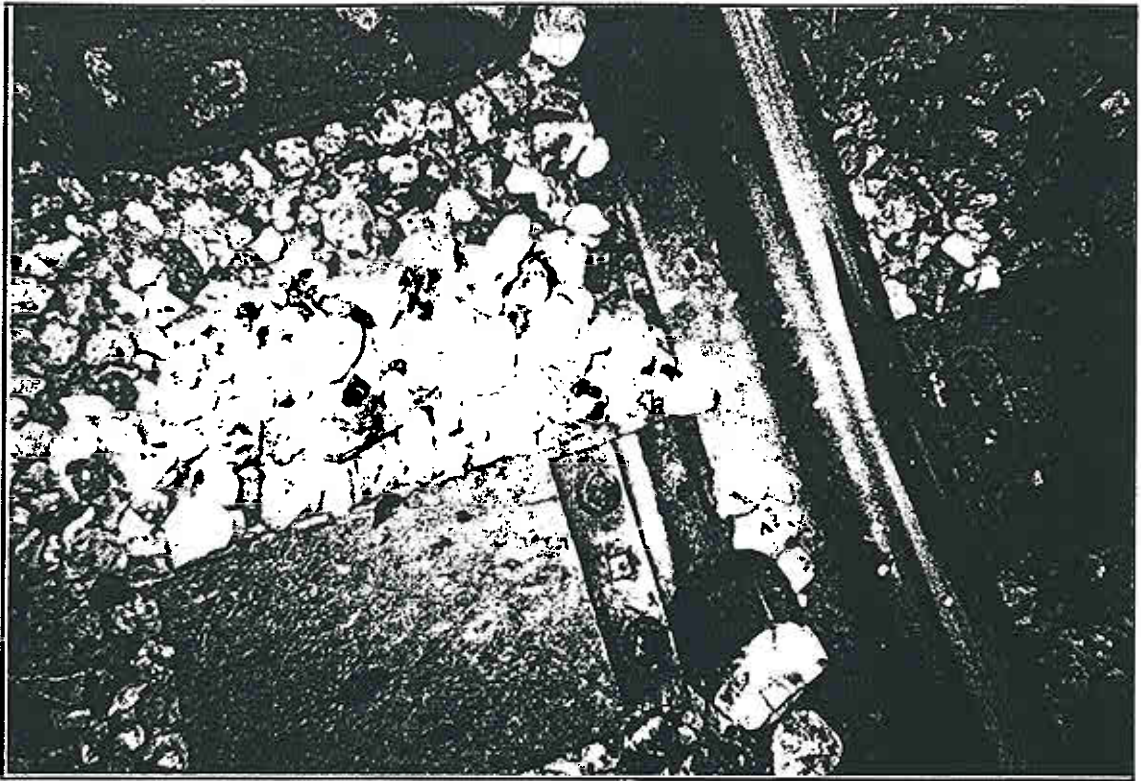
Photograph 3: USPL Plastic Tie with Crack

- The plastic ties were likewise reported as generally performing well. However cracking at the pre-bored screw spike holes (bored undersized) was reported. See visual observations (below).

- 1988 Oak ties in Section 7 continue to perform well. Over 880 MGT cumulative tonnage.
- Softwood ties in section 25 performing well (premium truck operations)
- Cracks were observed coming from the spike holes (undersize pre-bored holes for screw spikes) of several USPL ties in Section 7. See Photos 3 and 4.
- Concrete "ladder" sleepers in Section 38 were performing well after approximately 160+ MGT.
