**CROSSTIE AND FASTENER
TESTS AT FAST: 1988-1999**

REPORT NO. R-937

Transportation Technology Center, Inc.,
a subsidiary of the Association of American Railroads
Pueblo, Colorado

APRIL 2000

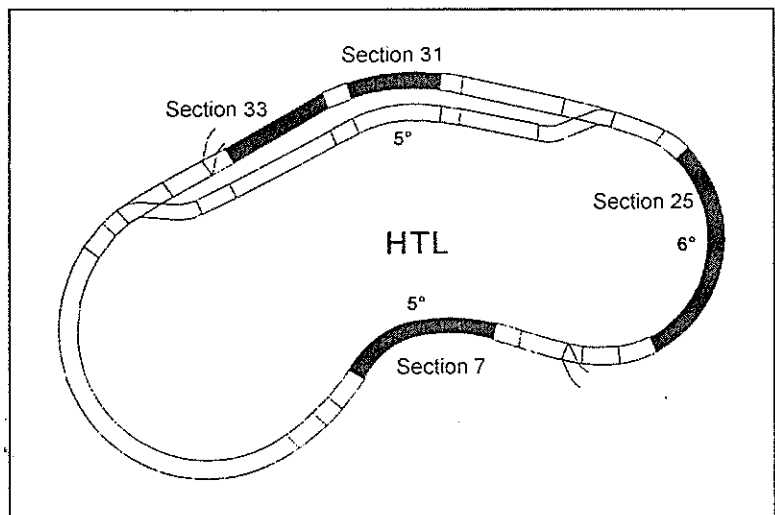
Exhibit 1. Wood Tie and Fastener Test Zone Locations on the High Tonnage Loop (HTL)

morning. It operates 4 days per week generating 3 to 5 million gross tons (MGT) weekly. The Tie and Fastener Test zones are located in Sections 7 and 31, both of which are 5-degree curves, and in the 6-degree curve of Section 25. At a steady 40 mph, the train runs at 1.7 inches over balance speed in Sections 7 and 31, and at 1.6 inches over balance speed in Section 25.

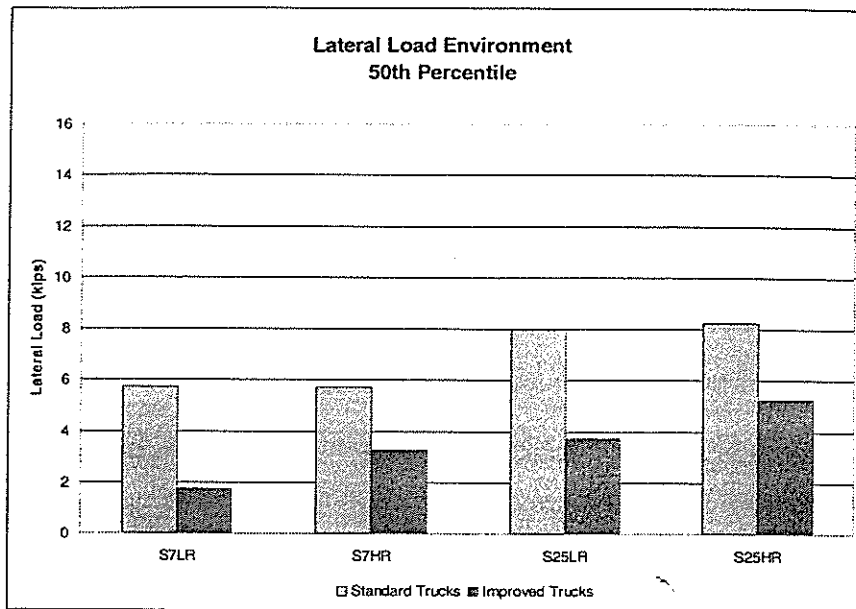
Exhibit 3. Median Lateral Loads on the High and Low Rails in Sections 7 and 25

The use of improved suspension trucks during Phase III testing significantly reduced the lateral load environment; and thereby its effect on the performance of the crossties and fasteners tested at FAST. Typical median lateral loads decreased by about 57 percent in Section 7 under improved suspension trucks from 5.8 kips to about 2.5 kips. Similar results were seen in the Section 25 6-degree curve where the use of improved suspension trucks reduced the typical median lateral loads about 45 percent from 8.1 kips to 4.5 kips. Although the load environment was significantly reduced with the introduction of improved suspension, the loads measured in the Section 25 6-degree curve remained higher, at 4.5 kips, than those in the 5-degree curve of Section 7 at 2.5 kips.

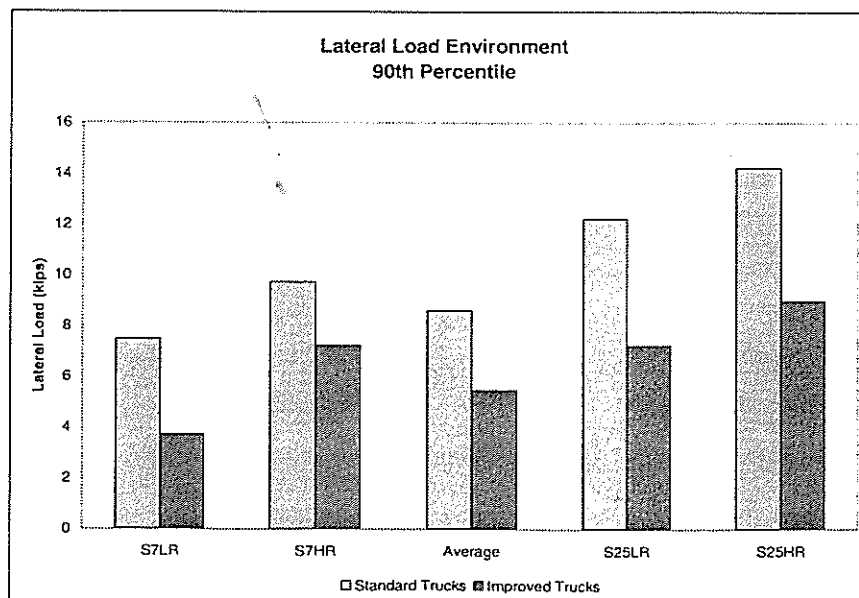
Exhibit 4. Lateral Loads at the 90th Percentile on the High and Low Rails in Sections 7 and 25

As shown in Exhibit 4, at the 90th percentile the average lateral load (high rail and low rail) in Section 25 was about 13.3 kips under standard suspension trucks and 8.1 kips under improved trucks for a reduction of 39 percent. Similarly, the 5.5 kips measured in Section 7 under improved suspension was about 36 percent less than the 8.6 kips measured under the standard trucks.

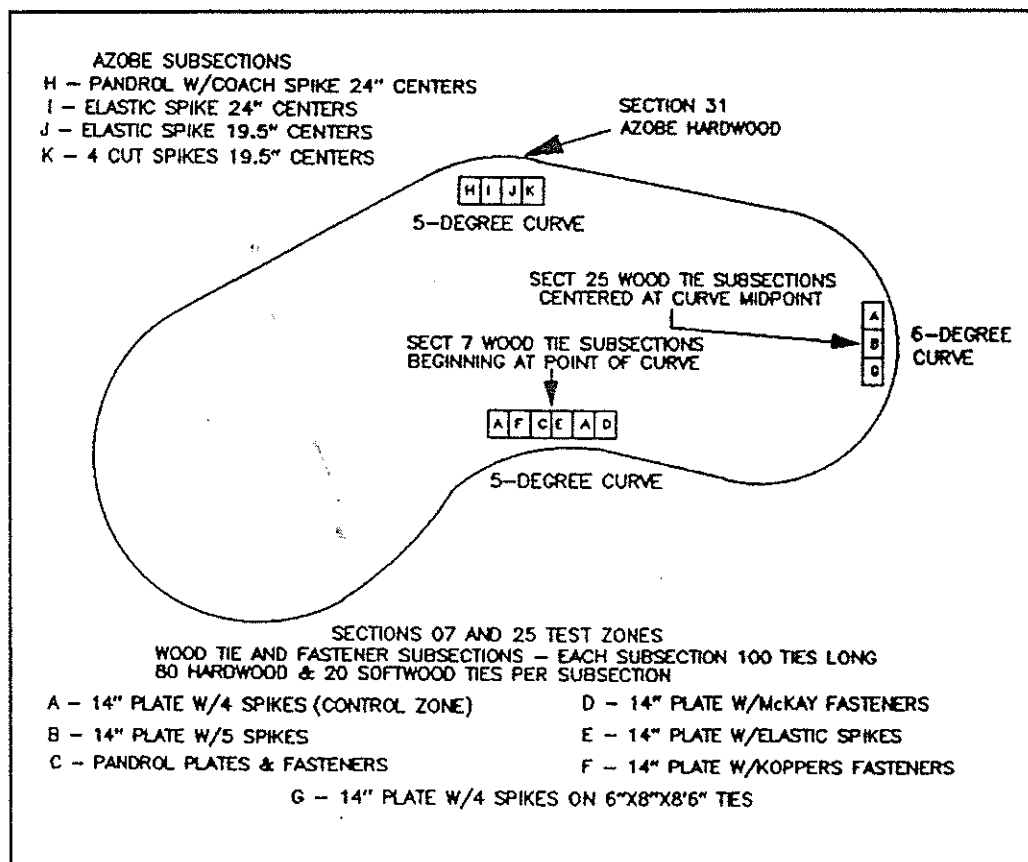
Exhibit 7. Location of the Wood Tie and Fastener Test Subzones on the HTL at the Start of Phase I

Section 31 at 19.5 inch centers. Half of these azobe ties were equipped with American Railway and Maintenance of Way Engineering Association (AREMA) 14-inch tie plates with four cut spikes per tie plate, and the other half were equipped with AREMA 14-inch tie plates and double elastic spikes. An additional 80 azobe ties were installed at 24-inch centers, half with double elastic spikes and half with PANDROL® E-clip fasteners. All ties were installed using the same basic procedure: about 6 inches of ballast was removed beneath the ties using a Cannon Track-Gopher; the existing ties were removed, and the pre-plated test ties were installed under existing rail. The track was re-ballasted and brought to final profile and alignment. All ties were new when installed.

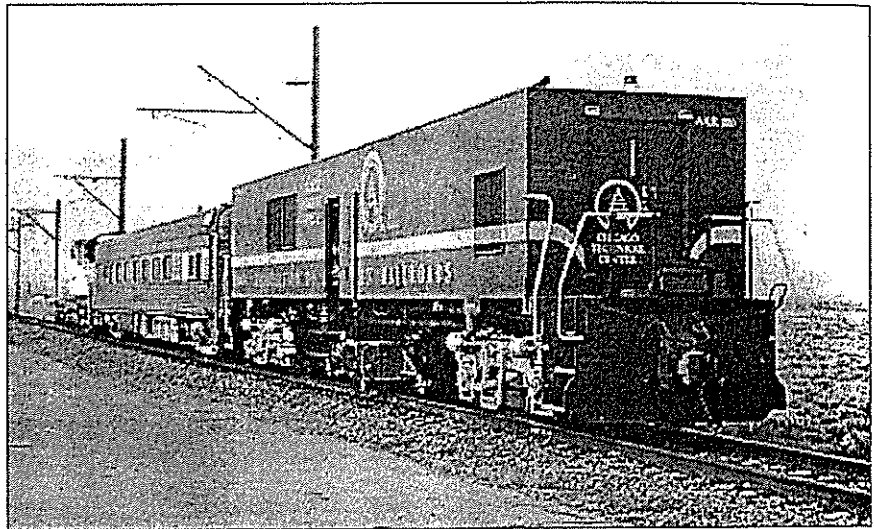
Exhibit 12. Track Loading Vehicle (TLV) Consist at TTC

actuators, a laser unloaded-gage measurement mechanism, and a split-axle wheelset loaded-gage measurement mechanism. The laser gage measurement system is located about 16 feet ahead of the centrally located split-

axle wheelset. The TLV is operated from the AAR-100 Research Car which is equipped with the electro-hydraulic actuator control system, a digital computer, data storage and display devices, analog-to-digital converters, keyboards, signal conditioning electronics, control-module electronics, and other hardware.

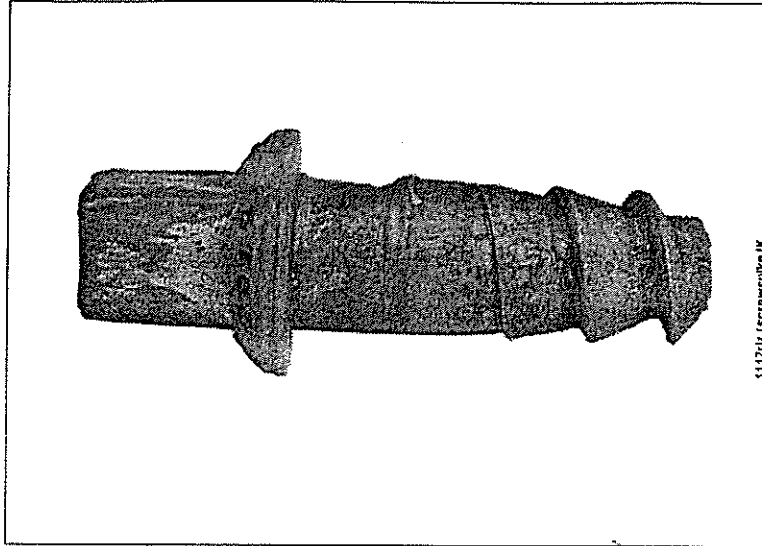
Exhibit 17. Fractured Screw Spike from Section 25

Five fractured samples were examined at TTCI's metallurgy lab. Each of the fractures on the forged screw spikes occurred between 2 and 2.5 inches below the head flat seating surface at thread roots that are directly in alignment with mechanical damage sustained at the screw spike shank/tie plate contact points. The initiation sites are directly below and in alignment with mechanical damage between the screw spikes and the interacting tie plate. In one instance, this damage produced deformation on the smooth shank portion of the screw spike penetrating to a depth of approximately 0.15 inch.

The lower density of the Douglas fir softwood ties may have exaggerated this condition by not holding the screw spike rigidly within the tie allowing the screw spike to move slightly. However, no fractures have been documented on other softwoods.

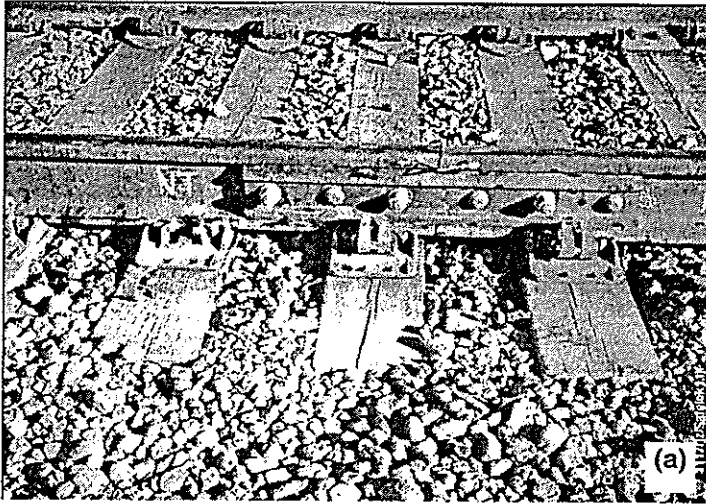
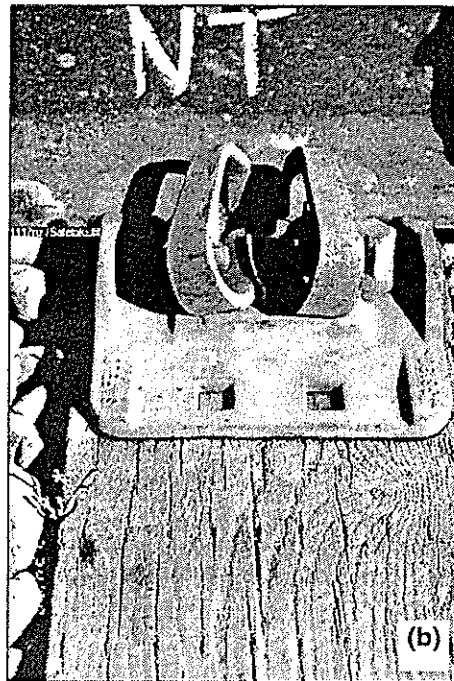
Exhibit 18. (a) One of the Rail Joints where SAFELOK® Rail Clip Fractures Occurred and (b) a Typical Fracture

SAFELOK® rail clip failures occurred regularly in the 5-degree curve of Section 7 on wood ties near mechanical rail joints where vertical track deflection (that is, track pumping) is more severe than under continuous welded rail (cwr). The five SAFELOK rail clips examined at TTCI's metallurgy lab fractured at the top corner of the radius between the two toe load prongs. The rail clip fractures occurred primarily on wood ties fitted with SAFELOK tie plate model number 38190. Exhibit 18 shows one of the rail joints where clip fractures occurred and a typical fracture.

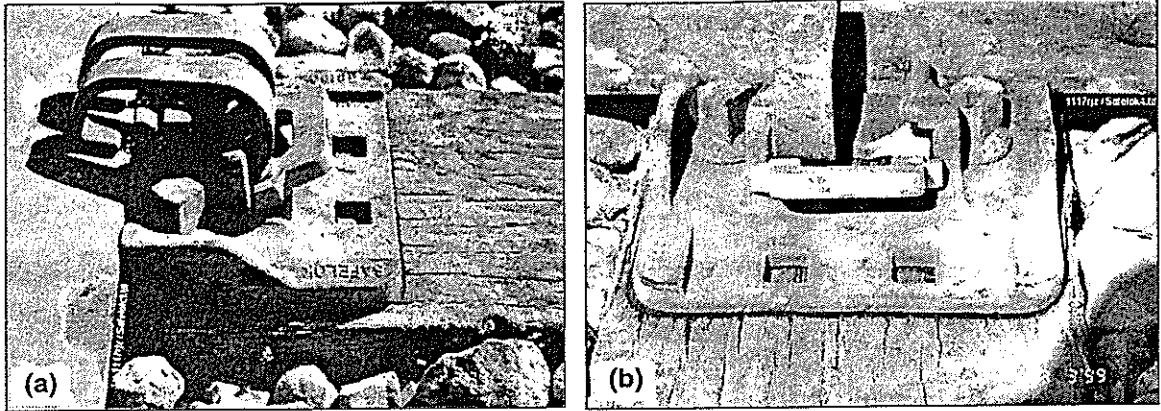
Exhibit 19. (a) SAFELOK[®] Rail Clip with Wedge and (b) Fractured Clip after about 2.5 MGT

Six rail clip wedges, provided by PANDROL, were installed in an effort to eliminate the problem. Installation is by impact after the rail clip is in place. Two of the wedges were installed on the low rail, one on the gage and one on the field side of the same tie. The remaining four wedges were installed on the high rail under the four rail clips of two adjacent ties. The clips installed at the low rail field side locations using wedges fractured several times at about 2.5 MGT intervals — about the same as without the wedge. Exhibit 19 shows a wedge in place between the rail clip and the tie plate and a fractured rail clip after about 2.5 MGT.

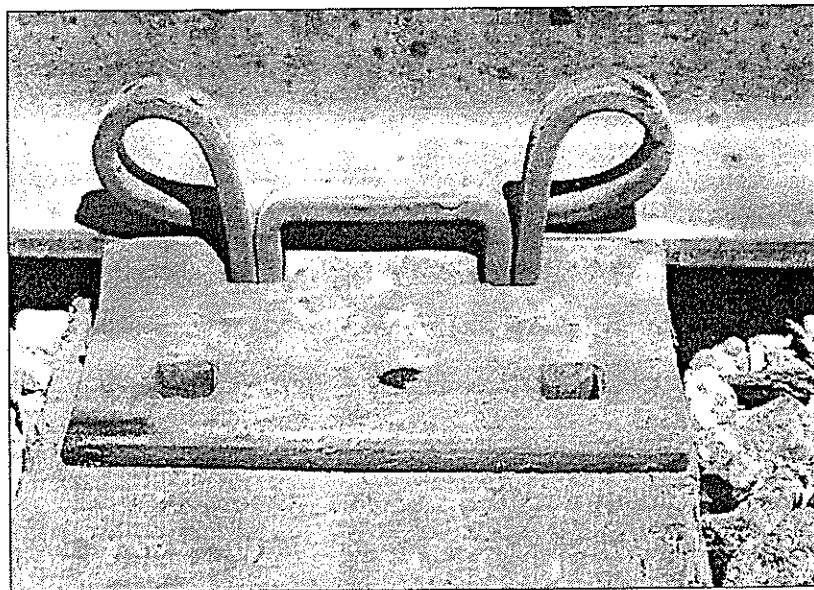
Exhibit 20. Double Elastic Fastener Similar to Those Removed from the Azobe Ties

Double elastic fasteners similar to the one shown in Exhibit 20 were in service in the 19.5-inch and the 24-inch spaced azobe tie subzones of Section 31 for 390 MGT. During a recent rail change, a number of the spike type elastic fasteners fractured below the tie surface as they were being removed. At that time all the double elastic fasteners in those two subzones were replaced with a typical cut spike system. Double elastic fasteners are still in service and are performing adequately in an oak tie subzone in the 5-degree curve of Section 7.

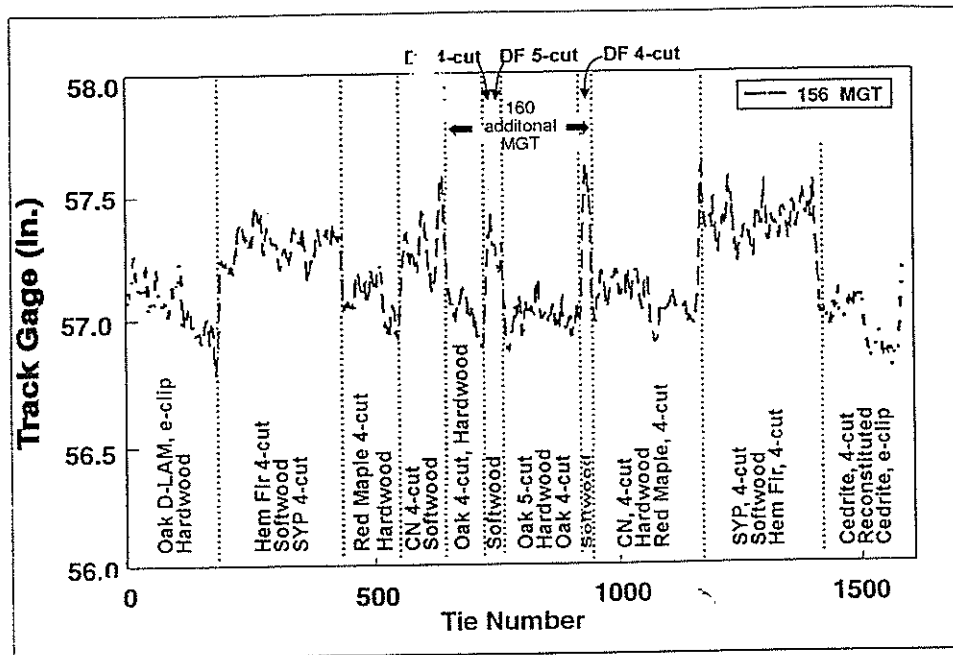
Exhibit 21. Measured Track Gage Using the EM-80 Track Geometry Vehicle

Exhibit 21 shows the track gage measured using EM-80 track geometry car data. Data in the center of the curve, labeled 160 additional MGT, represents gage degradation of the ties installed at the beginning of Phase I. After 360 MGT of HAL traffic, two of the three Douglas fir subzones of that original installation reached the FRA track safety standard gage limit for Class 4 track of 1 inch over standard gage (56.5 inches). Of the two subzones, one was fastened using four cut spikes per tie plate and the other using five cut spikes per plate. At that point, the two subzones were re-gaged and the fastening system changed to PANDROL plates, e-clips, and screw spike hold downs. Shortly thereafter, at 375 MGT, the third of the original Douglas fir subzones also reached the gage limit and it was re-gaged. This subzone, however, remained fastened with four cut spikes per tie plate. The Douglas fir ties in Section 7, having accumulated the same amount of tonnage, required no maintenance. Two hem fir and two southern yellow pine subzones also reached that limit after 200 MGT and they too were re-gaged.

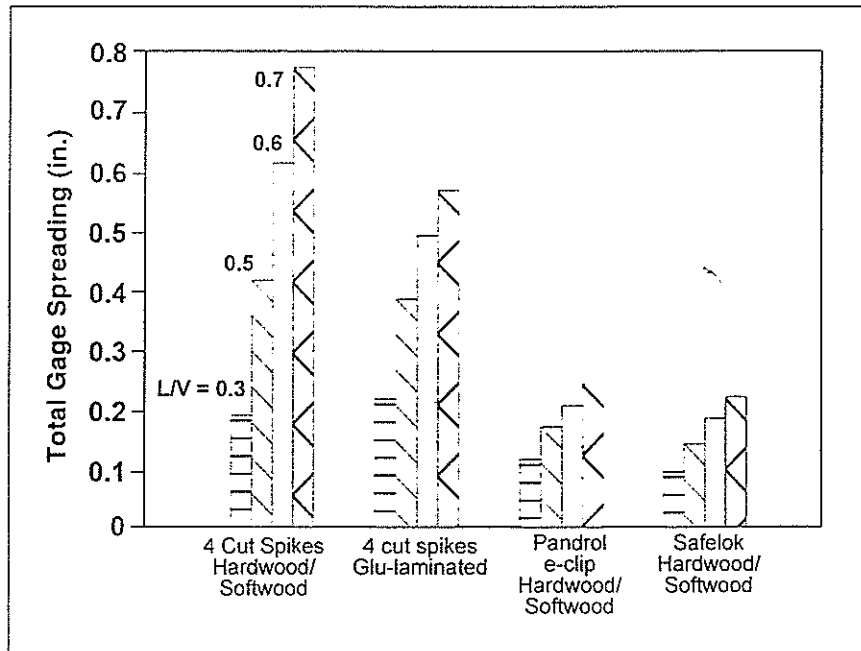
Exhibit 22. Comparison of Static Gage Spreading on Hardwoods and Softwoods using Different Fasteners, Section 7, 5-degree Curve

five times the gage spreading at a 0.3 L/V ratio in the case of domestic hard/softwoods with four cut spikes in Section 7. Such a dramatic effect is not evident with the PANDROL E-clip or SAFELOK fasteners where only approximately a doubling of the gage spreading occurred when the L/V ratio was increased from 0.3 to 0.7.

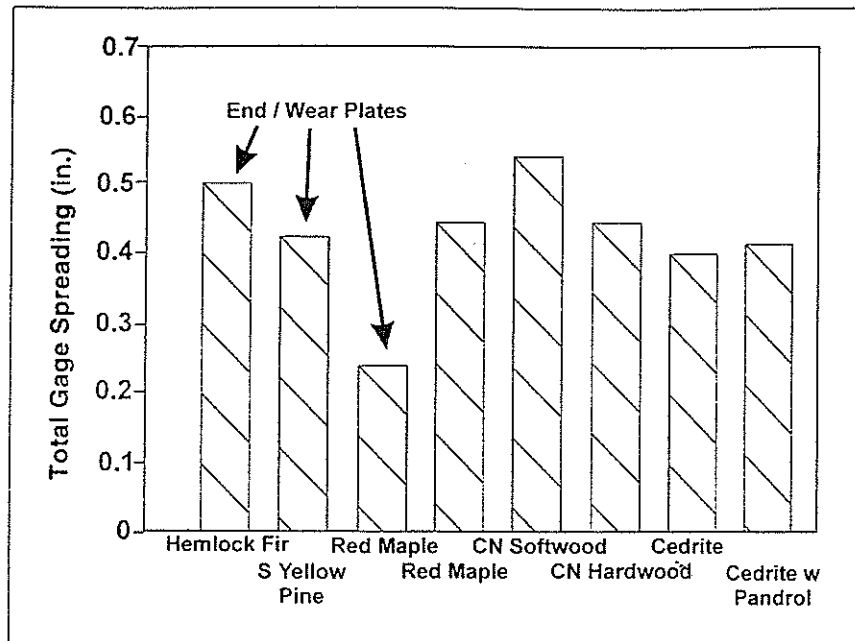
Exhibit 23. Comparison of Static Gage Spreading of Different Tie Types Fastened with Cut Spikes at 0.6 L/V (22-kip/39-kip), Section 25, 6-degree Curve

Exhibit 23 compares the gage spreading strength of different types of wood ties in Section 25 using a 22-kip gage spreading load under a 39-kip wheel load. With the exception of the Red Maple, there is no significant difference in the gage widening strength of these different tie types.

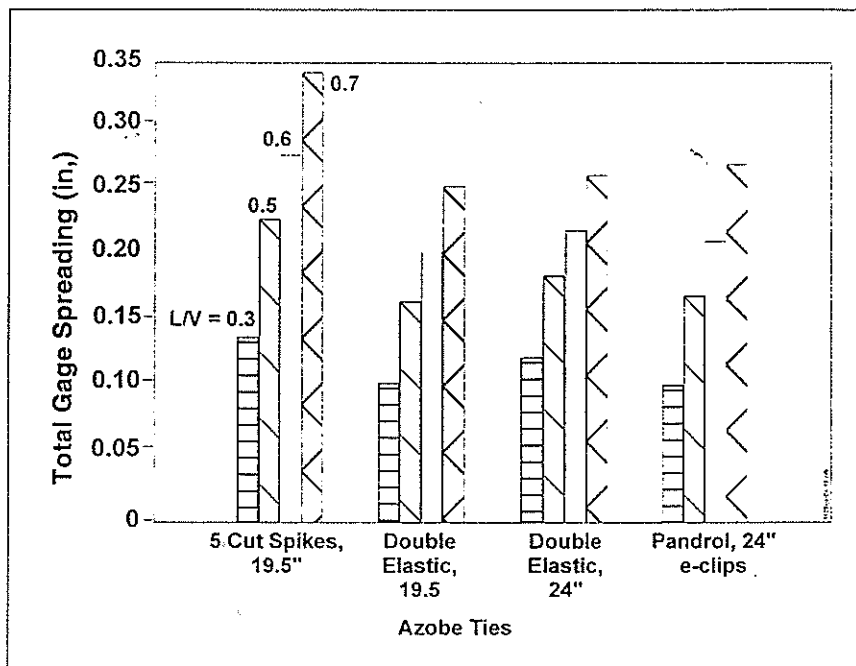
Exhibit 24. Comparison of Static Gage Spreading of Different Fasteners on Azobe Ties, Section 31, 5-degree Curve

The tangent test zone in Section 33 consisted of domestic hard/softwood ties with four and five cut spikes, Cedrite ties with PANDROL E-clip fasteners, and concrete ties with e-clips. A comparison of responses of the five cut spike domestic hard/softwood ties in this zone (Exhibit 25) to the response of the five cut spikes on azobe ties (Exhibit 24) clearly shows the much greater strength of the azobe ties over the domestic hard/softwood ties.

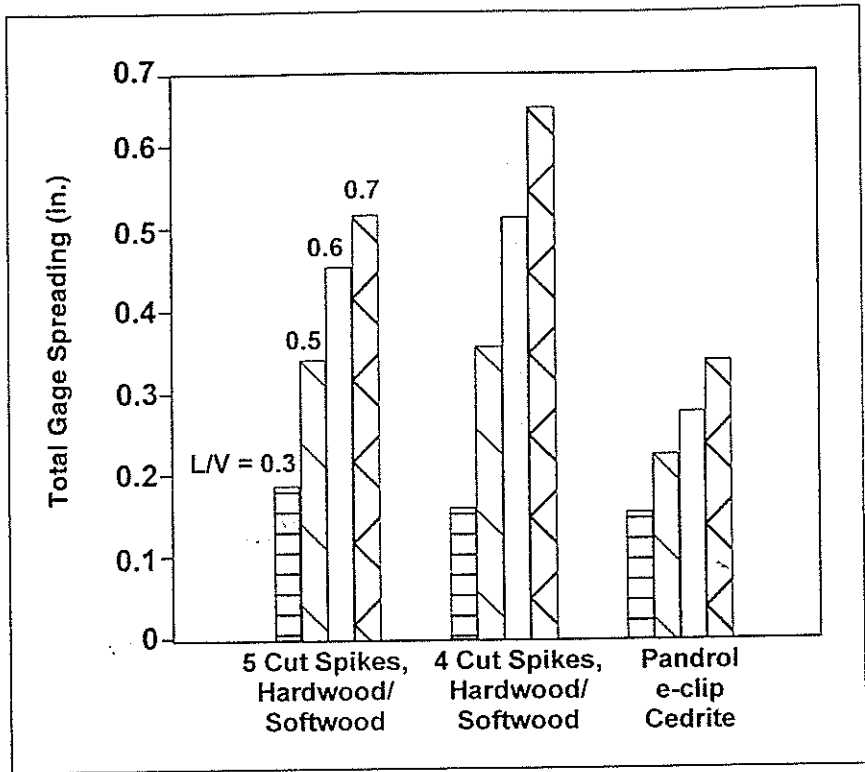
Exhibit 25. Comparison of Static Gage Spreading on Different Tie/Fastener Combinations, Section 33, Tangent Track

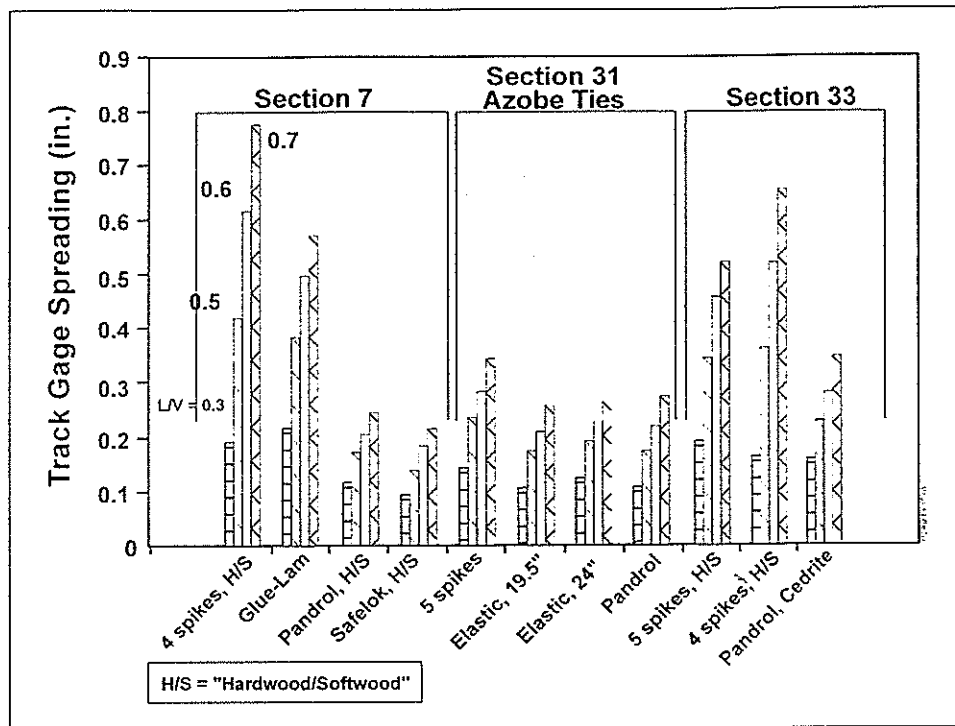
Exhibit 26. Comparison of Static Gage Spreading of Different Tie/Fastener Combinations in the Two 5-degree Curves (Sections 7 and 31) and the Section 33 Tangent Test Zone

Exhibit 26 shows overall comparisons of the fasteners tested in Sections 7, 31, and 33 under 39-kip wheel loads. The exhibit shows that an increasing L/V ratio results in a much greater increase in gage spreading in the case of domestic hard/softwoods with four cut spikes than in that of elastic fasteners such as PANDROL E-clip and SAFELOK.

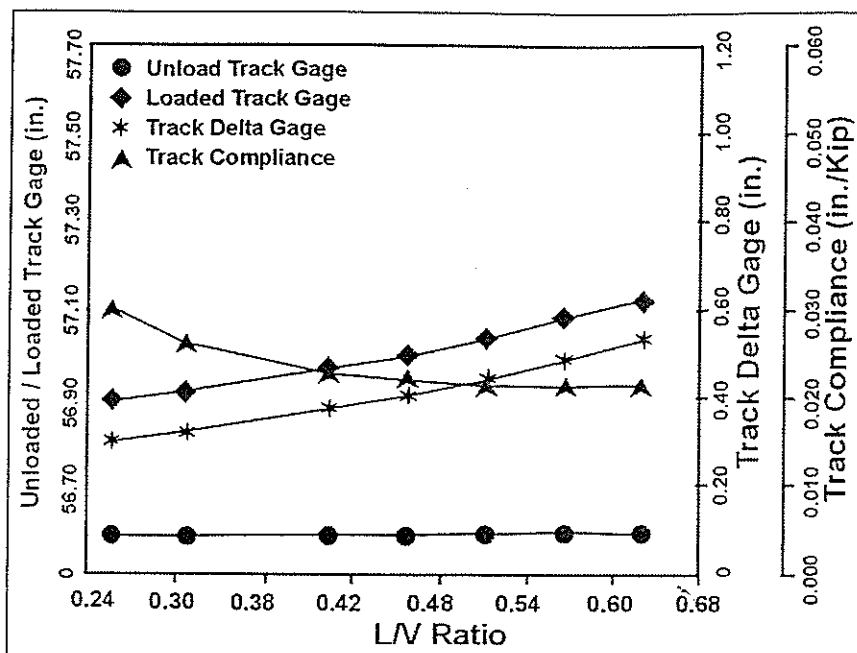
Exhibit 27. Concrete Ties with Pandrol E-clips, Unloaded, Loaded, Delta Gage and Track Compliance versus L/V Ratio where V=39 Kips

Exhibit 27 show the results of the TLV in-motion gage restrain tests conducted on the concrete ties of the 5-degree curve of Section 3.

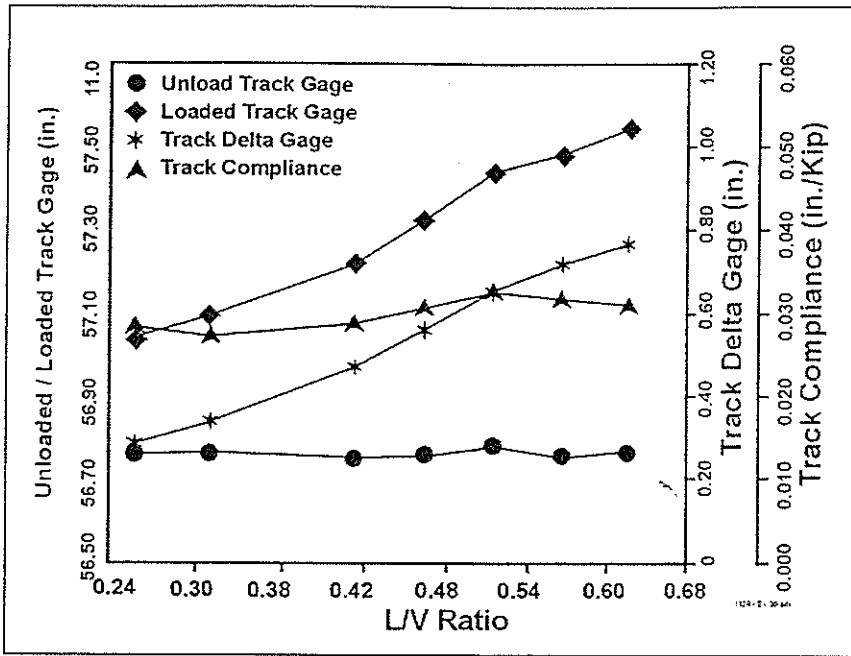
Exhibit 28. Hardwood/Softwood Ties with Four Cut Spikes, Unloaded, Loaded, Delta Gage and Track Compliance versus L/V Ratio where V=39 Kips

A very important characteristic to note from these curves is that, for cut spikes on hard/softwood ties and glue laminated ties, the track compliance stays approximately constant with increasing magnitudes of gage spreading load or the corresponding L/V ratio. On the other hand, in the case of the concrete ties with PANDROL E-clips and wood ties with e-clips and SAFELOK fasteners, the track compliance decreases with increasing load or L/V ratio. Since track compliance is the quotient between delta gage and the corresponding gage spreading load, constant compliance implies linearly increasing magnitude of delta gage with respect to gage spreading load. In other words, the behavior of hard/softwoods with cut spikes is like that of a linear spring. In contrast, in the case of concrete ties and wood ties with PANDROL and SAFELOK fasteners, gage hardening characteristics are apparent. That is, they provide increasing gage spreading strength at higher gage spreading loads. The occurrence of gage spreading stiffness with increasing gage spreading loads is one of the most important results from these tests.

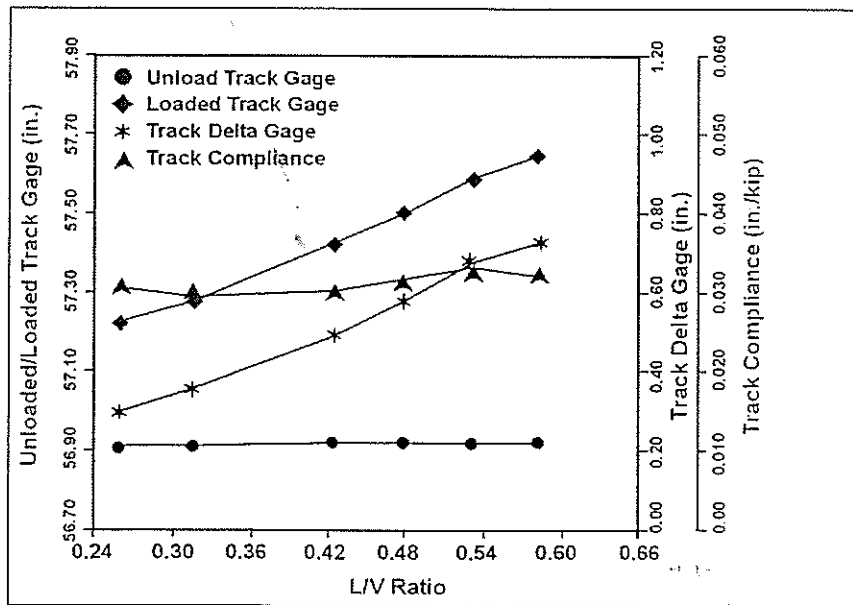
Exhibit 29. Glue Laminated ties with Four Cut Spikes, Unloaded, Loaded, Delta Gage and TRACK Compliance versus L/V Ratio where V=39 Kips

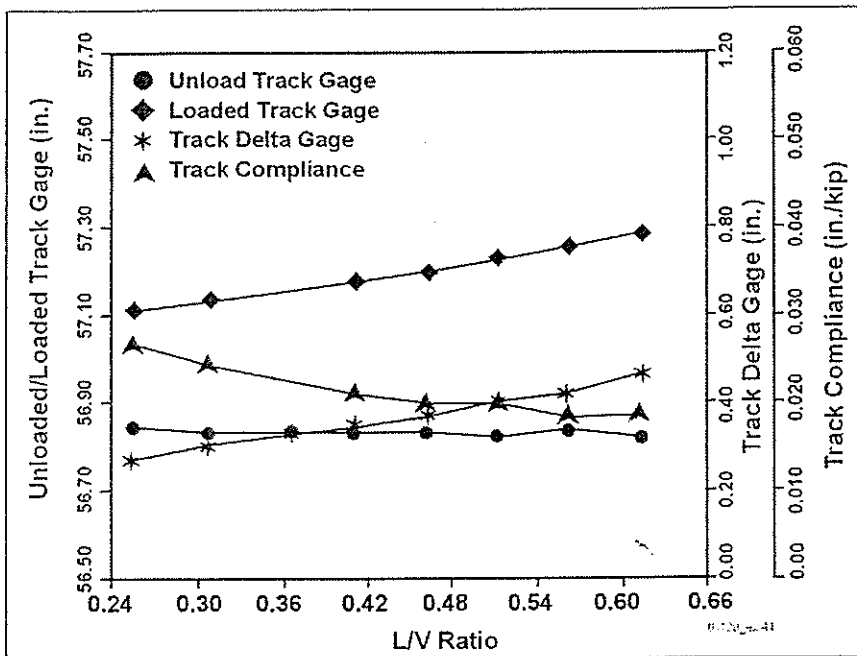
Exhibit 30. Hardwood/Softwood Ties with Pandrol E-clips. Unloaded, Loaded, Delta Gage and Track Compliance versus L/V Ratio where V=39 Kips

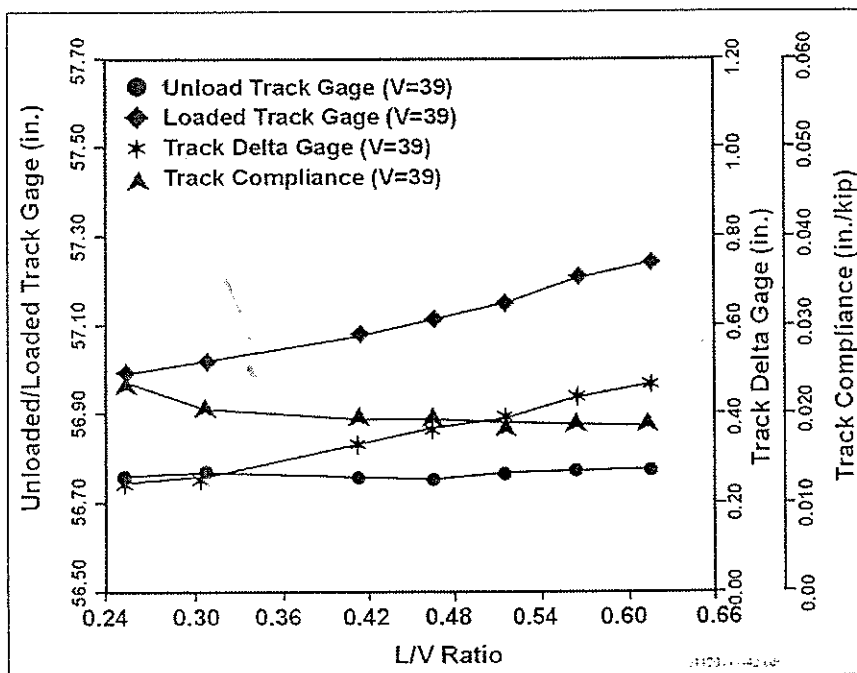
Exhibit 31. Hardwood/Softwood ties with Double Elastic Fasteners, Unloaded, Loaded, Delta Gage and Track Compliance versus L/V Ratio where V=39 Kips

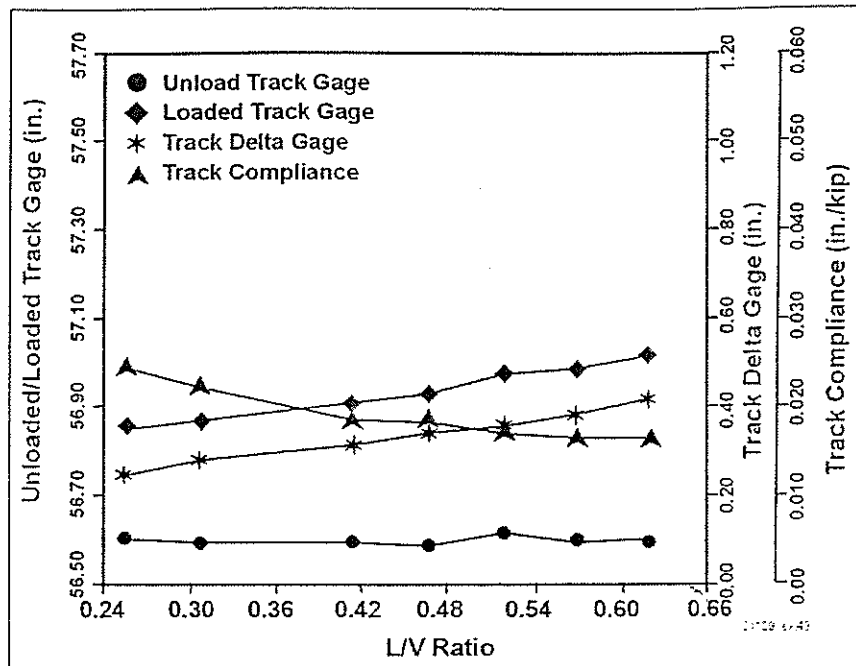
Exhibit 32. Hardwood/Softwood ties with SAFELOK® Fasteners. Unloaded, Loaded, Delta Gage and Track Compliance versus L/V Ratio where V=39 Kips

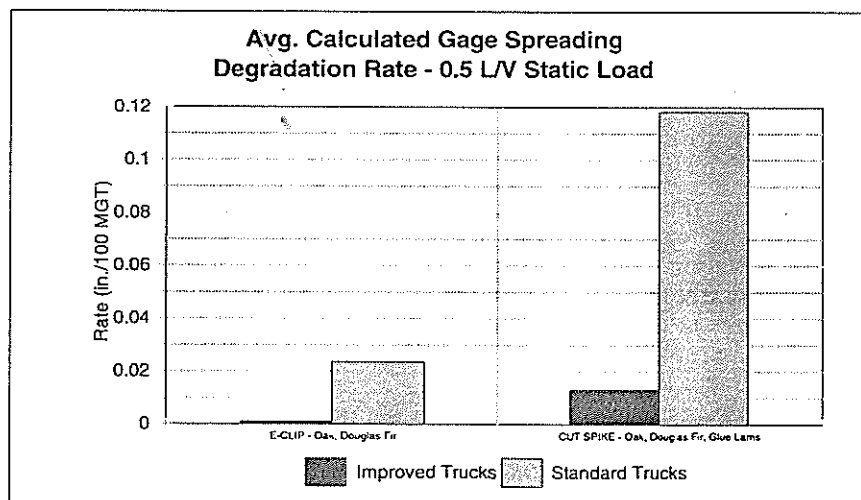
Figure 33. Average Calculated Gage Spreading Degradation Rate Under Static 0.5 L/V Loads in the 5-degree Curve of Section 7

Exhibit 33 compares oak, Douglas fir, and glued laminated ties fastened with cut spikes under standard and improved suspensions with oak and Douglas fir ties fastened with PANDROL E-clip elastic fasteners, again under standard and improved trucks. The results show that the average calculated gage spreading degradation rate was nearly five times greater with cut spike fasteners than with PANDROL E-clip elastic fasteners during Phases I and II under the standard suspension trucks. Under the improved trucks, the difference in gage spreading degradation became very small between the two fastening systems.

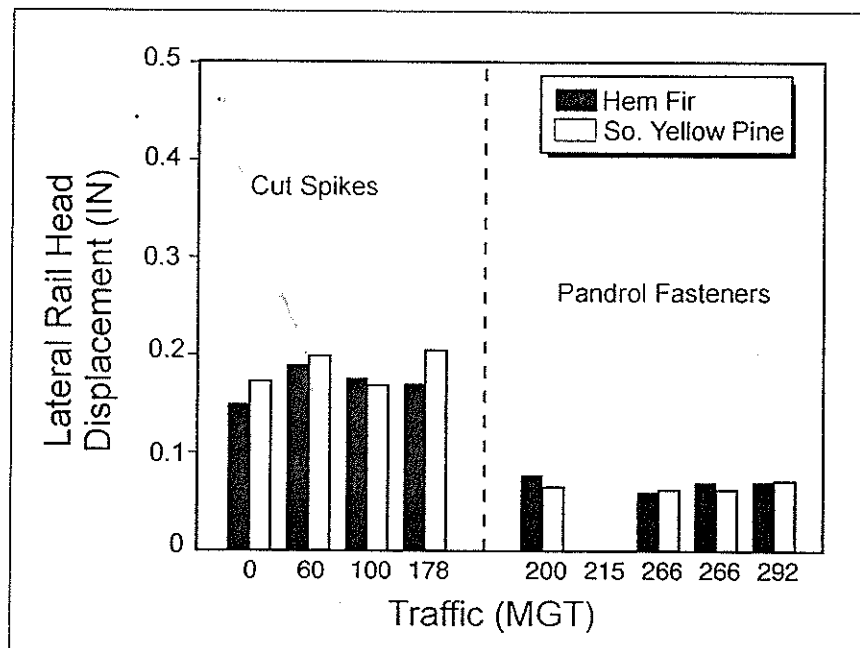
Exhibit 34. Comparison of Gage Restraint of Hem Fir and Southern Yellow Pine Ties Refitted with Pandrol E-clips after Re-gaging

During Phase II operations, many of the fasteners in the combined Wood Tie and Fastener Test and Rail Grinding Test zone of Section 25 were disturbed regularly due to rail plug replacement and re-gaging. Exhibit 34, however, shows about 50 percent increase in gage restraint when the hem fir and southern yellow pine subzones, which were originally fastened with cut spikes were re-gaged and refitted with PANDROL E-clip elastic fasteners.

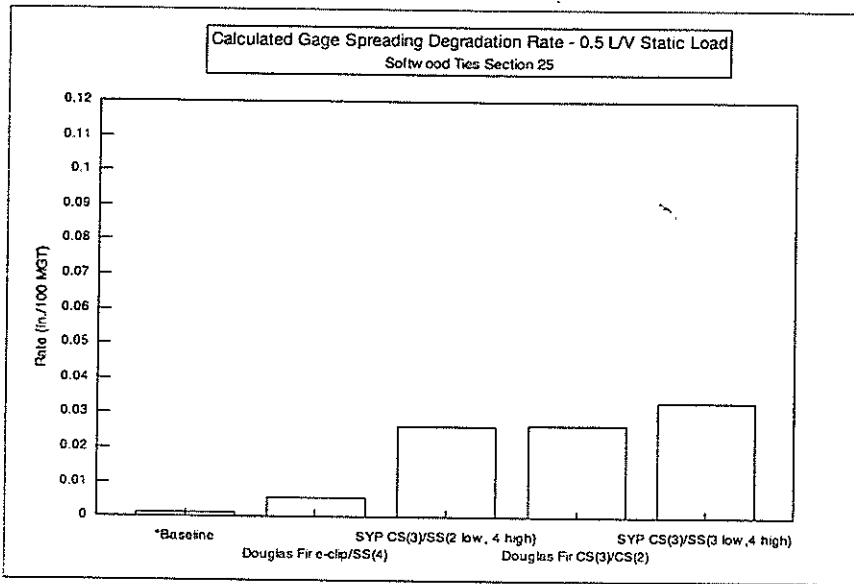
Exhibit 35. Calculated Gage Spreading Degradation Rate of Softwood Ties under Static 0.5 L/V Load Ratio in the 6-degree Curve

Exhibits 35, 36, and 37 illustrate the calculated gage spreading rate of the softwood, hardwood, and alternative ties tested in Section 25 during Phase III. The gage spreading degradation rate of the Douglas fir and southern yellow pine softwood ties and the oak ties, all fastened with cut spikes in Section 25 under improved trucks, was comparable to that of the Douglas fir and oak ties fastened with PANDROL E-clips in Section 7 under the standard truck conditions.

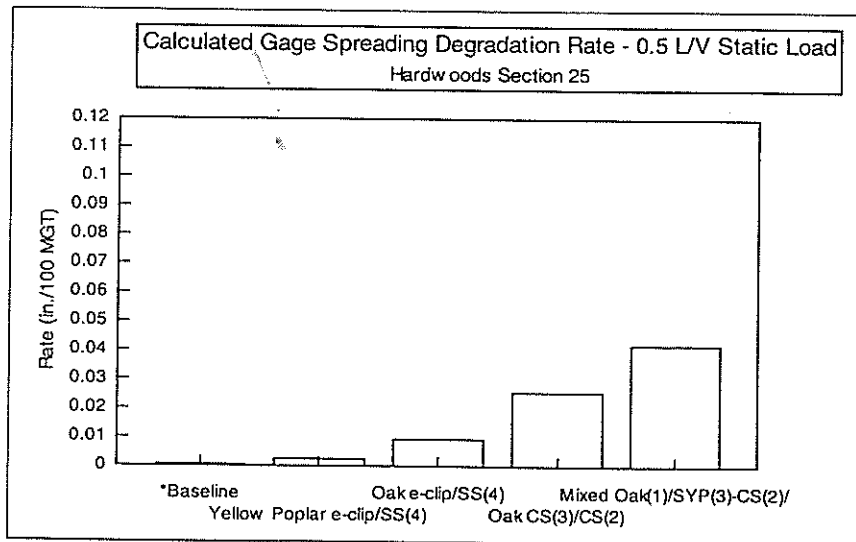
Exhibit 36. Calculated Gage Spreading Degradation Rate of Hardwood Ties under Static 0.5 L/V Load Ratio in the 6-degree Curve

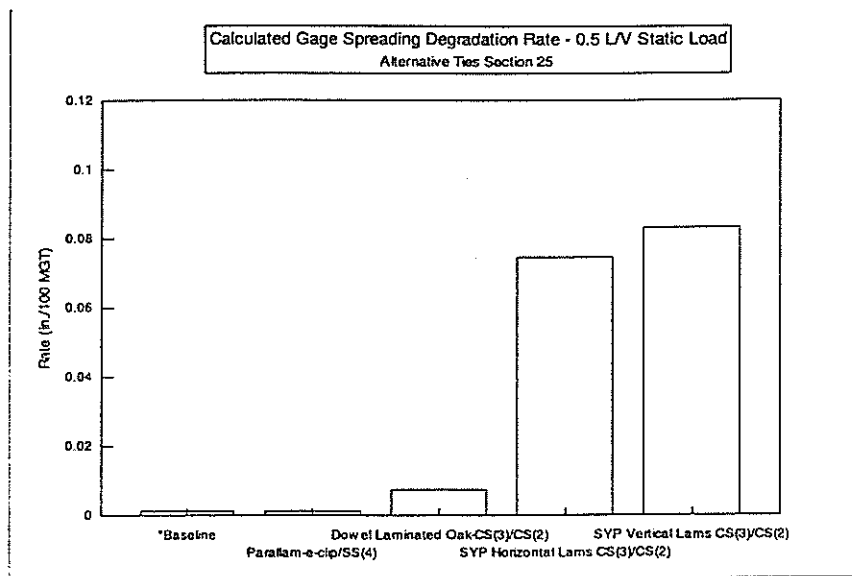
Exhibit 37. Calculated Gage Spreading Degradation Rate of Alternative Ties under Static 0.5 L/V Load Ratio in the 6-degree Curve

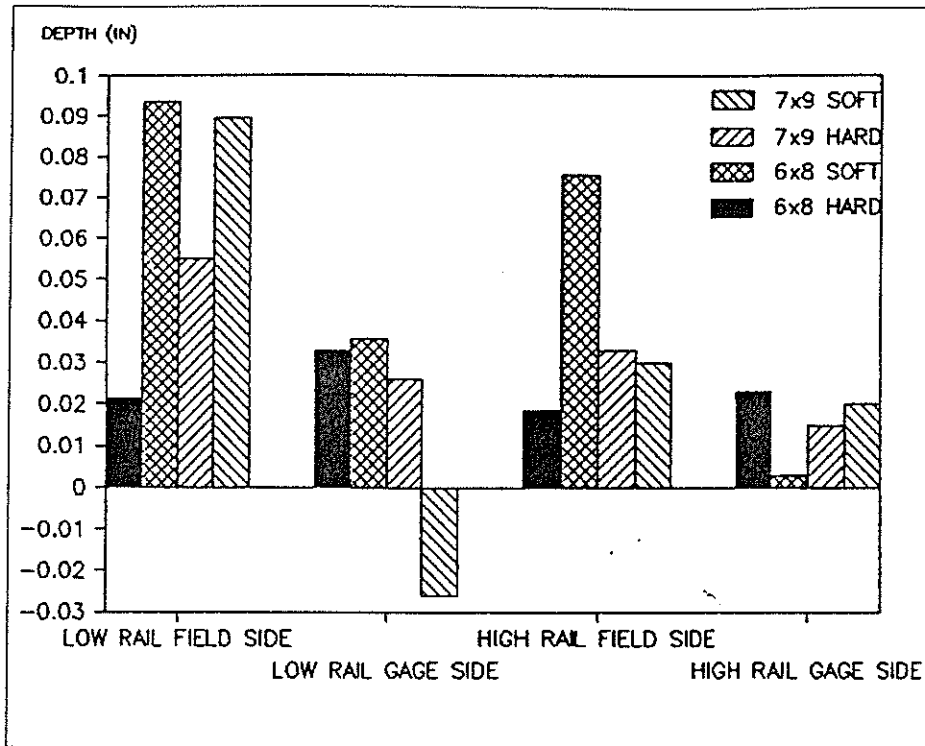
Exhibit 38. Average Tie Plate Cutting Depth on Hardwood and Softwood Ties in Section 25 after 160 MGT

None of the wood tie test zones showed any significant degradation in track geometry. Other than repair of a track buckle in Section 7 at 45 MGT, neither of the original test zones in Sections 7 or 25 were surfaced or lined during the initial 160 MGT of Phase I HAL operations.

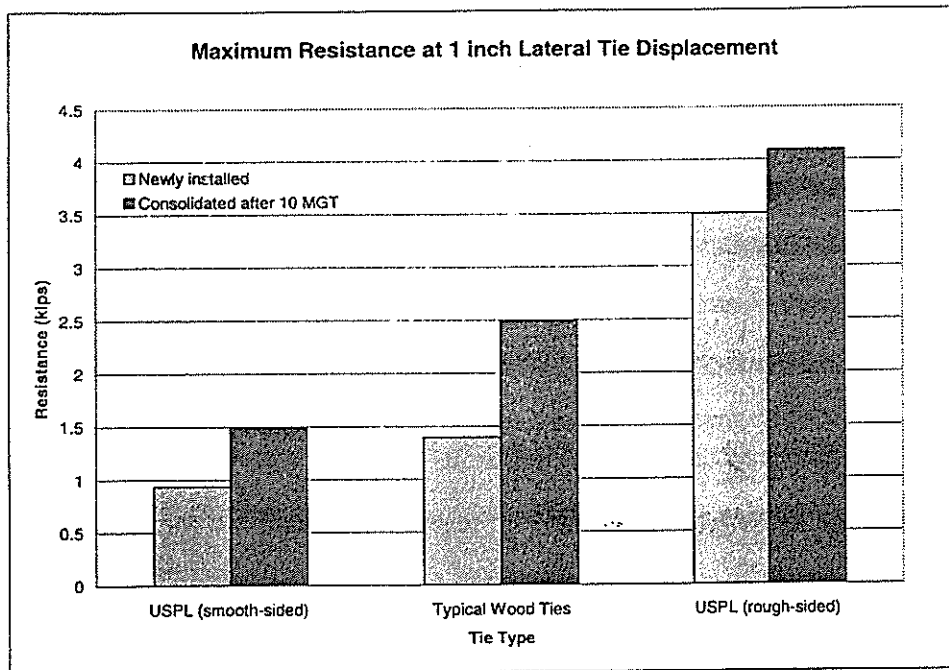
Exhibit 39. Maximum Single Tie Resistance at 1 inch Lateral Displacement

- The difference between single-tie lateral resistance under newly installed versus consolidated condition was less for the plastic composite ties than for the wood ties. That is, the lateral resistance of the plastic ties when newly installed was closer to their resistance after consolidation than was the case with the wood ties..
- The lateral resistance provided by typical consolidated-track single wood ties was nearly 70 percent greater than that of single smooth-sided plastic ties at consolidated-track conditions.

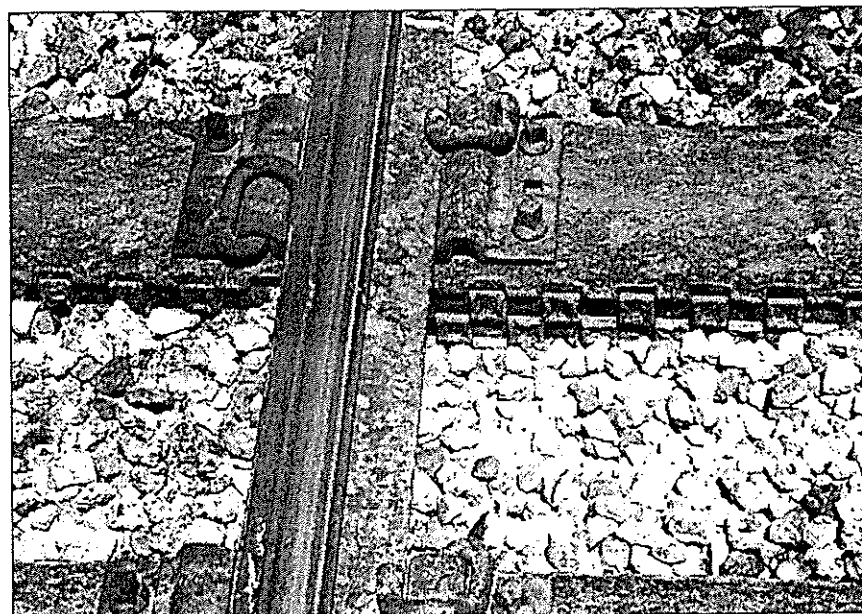
Exhibit 40. US Plastic Lumber Rough-sided Plastic Composite Tie

To increase resistance to lateral displacement, USPL developed a rough-sided plastic tie (shown in Exhibit 40) where the two side and bottom surfaces consist of square raised welts. The raised welts are intended to enhance the locking action between tie and ballast.
