**FAST/HAL TIE AND
FASTENER EXPERIMENTS**

**AAR REPORT NO. R-795
FRA/ORD-91/23**

***Facility for Accelerated Service Testing
Heavy Axle Load Program***

December 1991

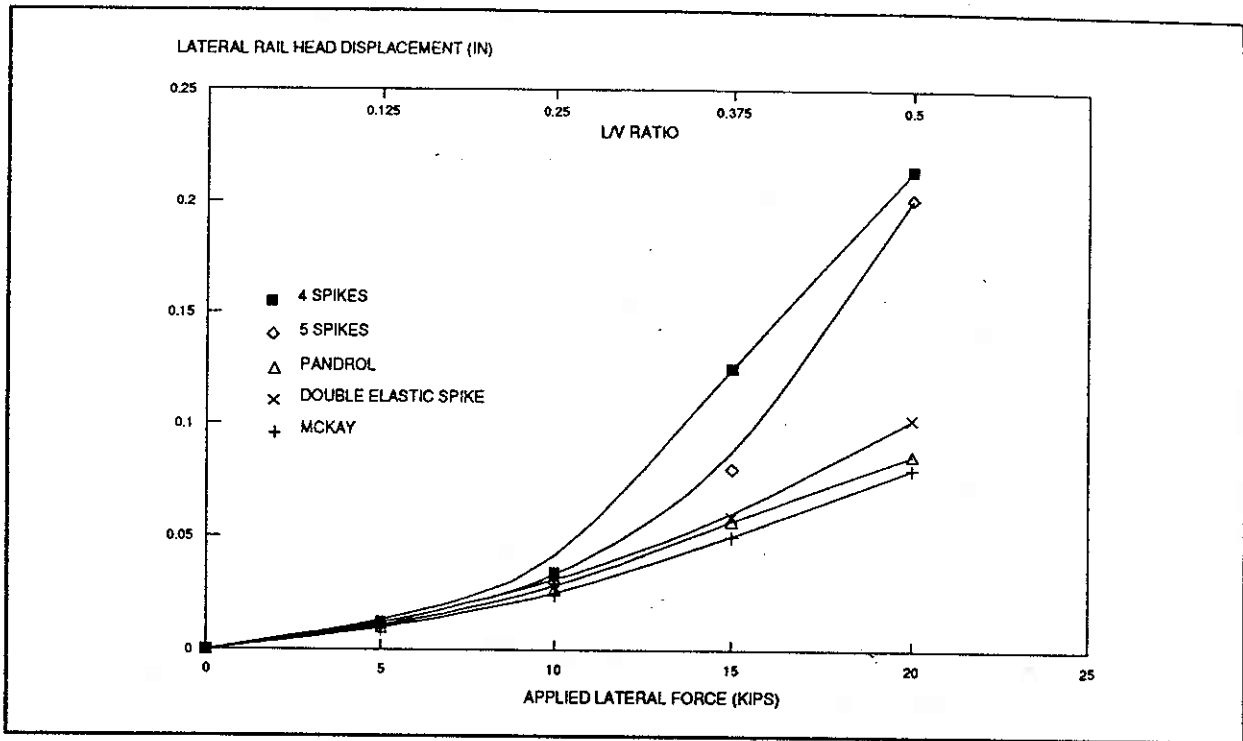
It is obvious from Figures 15 and 16 that lateral rail restraint provided by the cut spike system is considerably less than the restraint provided by the elastic fasteners at an applied vertical and lateral force which is equivalent to a L/V ratio of 0.5. However, if the entire force/displacement curve is plotted for each fastener type, as in Figure 17, where a vertical force of 40,000 pounds is constant and the lateral force is increasing, there appears to be little difference in lateral restraint provided by various systems at L/V ratios of 0.25 or less. In Figure 17, the average displacement of each fastener type in Section 07 as well as the five cut spike and smaller tie dimension subsections of Section 25, is plotted for each 5,000 pound increment of lateral force. Data in Figure 17 was recorded at 160 MGT.

Figure 17. Lateral Rail Force and Displacement Curves for Section 07 Fastener Types at 160 MGT

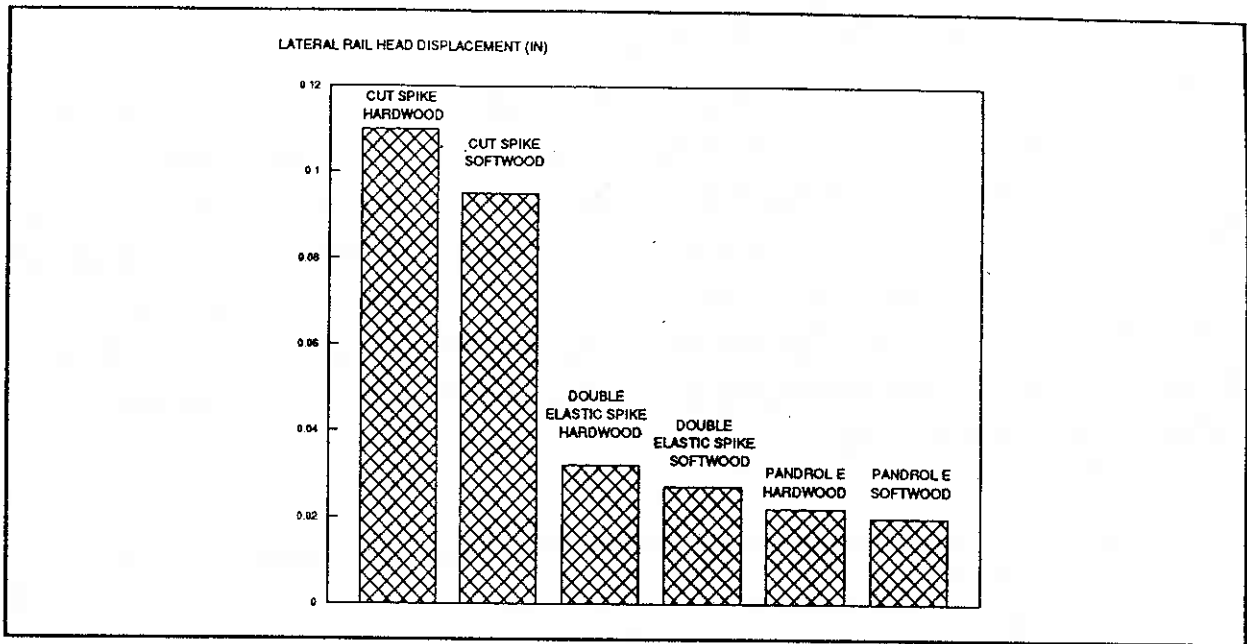
Figure 23. Comparison of Lateral Railhead Displacement Increase Over Time Allowed by Hardwood and Softwood Ties in Section 07

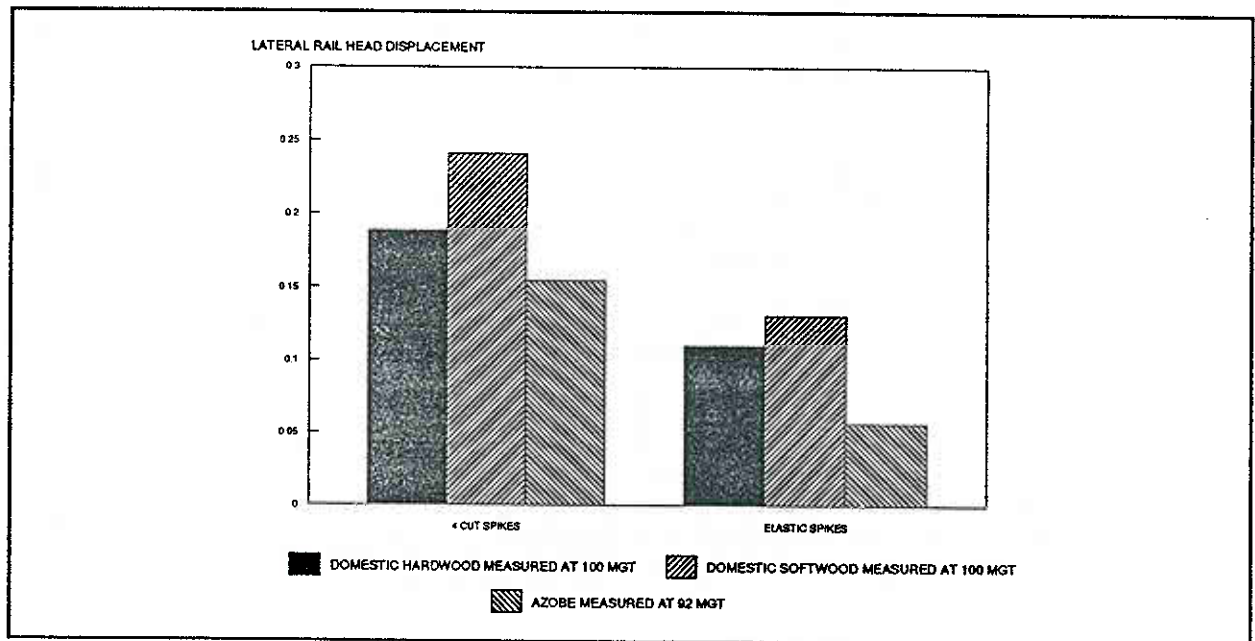
Figure 24. Comparison of Lateral Railhead Displacement Measured on Azobe and Domestic Hardwood/Softwood Ties

6. There is no significant difference in the measured and observed performance of the four and five cut spike systems.
7. Lateral railhead displacement measured on Azobe ties with cut and elastic spikes at 92 MGT is consistently less than displacements measured on domestic hardwood ties and softwood ties with similar fasteners at 100 MGT. In both cases, the displacements were measured under static forces equivalent to an L/V ratio of 0.5.

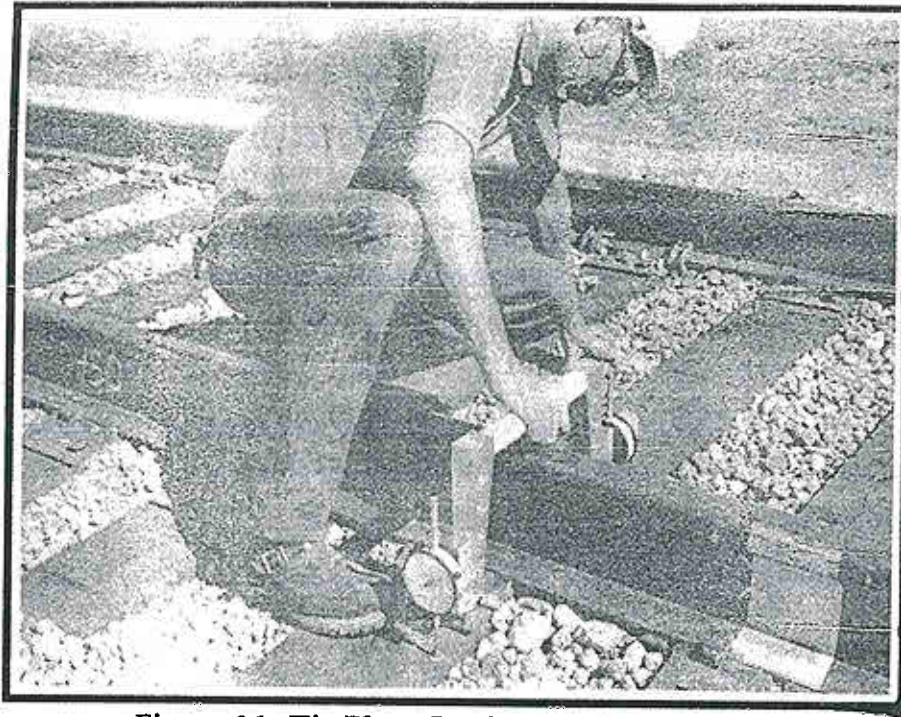
Tie plate cutting is a mode of tie failure which is directly influenced by vertical wheel loading and, therefore, can be considered a key indicator of tie performance under 39-ton axle load traffic. The tie plate cutting measurement fixture is aligned to indexing holes located at each corner of the tie plate and the change in tie plate height relative to the tie surface is measured with dial indicators with stems that rest on lag screws that have been glued into the tie as shown in Figure 26.

Figure 26. Tie Plate Cutting Measurement Fixture

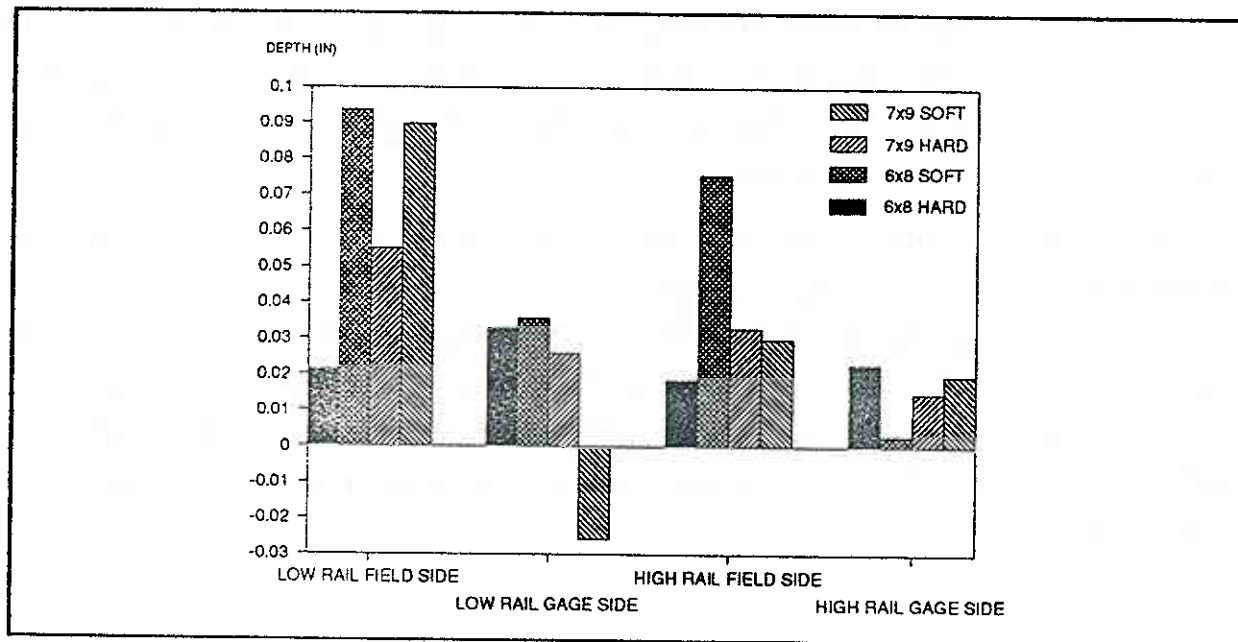
The average tie plate cutting depth for 7x9 inch and 6x8 inch ties with four cut spikes per plate in Section 27 is shown in Figure 27. The chart shows the total cutting at 160 MGT and the difference in the cutting depth between hardwood and softwood ties. Data in the chart indicates that the softwood ties are showing the most plate cutting, primarily on the field side of the low rail. The negative value shown for the 7x9 inch softwood ties indicates plates are lifting slightly from the tie surface on the gage side of the low rail when the rail is not under load.

Figure 27. Average Tie Plate Cutting Depth on Hardwood and Softwood Ties in Section 25 after 160 MGT

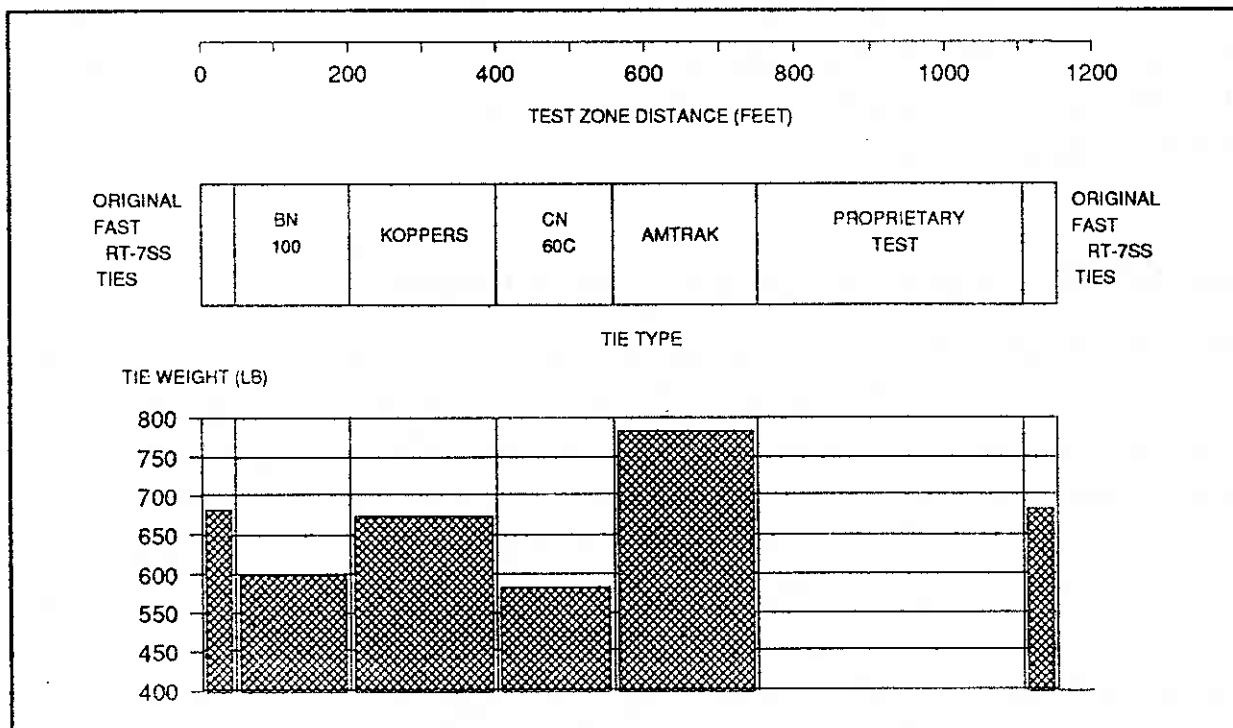
The concrete tie test zone in Section 03 is approximately 1,154 feet long. The zone is made up of 25 RT-7SS ties (original FAST ties) at both ends, which serve as transitions to the surrounding wood ties, 79 BN-100 ties, 98 Koppers ties, 79 CN 60C ties, 121 AMTRAK ties, and 175 ties under proprietary testing (Figure 2). The ballast in the test zone is a mixture of granite and quartzite material that was installed in 1979. Average depth of ballast beneath the low rail was 18 inches with the high rail elevated 4 inches.⁶ High rail ballast shoulder width was 15-18 inches and 1.5:1 slope. Rail in the zone was 136-pound continuous welded rail (CWR) with irregularly occurring joints. The high rail was changed at 15 MGT into the HAL program, and part of the low rail was changed at 70 MGT.

Figure 2. Layout of Section 03 Concrete Tie Test Zone

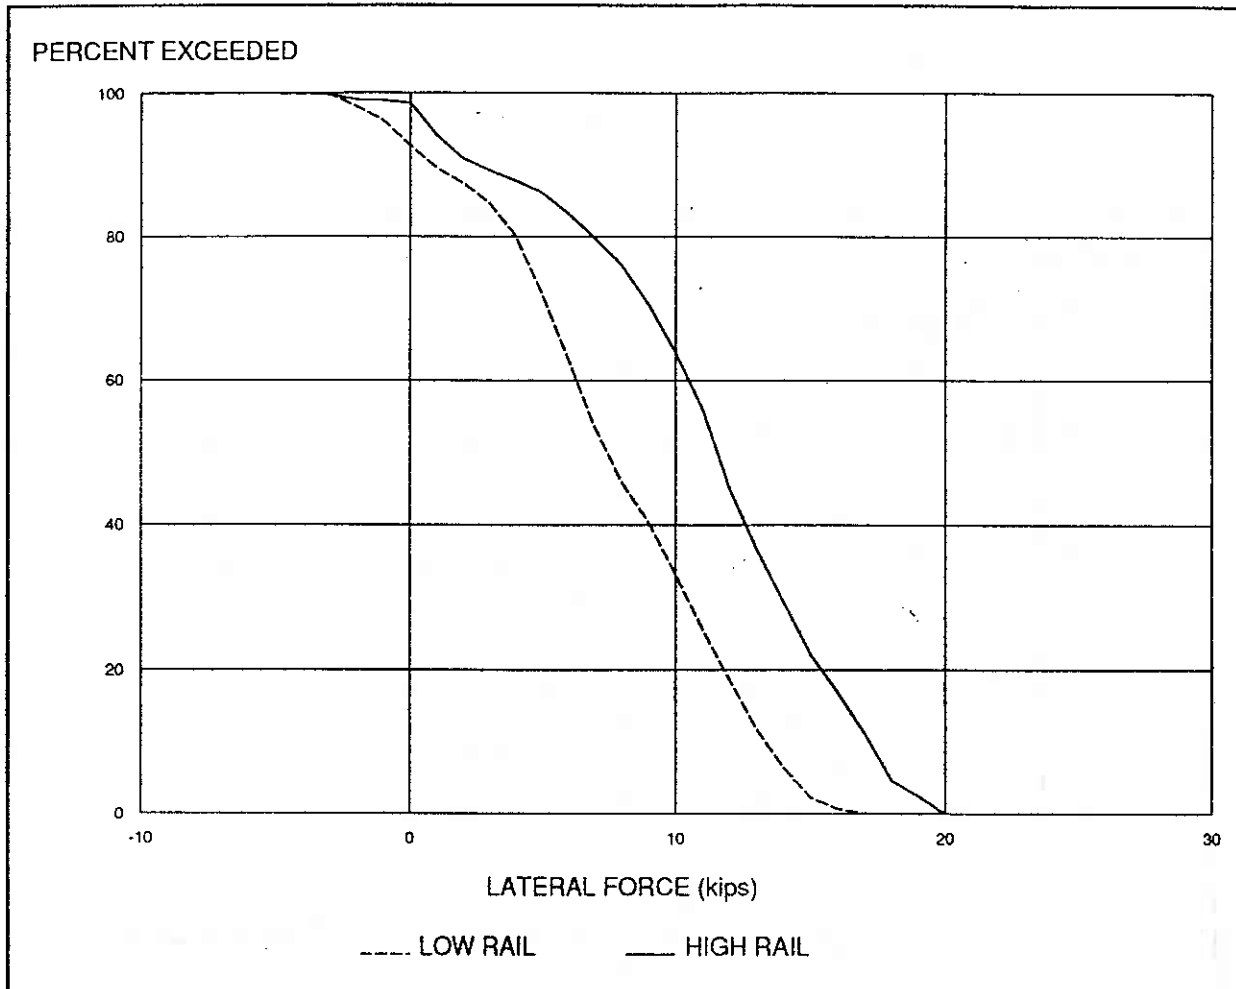
Wayside data was post processed to determine peak vertical and lateral force values of each wheel crossing each circuit. Distributions of peak vertical and lateral rail forces generated by the HAL train, excluding locomotives, measured at a single (high and low rail) wayside location about midway into the BN 100 tie subsection are shown in Figures 3 and 4 respectively. The distributions represent data from 25 consecutive passes of the train and are plotted as percentages of the total force population exceeding a given load value.

**Figure 3. Wayside Vertical Rail Force Distribution
Section 03 Concrete Tie Zone**

Figure 4. Wayside Lead Axle Lateral Rail Force Distribution For the Section 03 Concrete Tie Zone

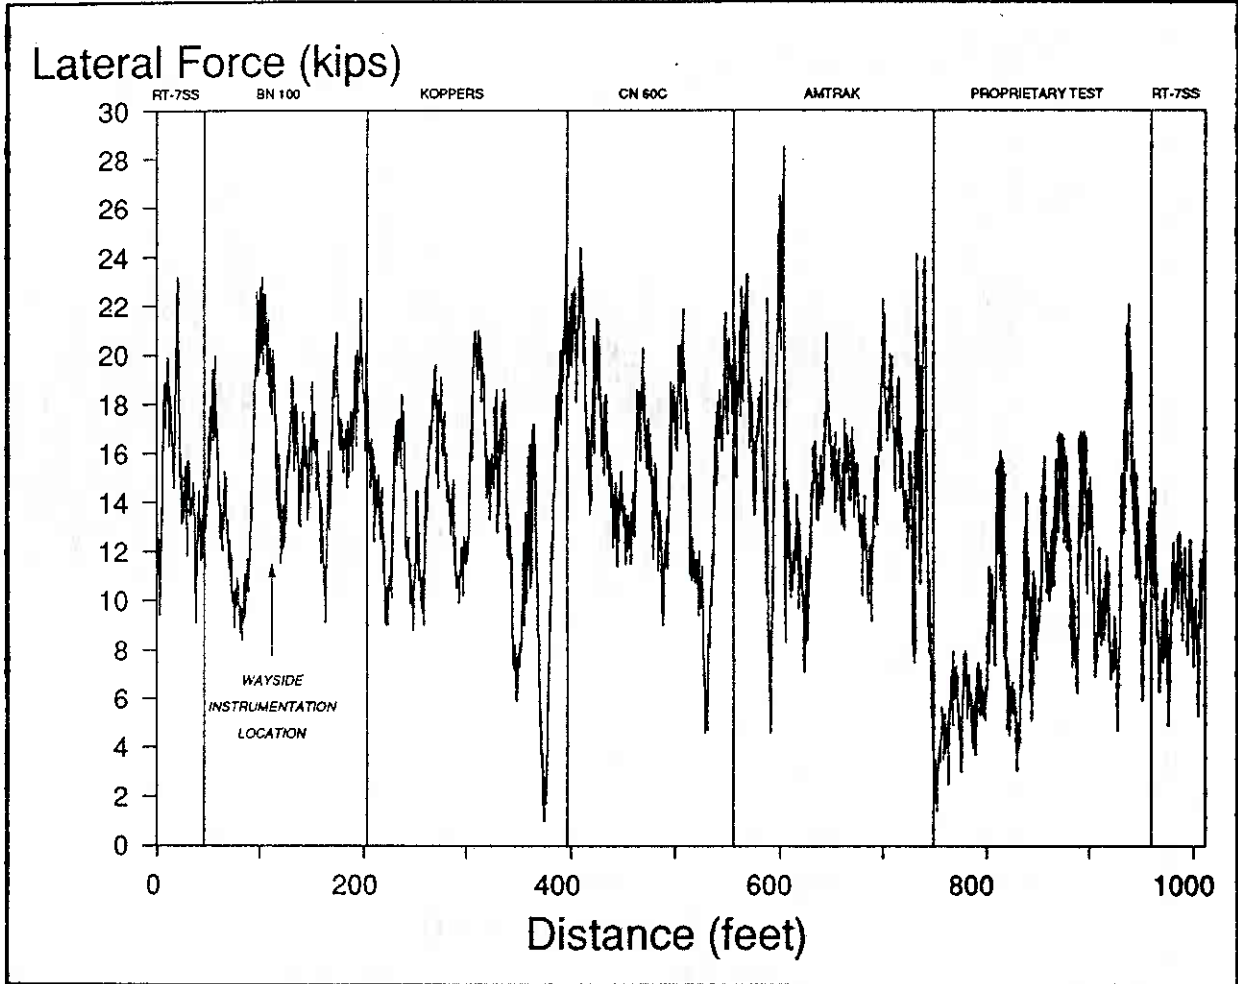
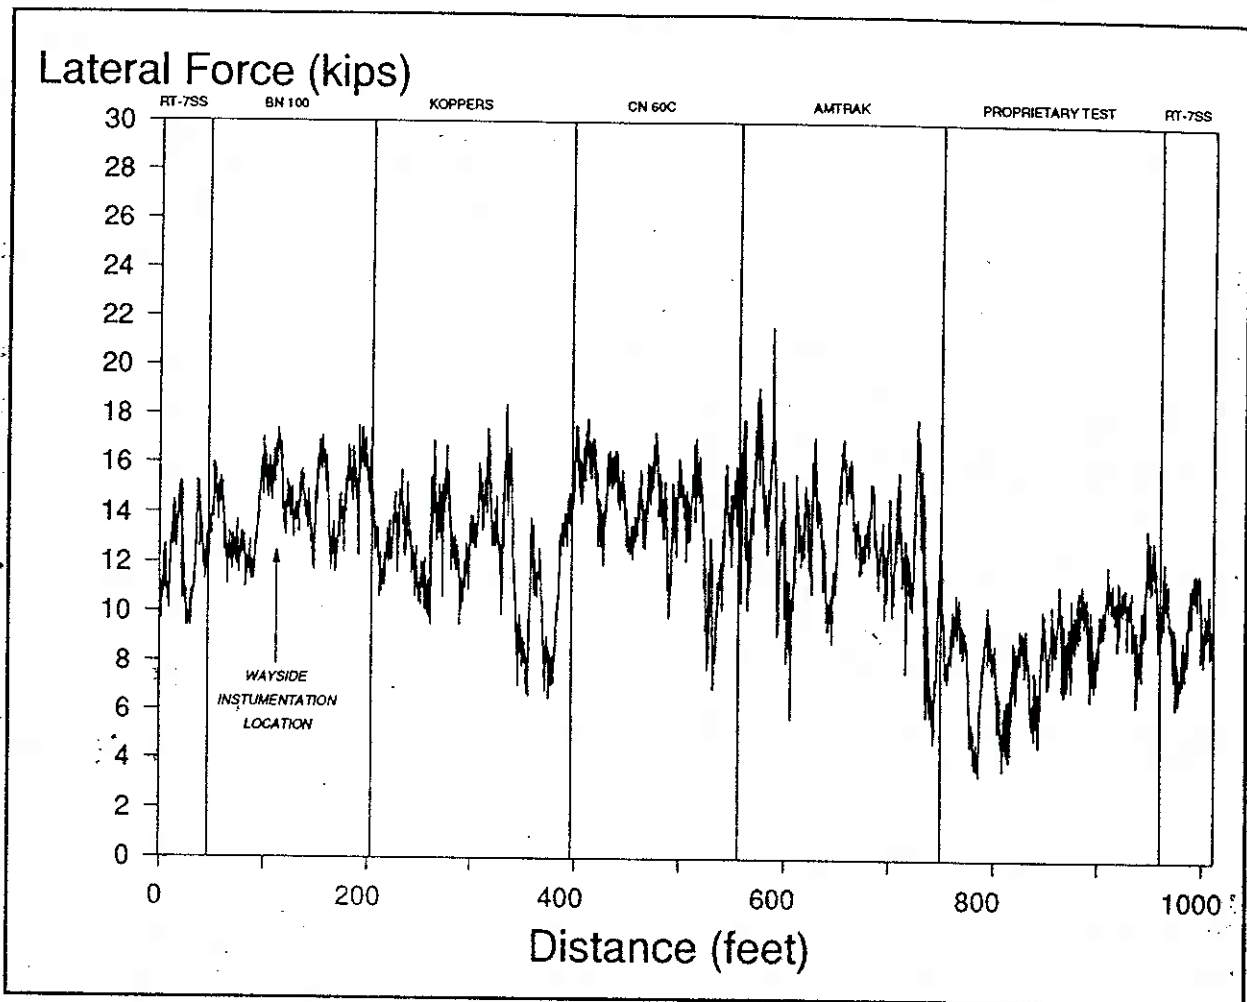
and lateral wheel forces recorded at 40 mph in the Section 03 test zone are shown in Figures 5, 6, and 7. The data was collected with an instrumented wheel set positioned as the leading axle of the lead truck, and the data represents one pass of the vehicle through the zone at 40 mph.

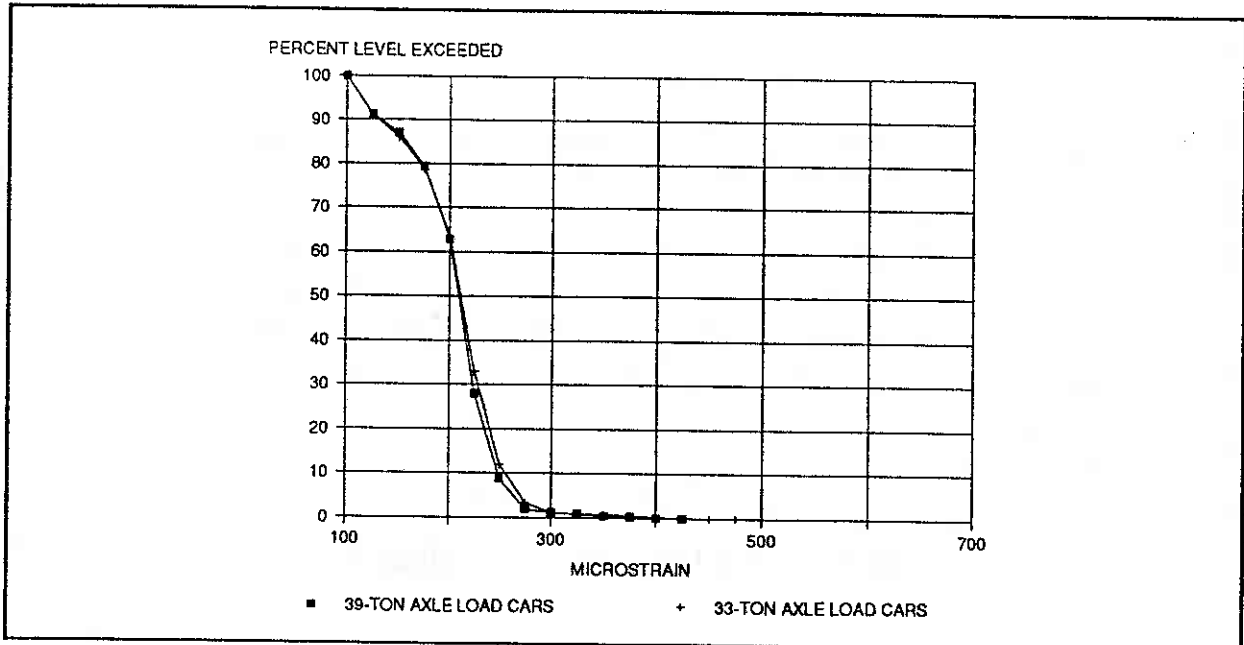
Distributions of strains above 100 microstrain were computed for each strain gage position. Comparisons of the distributions for 33- and 39-ton axle load cars are shown in Figures 9-14. The plots show that the lowest strains were recorded furthest from the tie center at the SG01 and SG05 positions, while the highest strains were at the SG02, SG03, and SG04 positions. All strains recorded were tensile, indicating negative bending of the tie between the rail seats as expected. No compressive strains were measured at any location.

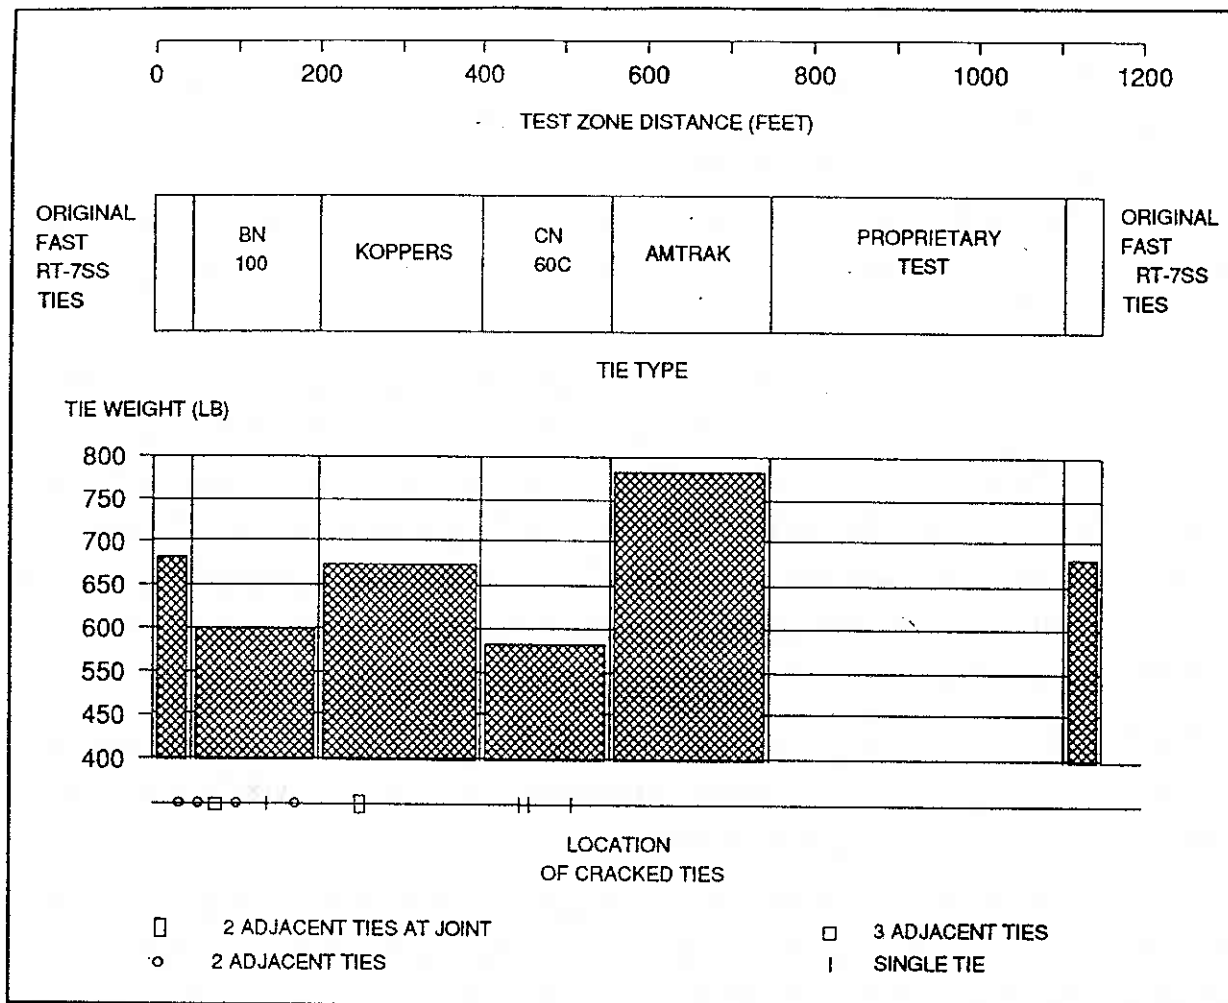
As indicated in Figure 15, most of the cracked ties in Section 03 were located in pairs, and in one case, three consecutive ties were cracked. All cracked ties were located in the west half of the Section 03 test zone and, with the exception of two RT-7SS ties, were the two lightest ties in the zone. The mechanism causing the cracks was not defined; however, cracked ties were observed at 20, 30, 55, 75, and 90 MGT which roughly correlated with track surfacing activity at 15 and 70 MGT. No new cracks were observed after 90 MGT.

Figure 15. Location of Cracked Ties in Section 03 Test Zone

Between 20 and 90 MGT of 39-ton axle load tonnage accumulation, 15 ties in Section 03, or 2.6 percent of the total number of ties in the zone, and one tie in Section 33, or 2 percent of the ties in that zone, developed flexural cracks. The cracks were located on the sloped section of the low rail side (outside rail of the loop in Section 33) of the tie about halfway between the rail seat and tie center. The cracks extended completely across the top surface of the tie and, in the most severe cases, extended down the vertical face about 1.5 inches. Similar cracks were not documented during the 33-ton axle load program.

None of the cracked ties were removed from service and the cracks had no adverse affect on the performance of the tie or track. Twenty ties from throughout the Section 03 test zone were removed at 160 MGT for inspection of the bottom of the tie at the rail seat area for cracks due to positive bending. As was the case during the 33-ton program, none of the ties currently in test exhibited visual cracks due to positive bending under the rail seat.
