MISSISSIPPI STATE
UNIVERSITY[™]

DEPARTMENT OF SUSTAINABLE BIOPRODUCTS

Tenth Annual Evaluation of Phase II MSU/RTA Alternative Preservative Study

July 11, 2022

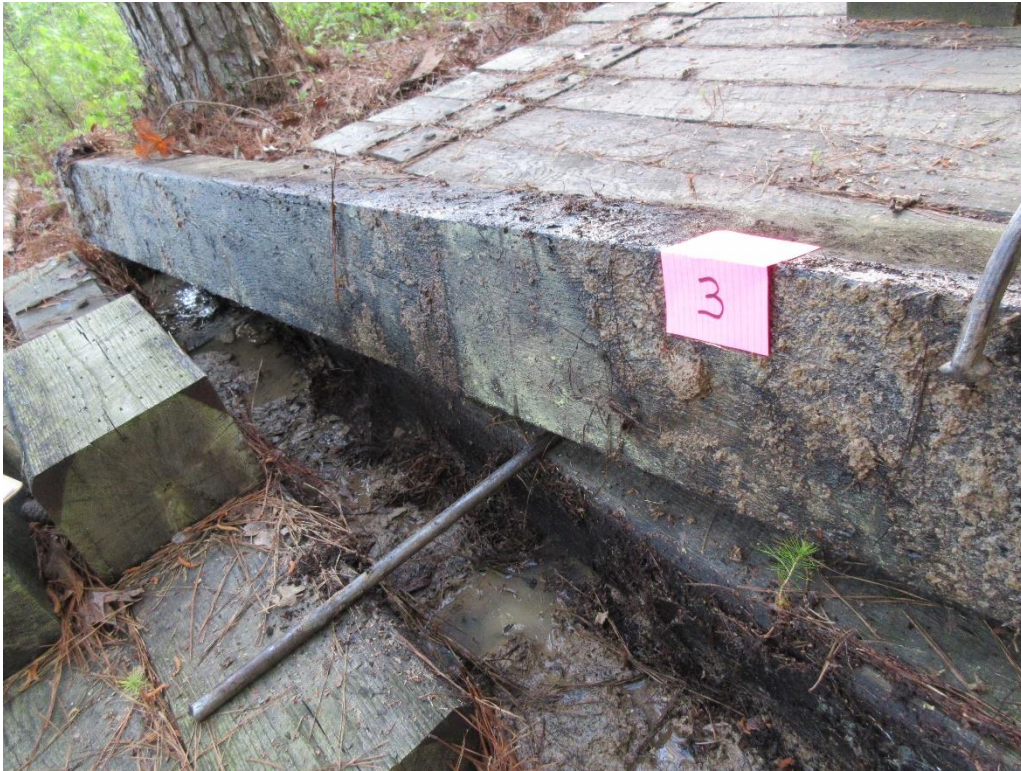
Figure 1 - Tie #3 white oak/borate/creosote 6# (Koppers).

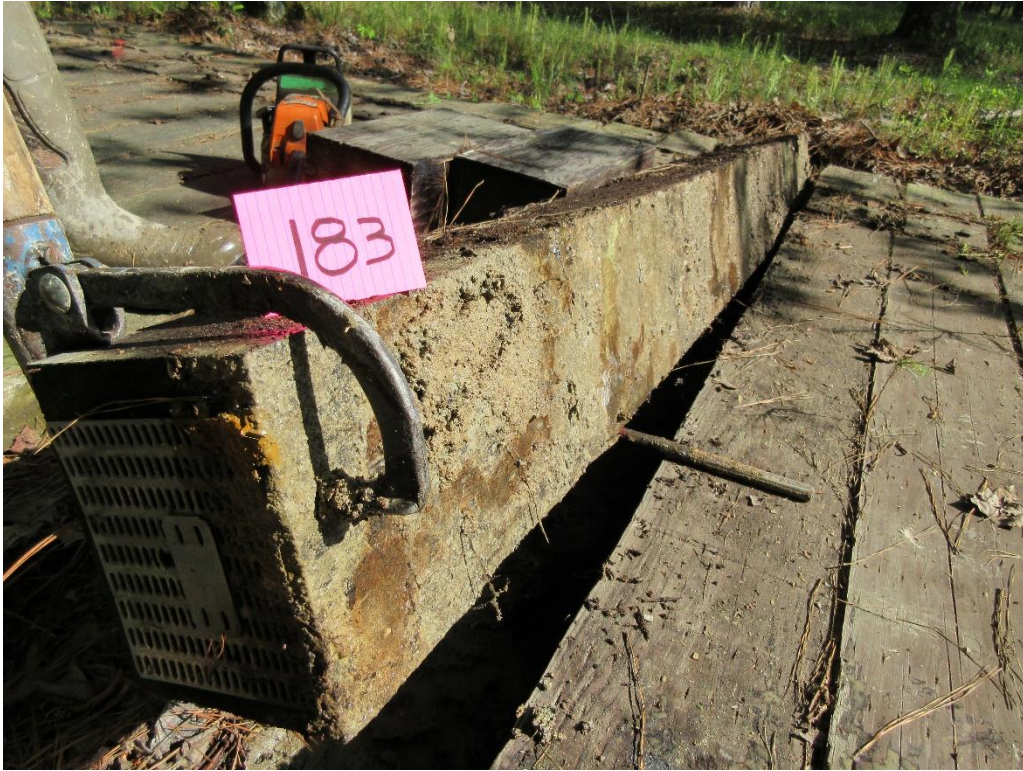
Figure 39 – Tie #183 Douglas fir/P2 creosote (Lonza).

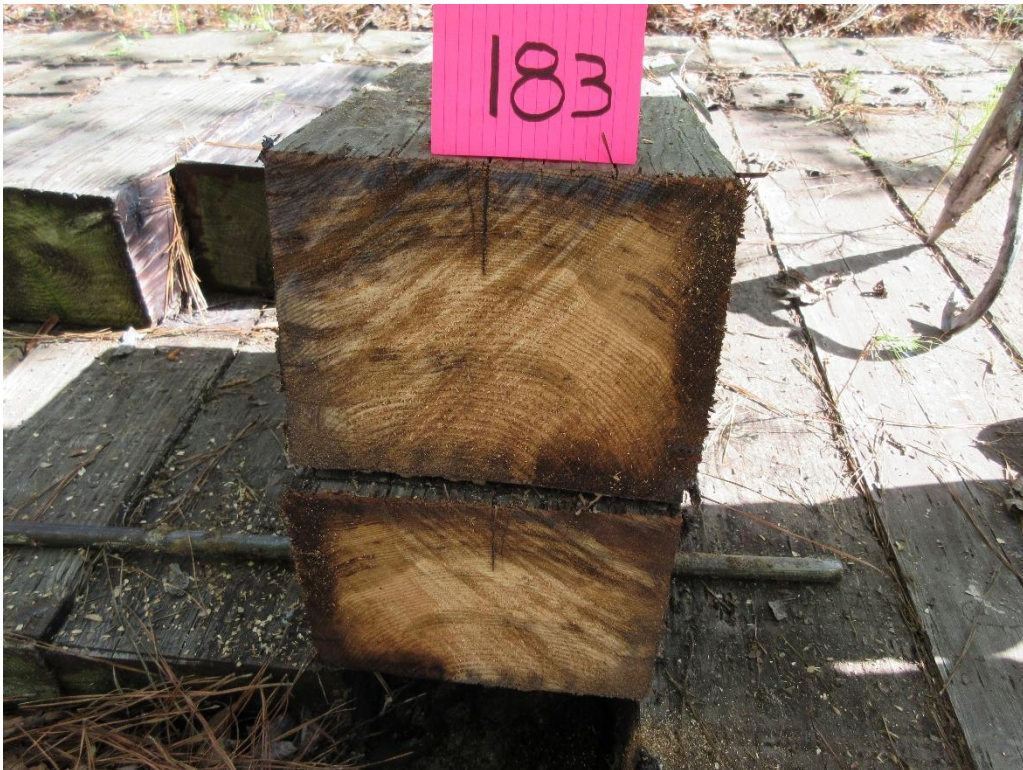
Figure 40 - Tie #183 Douglas fir/P2 creosote (Lonza).
