ASSOCIATION OF AMERICAN RAILROADS
RESEARCH AND TEST DEPARTMENT

EVALUATION OF NAIL PLATES AS AN
ANTI-SPLITTING DEVICE FOR
TIMBER TIES

REPORT NO. R-542

January, 1983

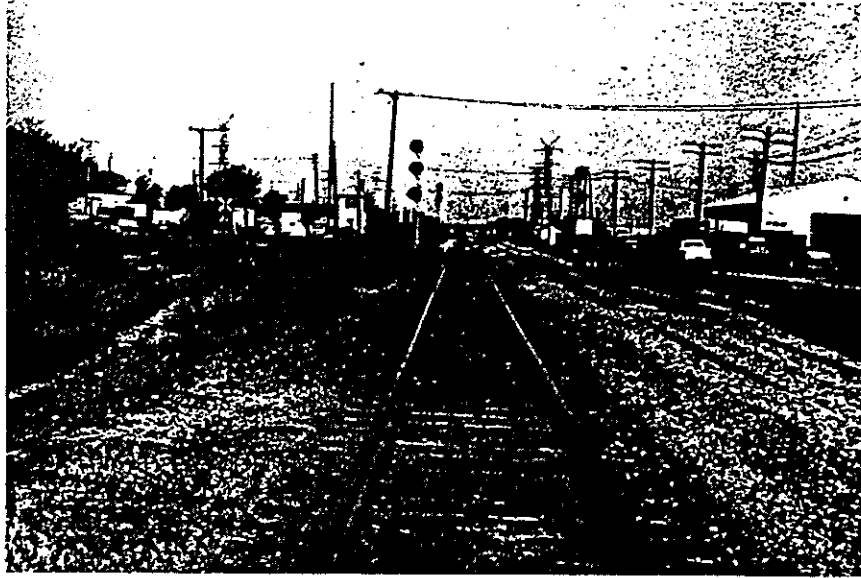
Figure 1. View Looking West Along the Milwaukee Road's Eastbound Main Track at Spaulding, Illinois, Showing the Test Tie Installation Site.

approximately 25 miles west of Chicago, and installed in the Milwaukee Road's eastbound main track (Figure 1) during April and May of 1964. The rails at this location are 132 lb. RE and the track has gravel ballast. The ties were inserted in numerical order, with Number 1 at the west end and Number 90 at the east end of the test section.
