ZETA-TECH
Associates, Inc.
900 Kings Highway N.
P.O. Box 8407
Cherry Hill, NJ
08002
(609) 779-7795
FAX: (609) 779-7436

AAR Research Review
December 1-2, 1998

Report to RTA

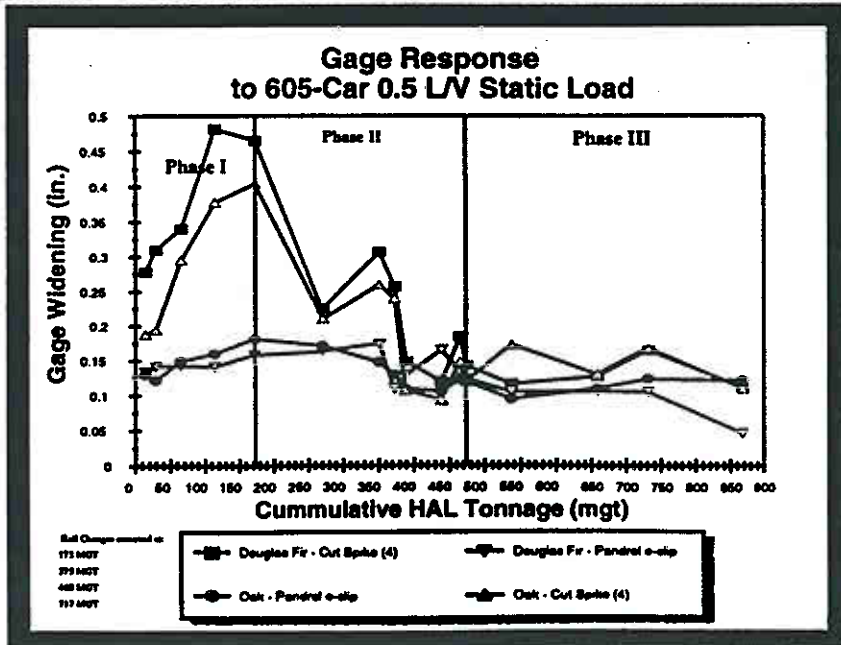
Figure 2

- Gage widening, as measured by the geometry car, was reduced by over 60% on Oak and Fir ties on the 5 degree curve in Section 7.
 - Static track strength degradation was reduced by almost 90% when compared to previous HAL tests under conventional trucks. This is illustrated in Figure 2.

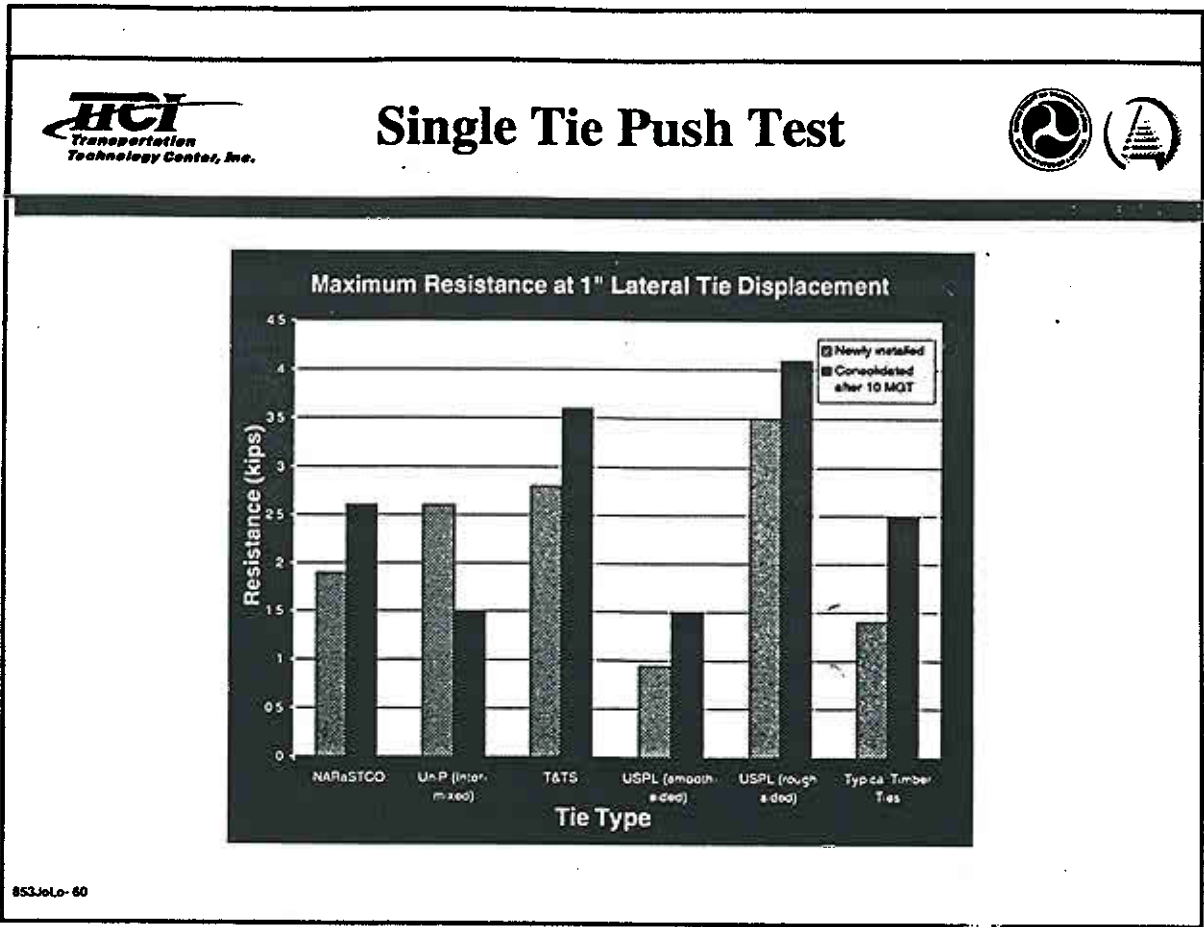
Figure 3

- Lateral resistance tests of the plastic ties (single tie push tests) showed that the smooth sided ties had lower lateral resistance than typical wood ties. However, the roughened surface ties (see Photo 2) had a higher lateral resistance than the wood ties. This is illustrated in Figure 3. Note; all reported plastic ties were U.S. Plastics & Lumber (USP&L). There were also several proprietary plastic ties in track, but no information was provided about these other ties.

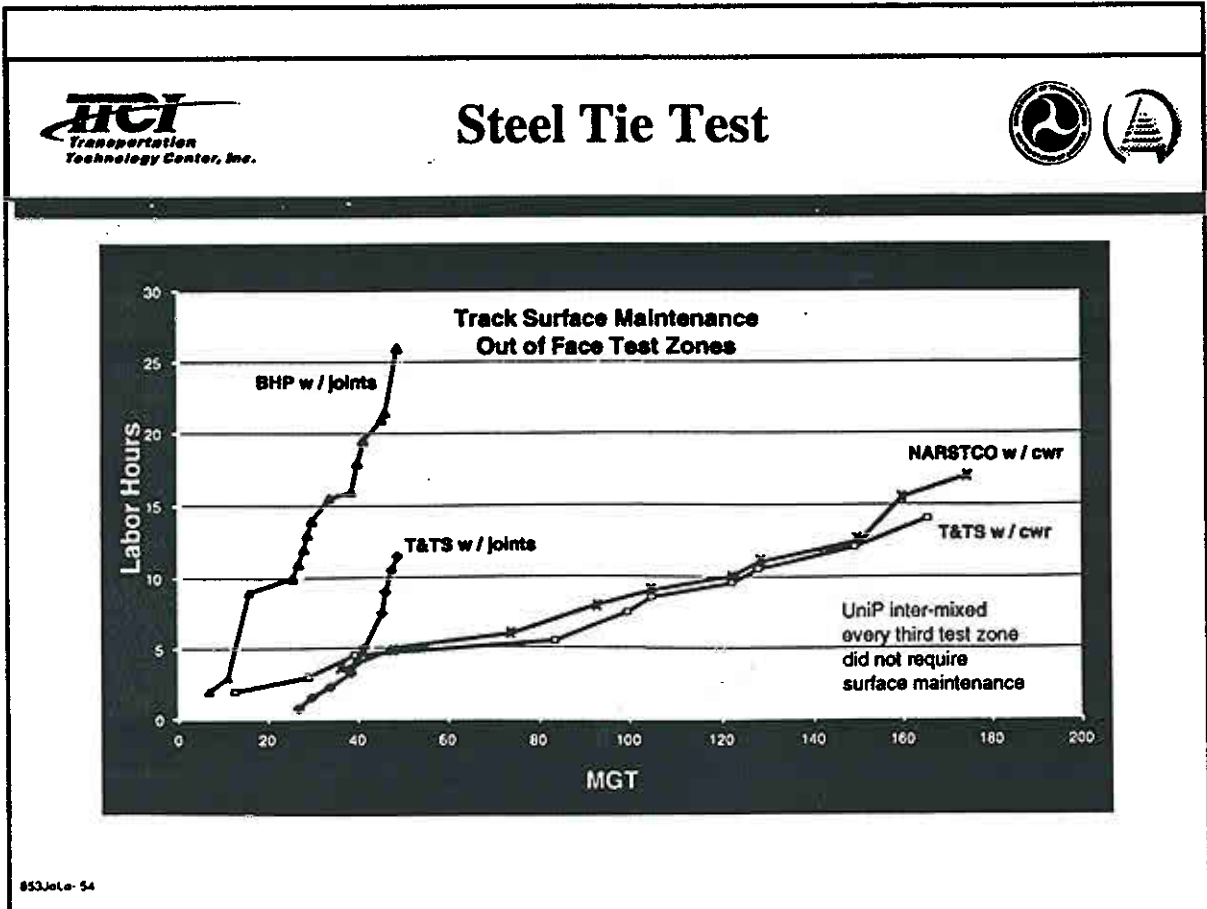
Figure 4

- Of the steel ties, two of the inverted trough design (T&TS and NARTSCO) were reported as performing well except where rail joints were present (see Figure 4). With rail joints present, surfacing was required every 3 MGT. With joints removed, surfacing was required every 15 MGT.
