MISSISSIPPI STATE
UNIVERSITY[™]

DEPARTMENT OF SUSTAINABLE BIOPRODUCTS

Tenth Annual Evaluation of Phase II MSU/RTA Alternative Preservative Study

July 11, 2022

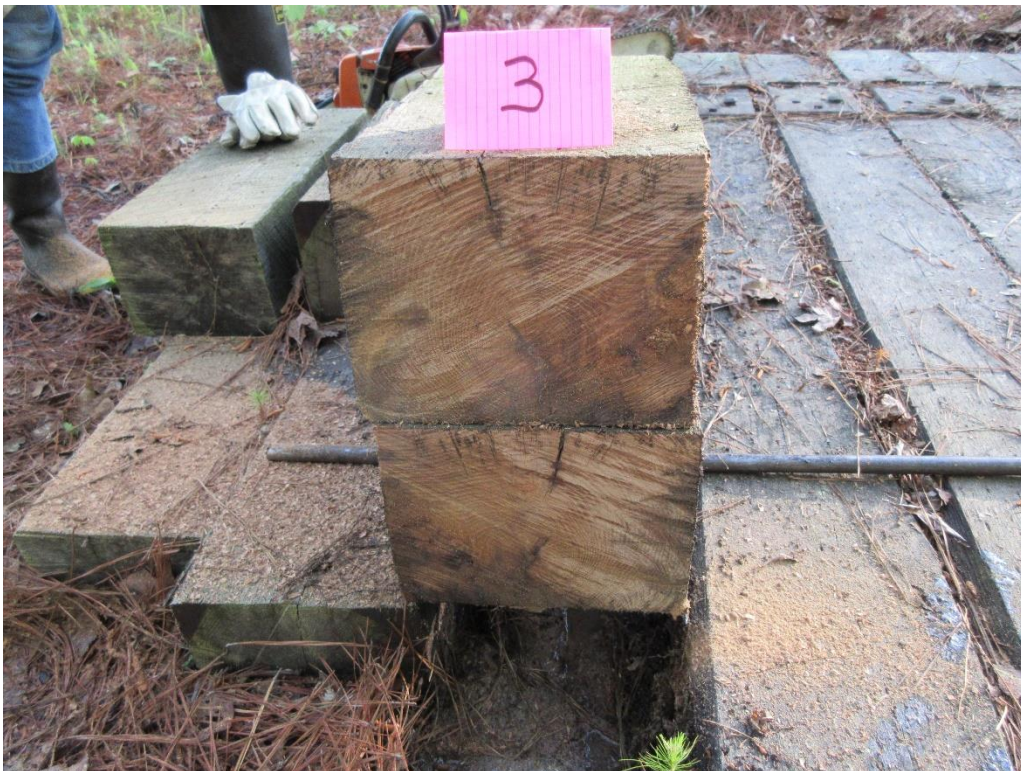
Figure 2 - Tie #3 white oak/borate/creosote 6# (Koppers).

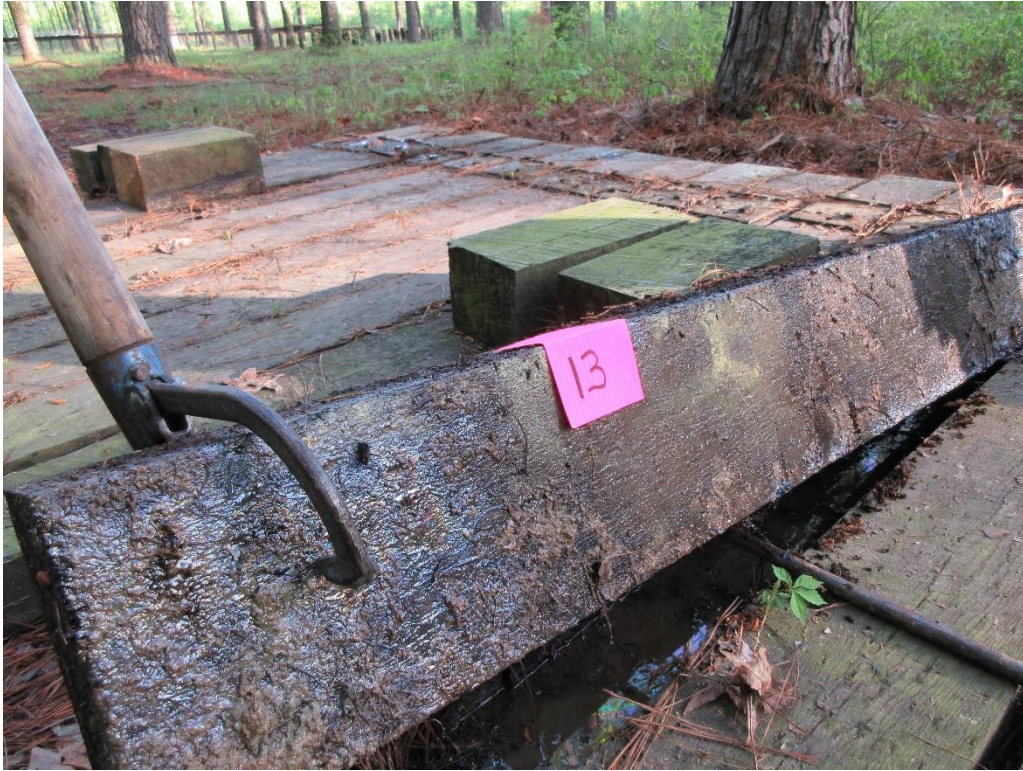
Figure 3 - Tie #13 red oak/borate/creosote 7lbs (Koppers).

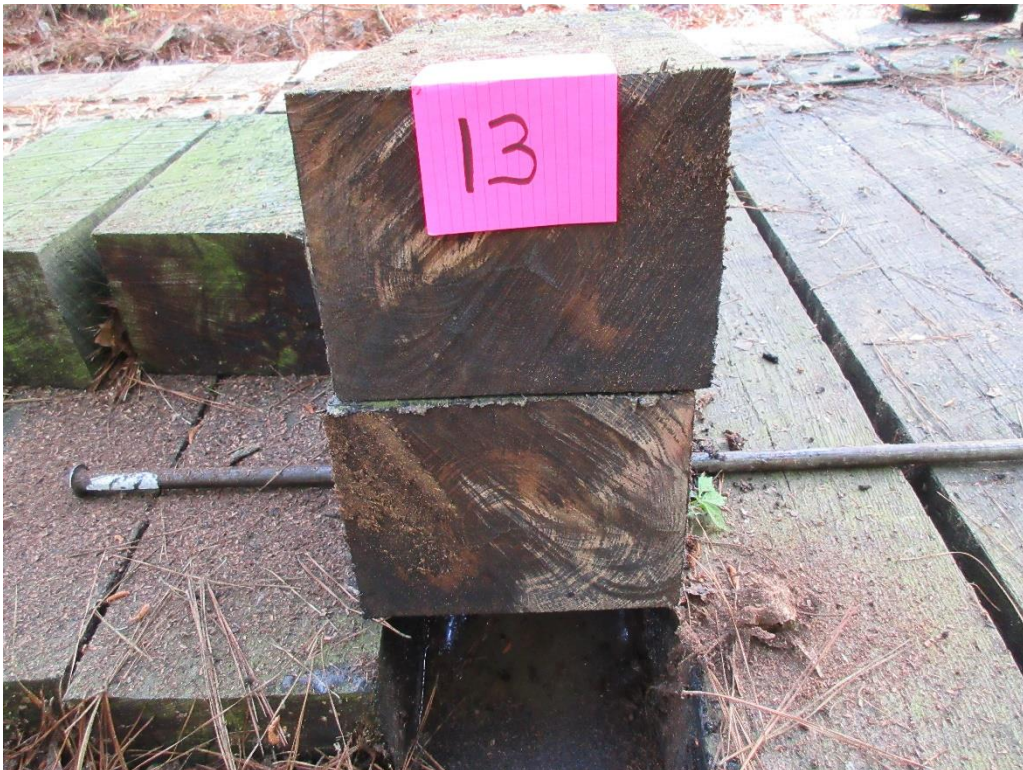
Figure 4 - Tie #13 red oak/borate/creosote 7lbs (Koppers).

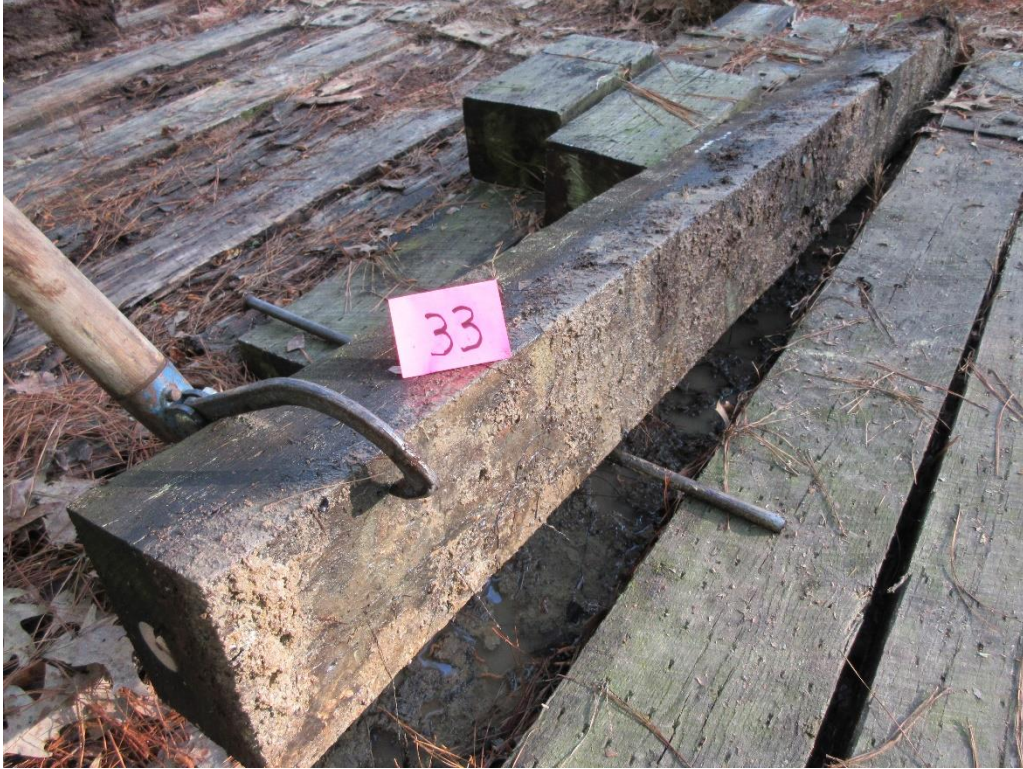
Figure 7 - Tie #33 red oak/creosote 7lbs (Koppers).

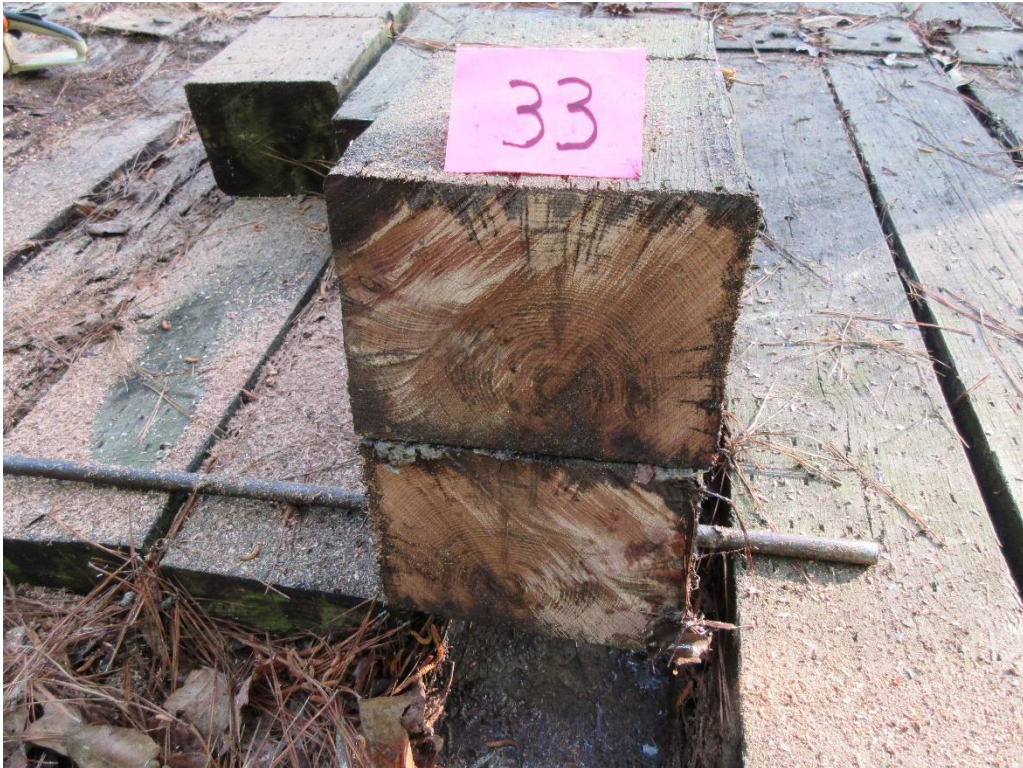
Figure 8 - Tie #33 red oak/creosote 7lbs (Koppers).

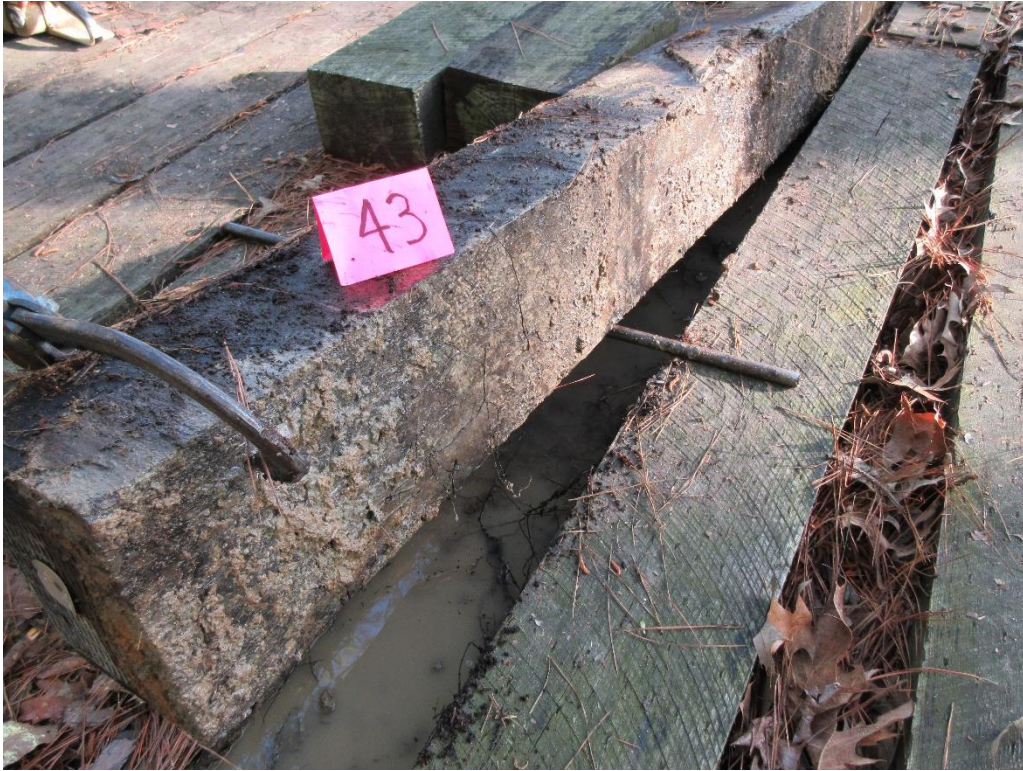
Figure 9 - Tie #43 white oak/borate/creosote 7lbs (Koppers).

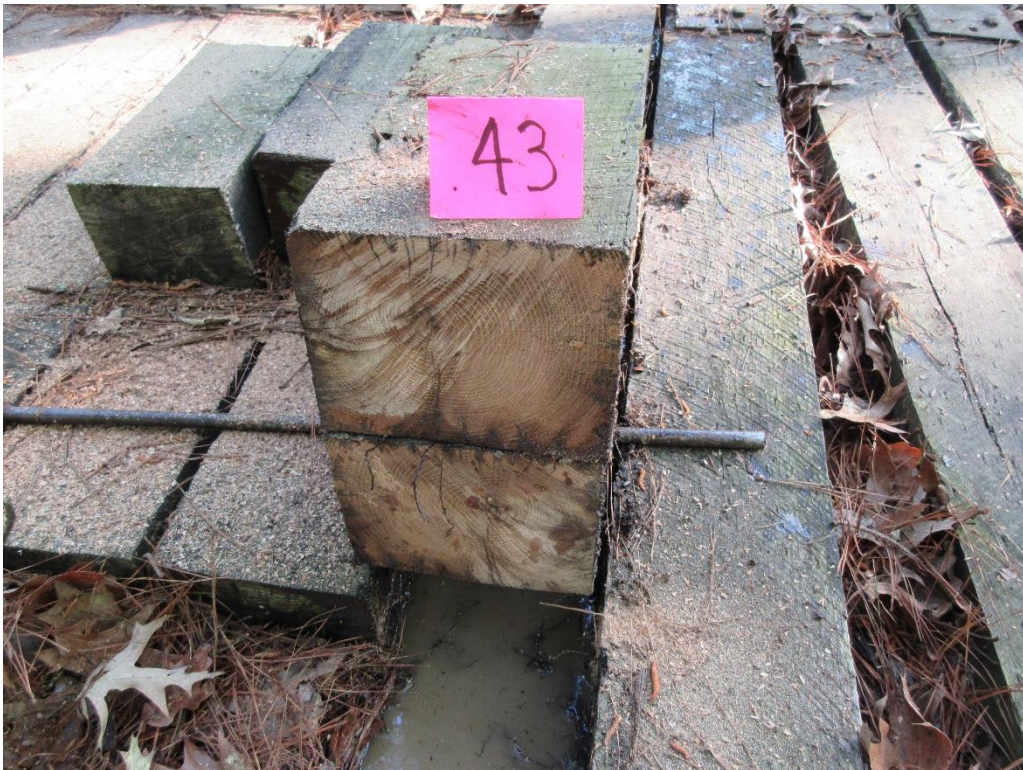
Figure 10 - Tie #43 white oak/borate/creosote 7lbs (Koppers).

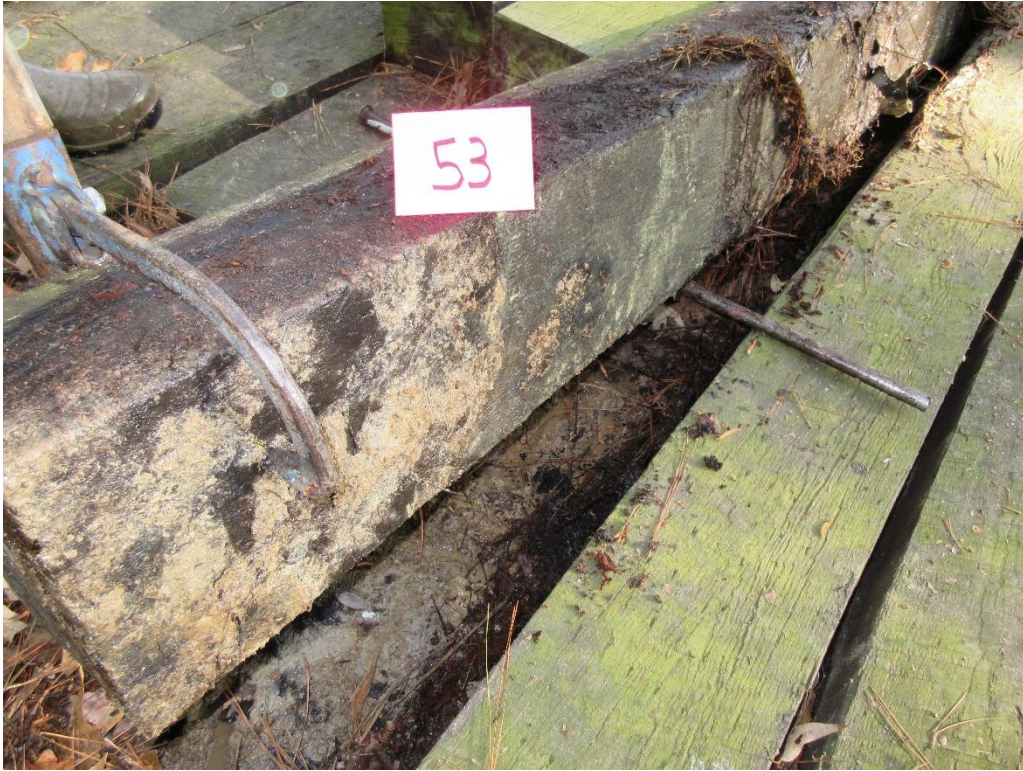
Figure 11 - Tie #53 red oak/borate/creosote 6lbs (Koppers).

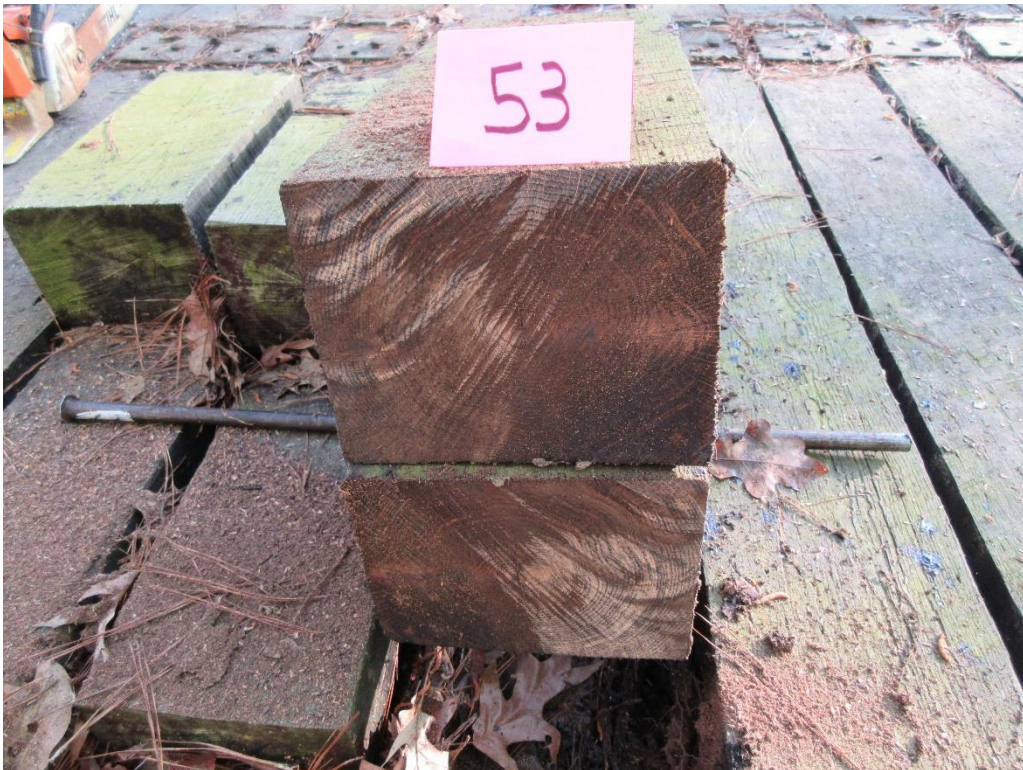
Figure 12 - Tie #53 red oak/borate/creosote 6lbs (Koppers).

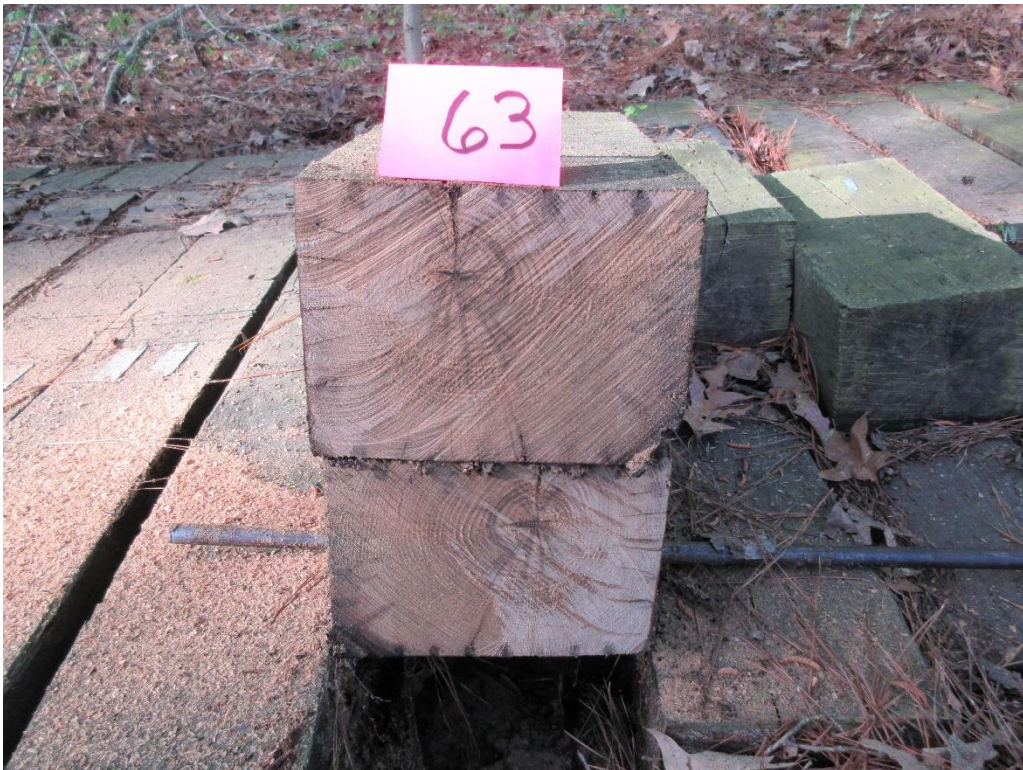
Figure 14 - Tie #63 red oak/1 step creosote borate (Stella Jones).

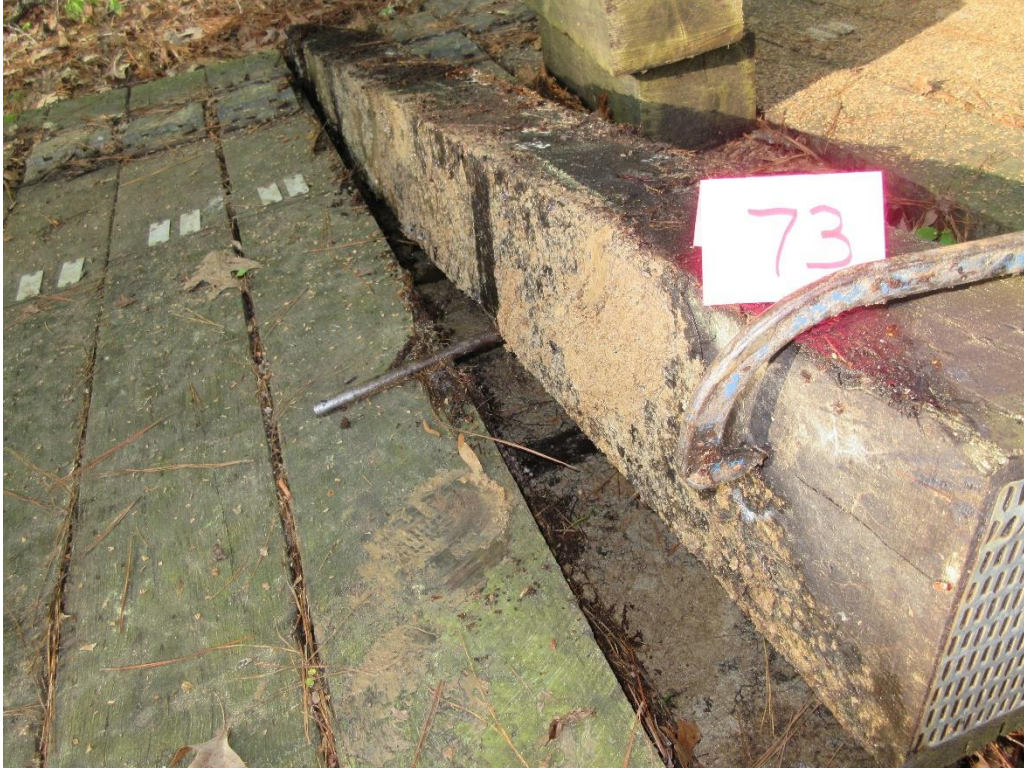
Figure 15 - Tie #73 white oak/creosote (Stella Jones).

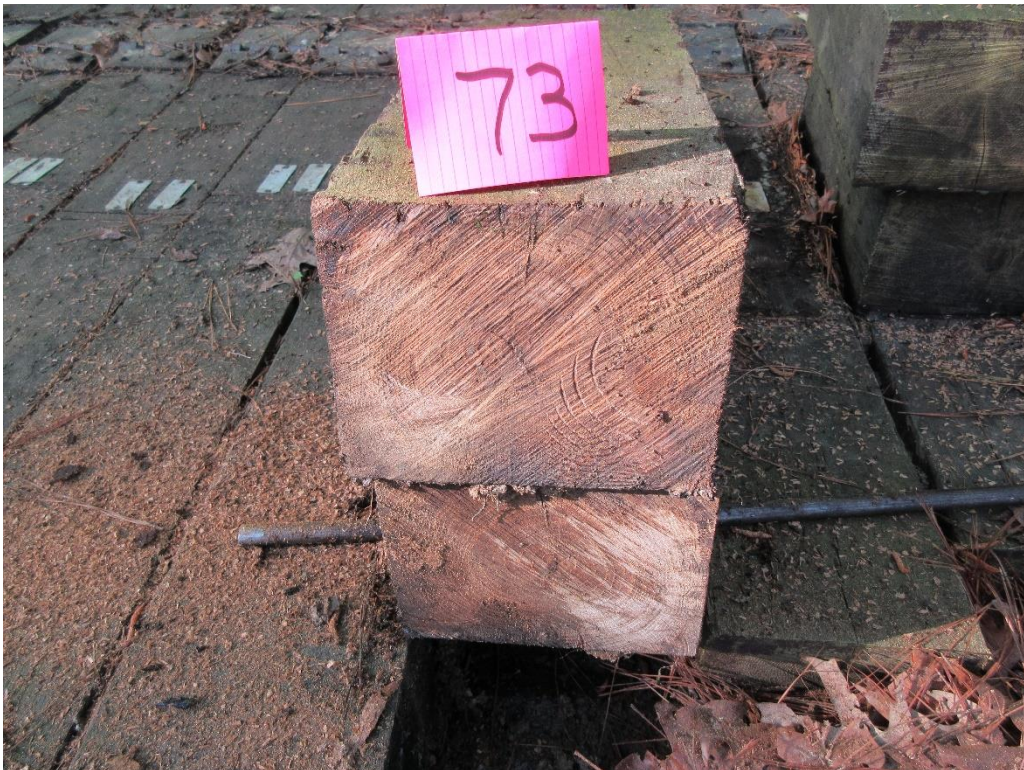
Figure 16 - Tie #73 white oak/creosote (Stella Jones).

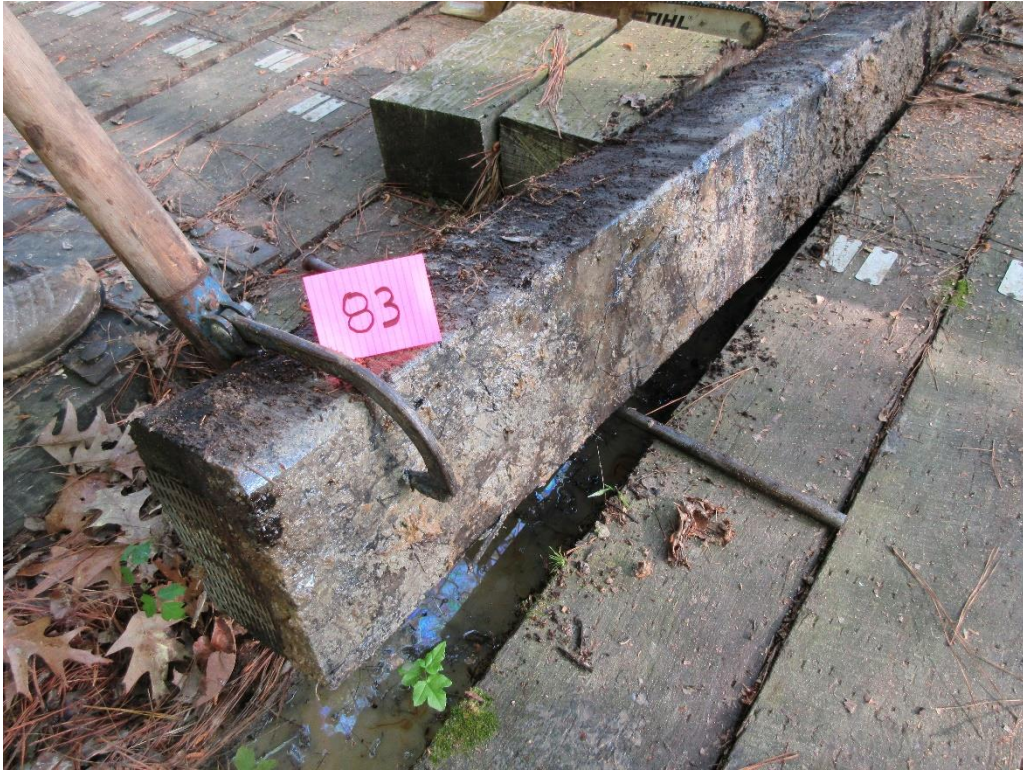
Figure 17 - Tie #83 white oak/one step creosote borate (Stella Jones).

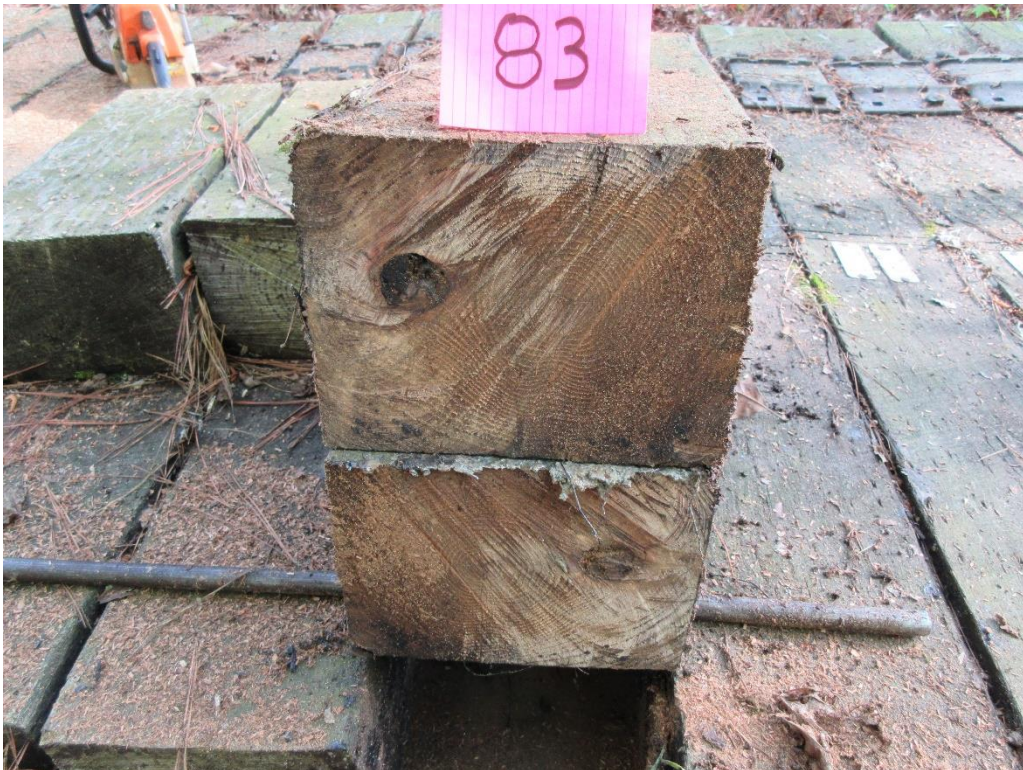
Figure 18 - Tie #83 white oak/one step creosote borate (Stella Jones).

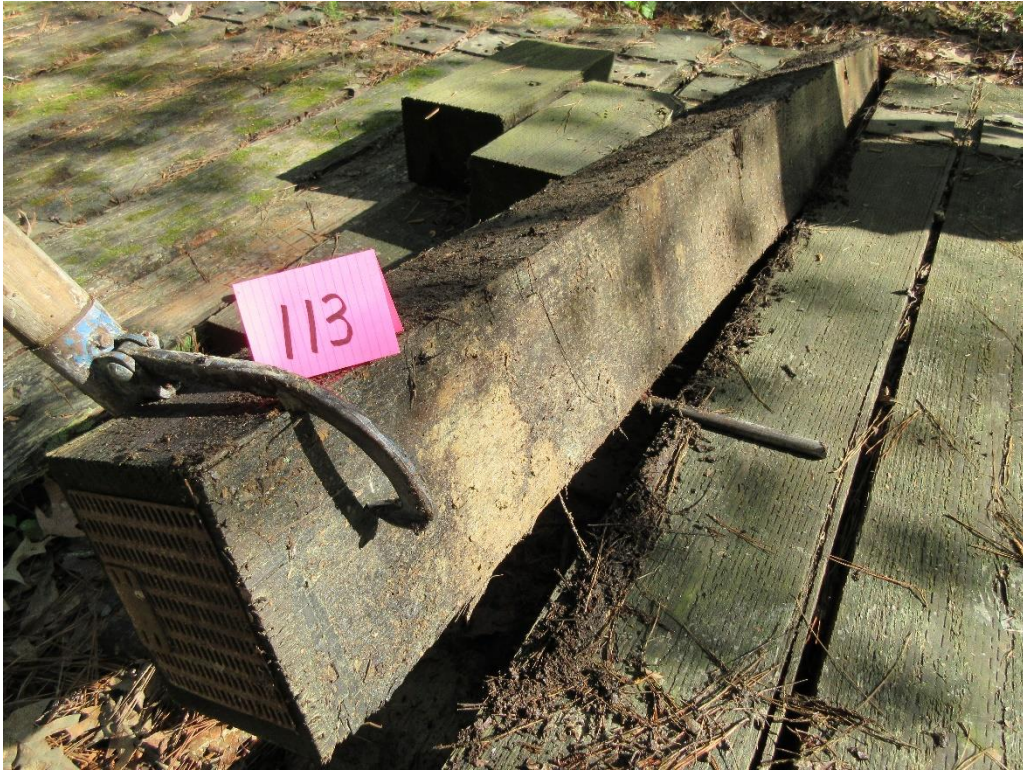
Figure 23 – Tie #113 Douglas fir/DOT/ACZA (Lonza).

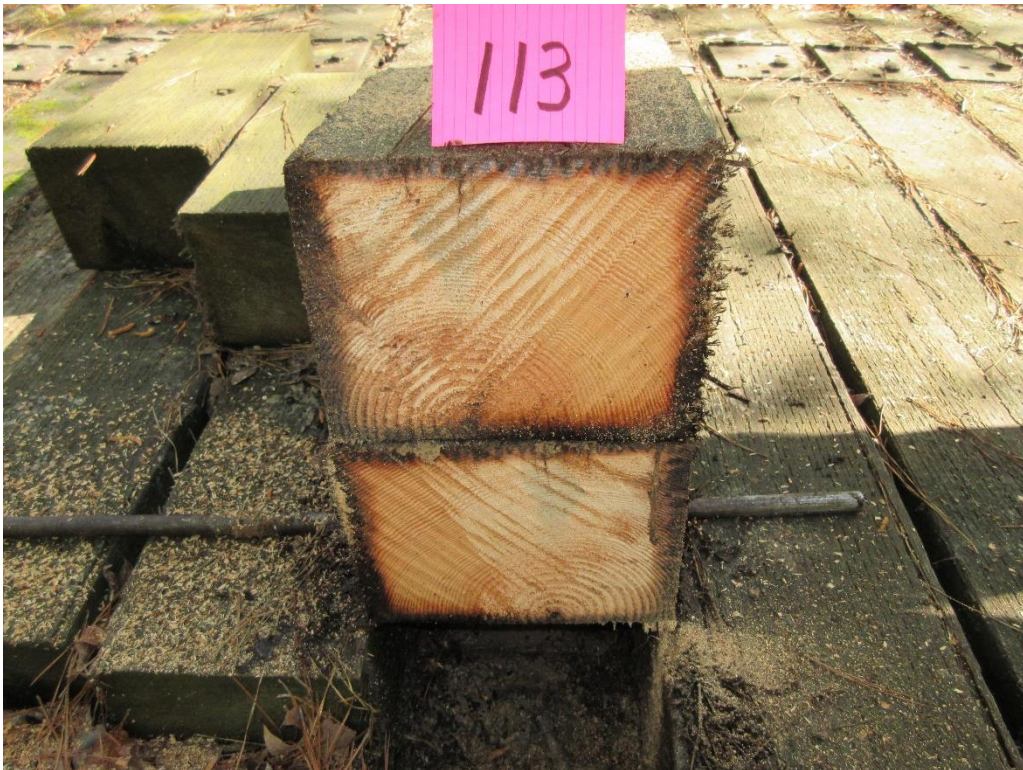
Figure 24 - Tie #113 Douglas fir/DOT/ACZA (Lonza).

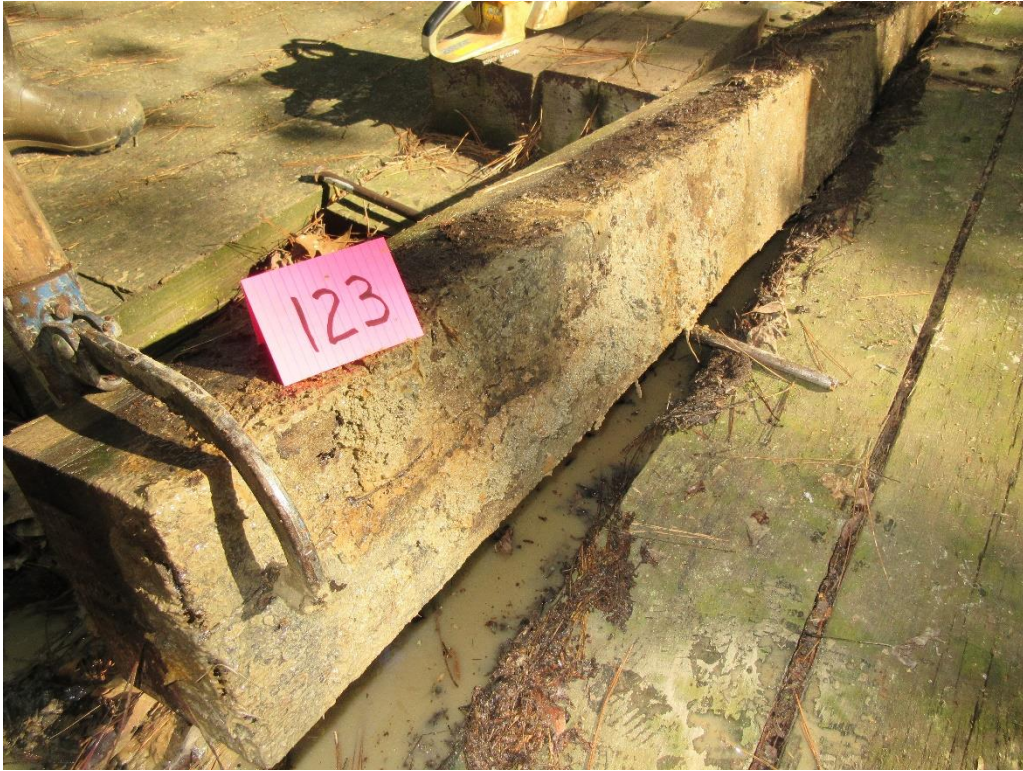
Figure 25 – Tie #123 red oak/DOT/ACZA/oil (Lonza).

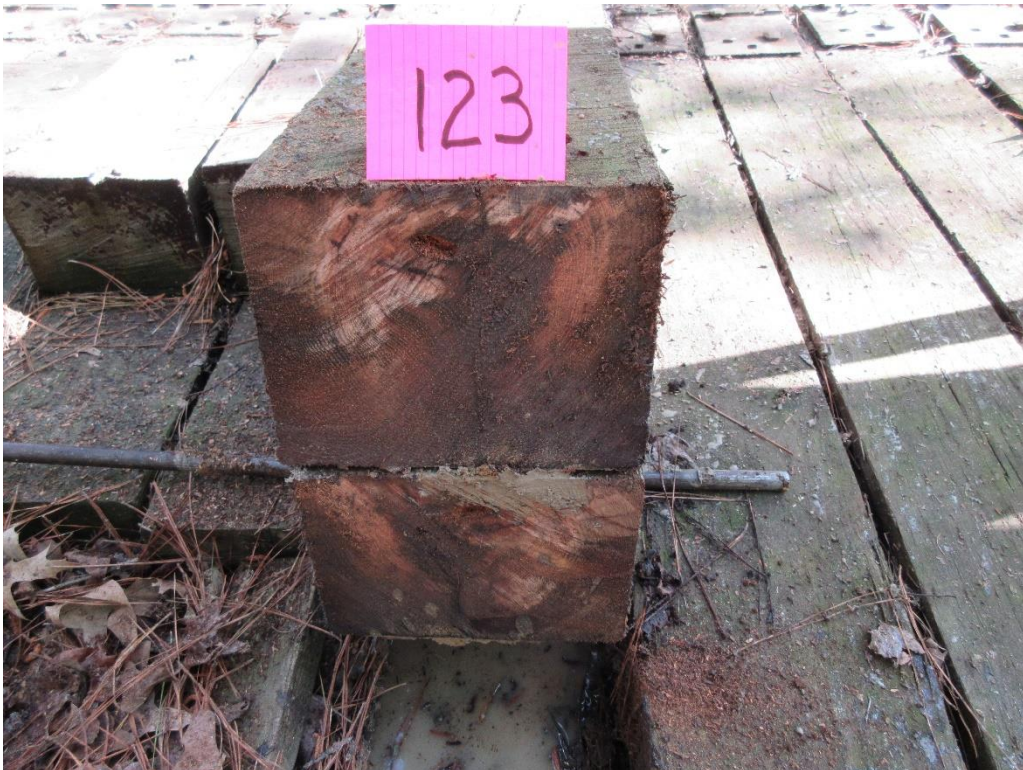
Figure 26 - Tie #123 red oak/DOT/ACZA/oil (Lonza).

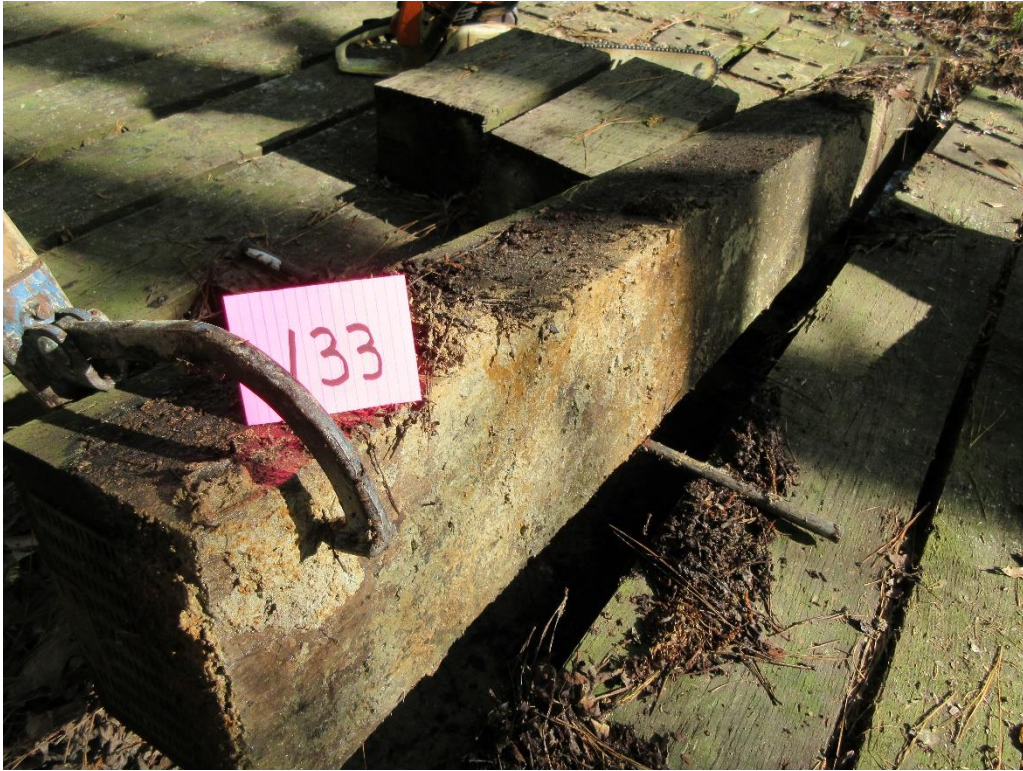
Figure 27 – Tie #133 red oak/ACZA/oil (Lonza).

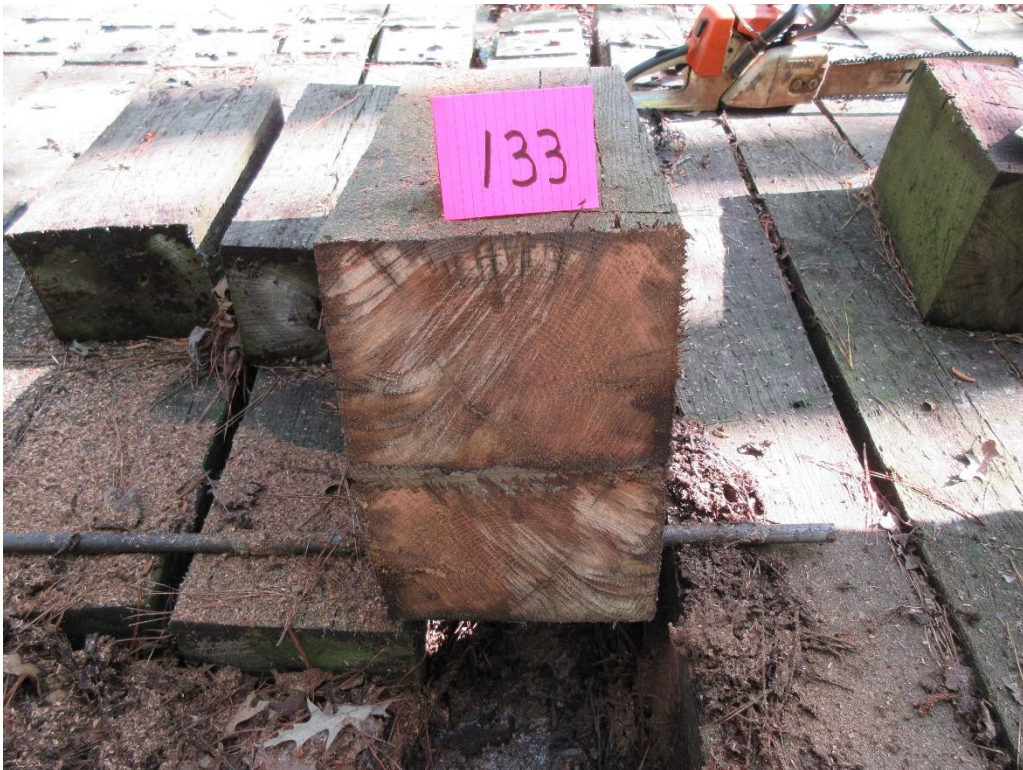
Figure 28 - Tie #133 red oak/ACZA/oil (Lonza).

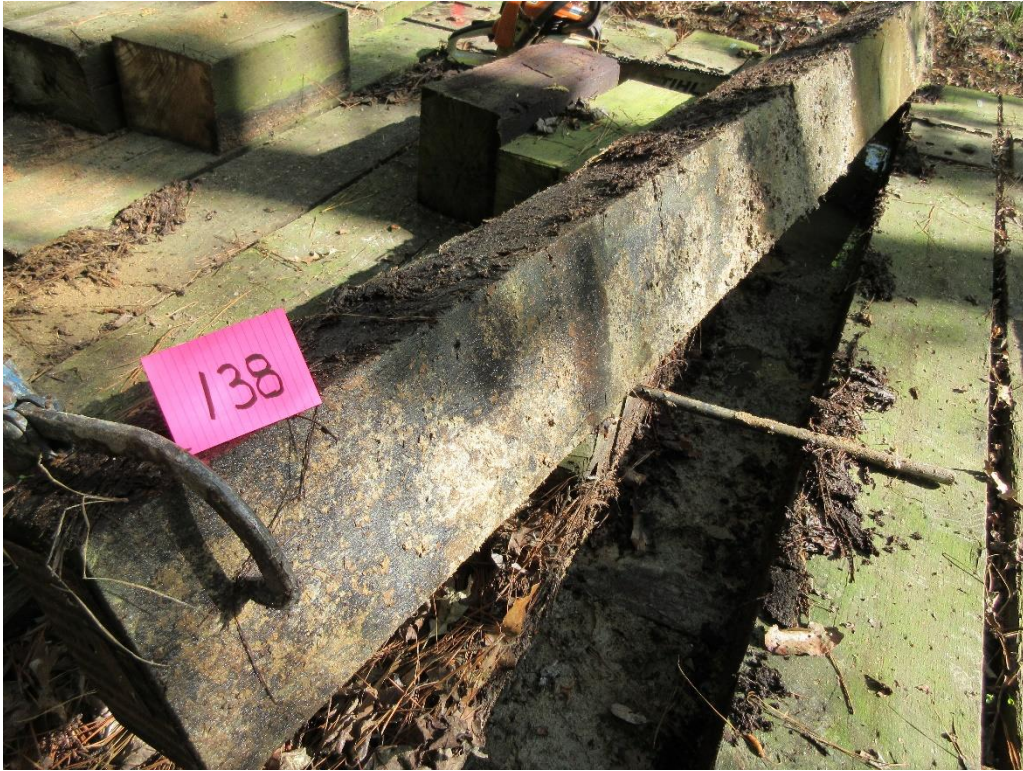
Figure 29 – Tie #138 white oak/ACZA/oil (Lonza).

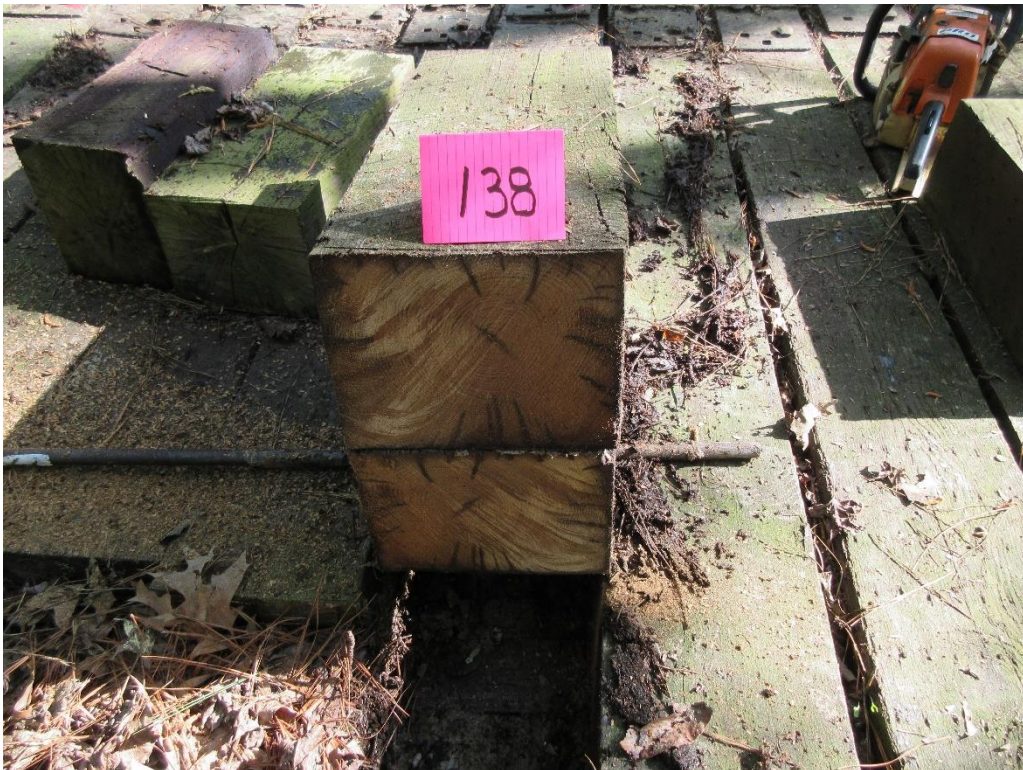
Figure 30 - Tie #138 white oak/ACZA/oil (Lonza).

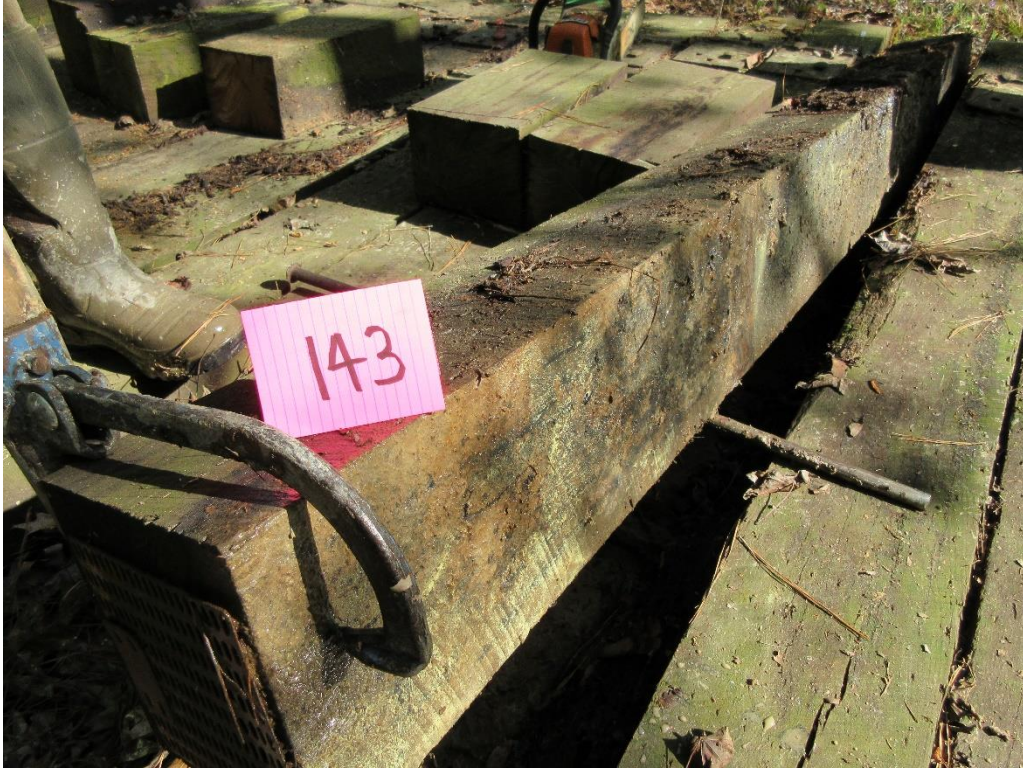
Figure 31 – Tie #143 white oak/DOT/ACZA/oil (Lonza).

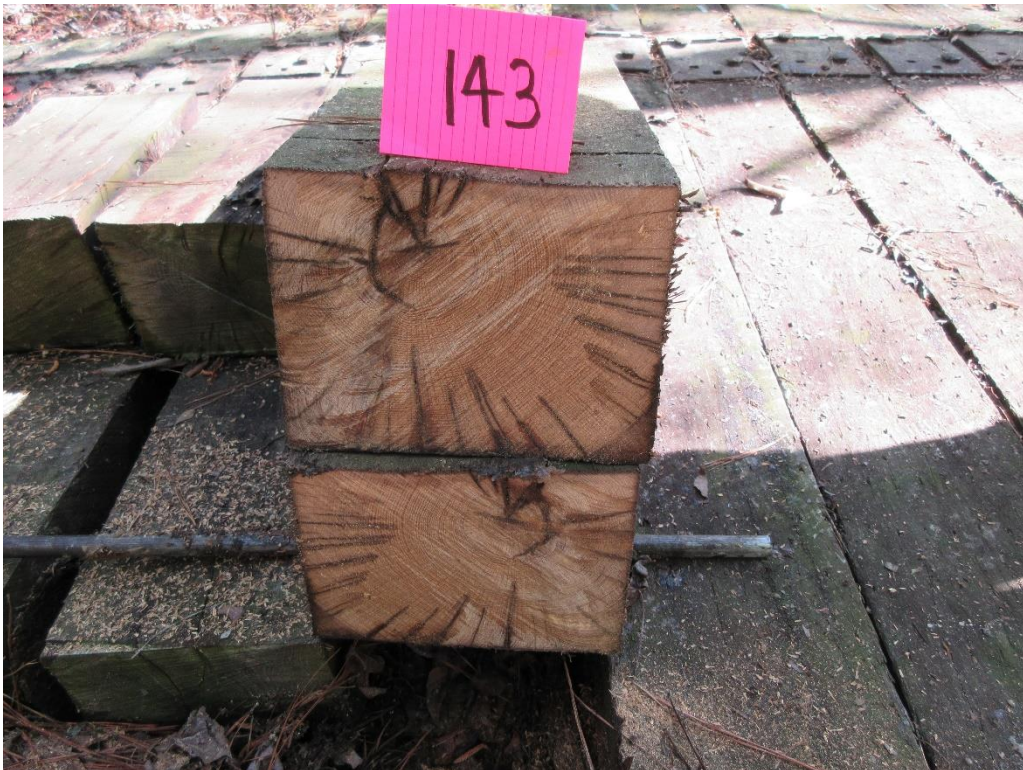
Figure 32 - Tie #143 white oak/DOT/ACZA/oil (Lonza).

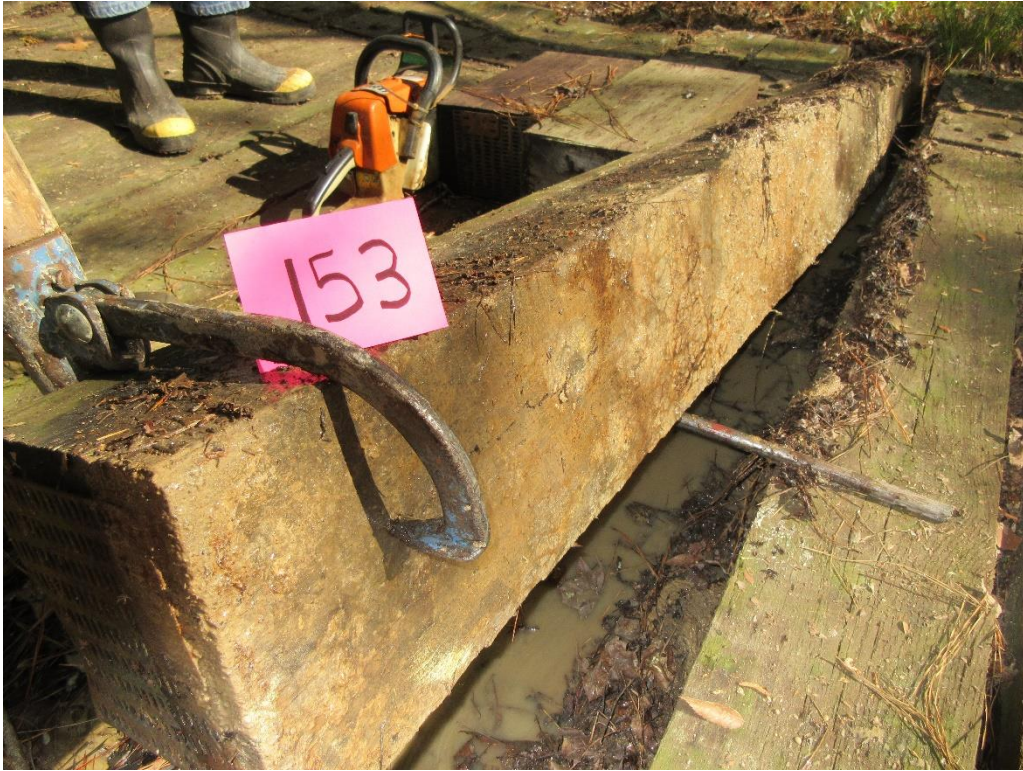
Figure 33 - Tie # 153 red oak/DOT/ACZA/oil (Lonza).

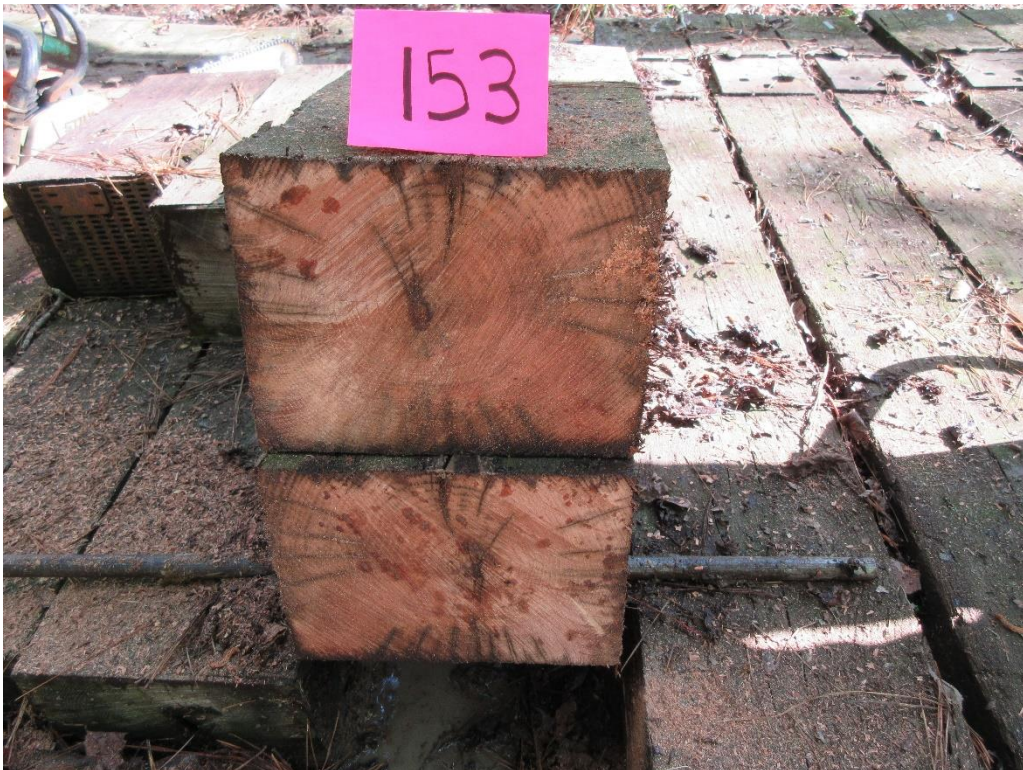
Figure 34 - Tie # 153 red oak/DOT/ACZA/oil (Lonza).

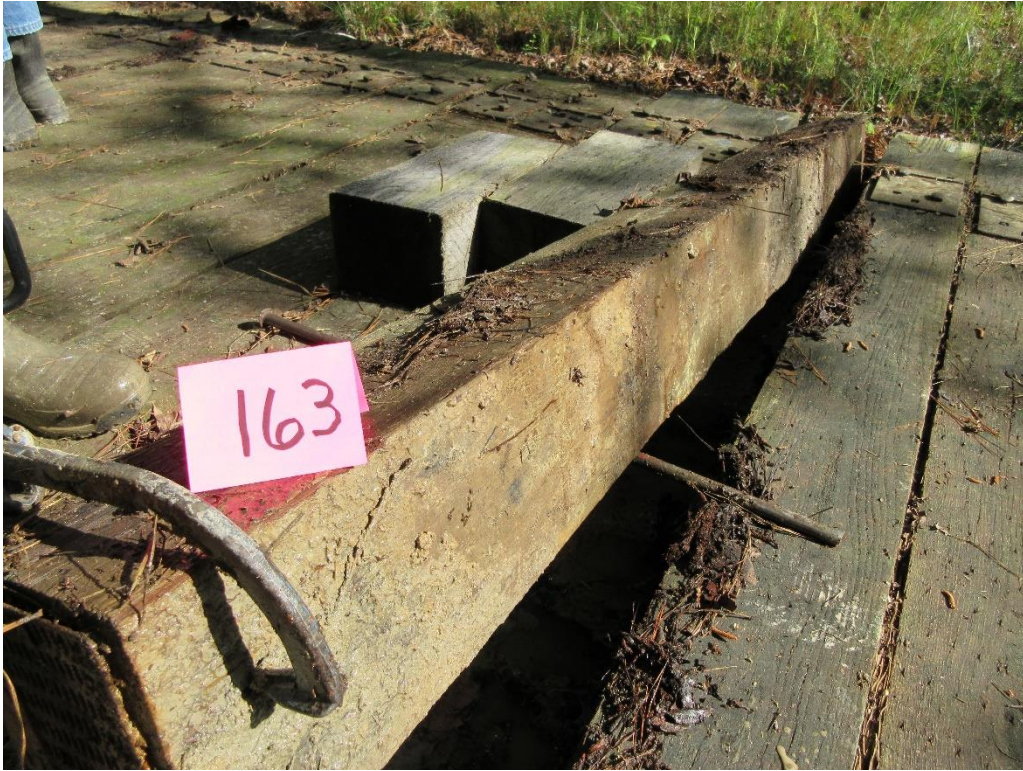
Figure 35 – Tie #163 red oak/ACZA (Lonza).

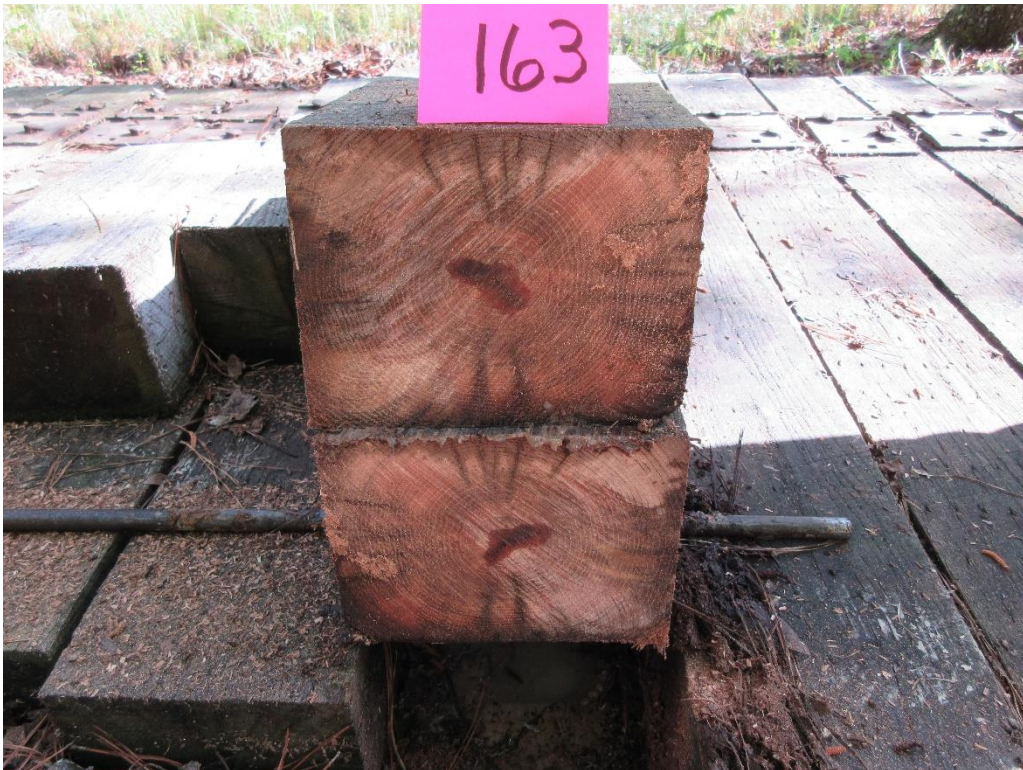
Figure 36 - Tie #163 red oak/ACZA (Lonza).

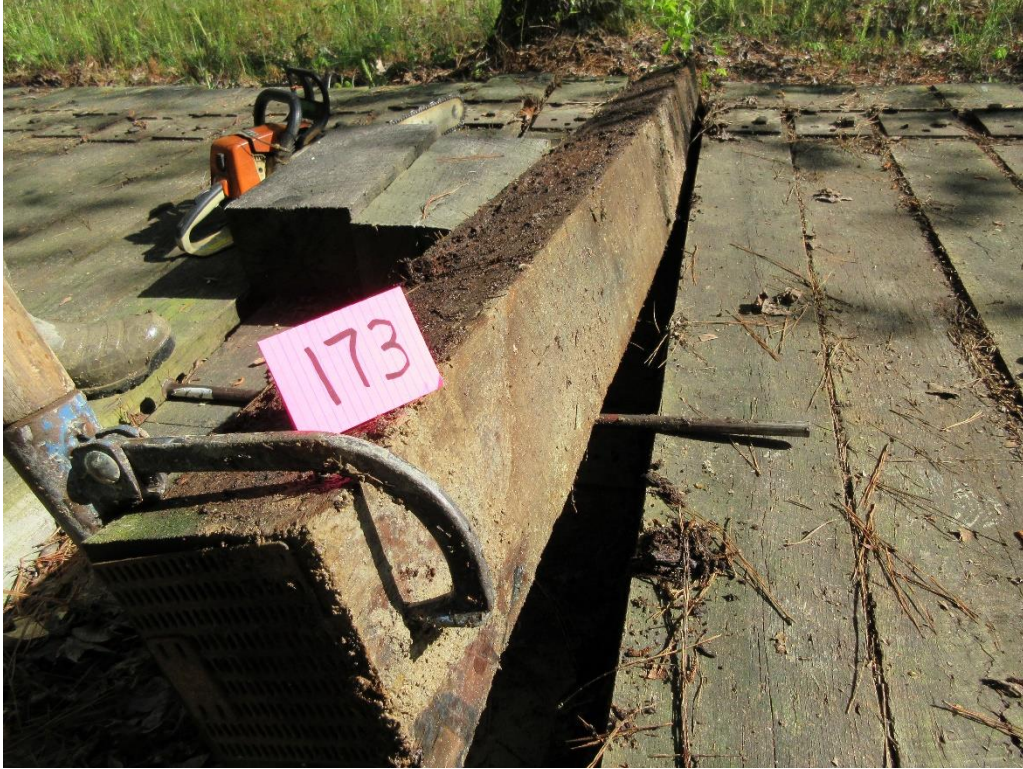
Figure 37 – Tie #173 white oak/ACZA (Lonza).
