MISSISSIPPI STATE
UNIVERSITY[™]

DEPARTMENT OF SUSTAINABLE BIOPRODUCTS

Tenth Annual Evaluation of Phase II MSU/RTA Alternative Preservative Study

July 11, 2022

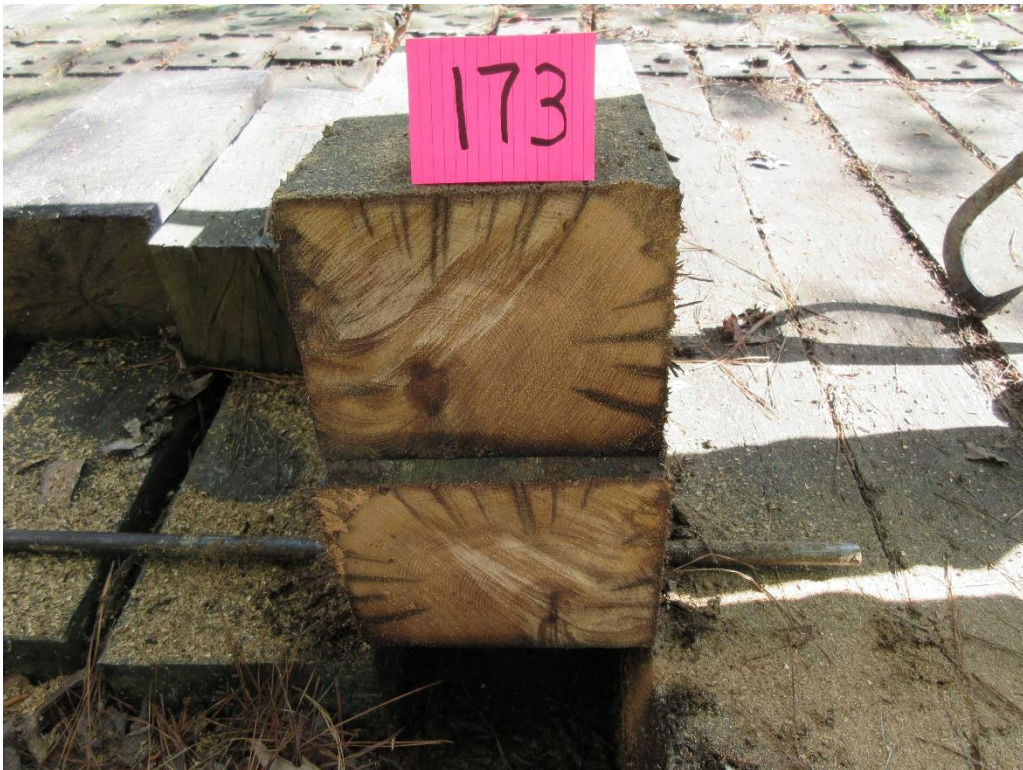
Figure 38 - Tie #173 white oak/ACZA (Lonza).

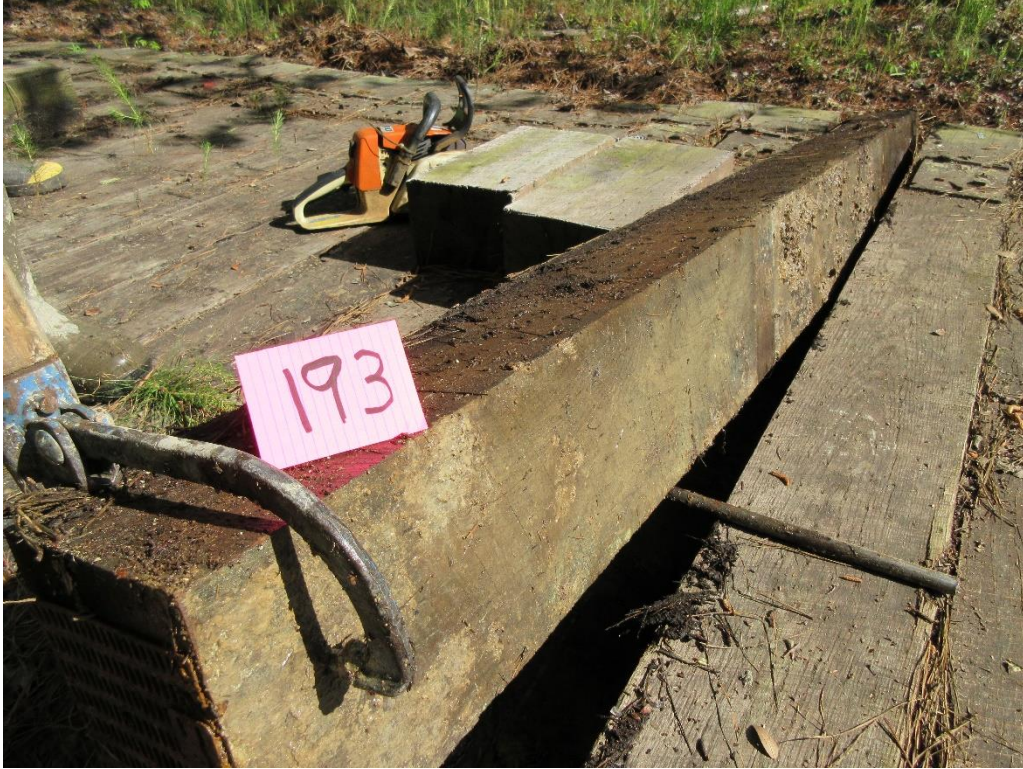
Figure 41 – Tie #193 white oak/ACZA/ET (Lonza).

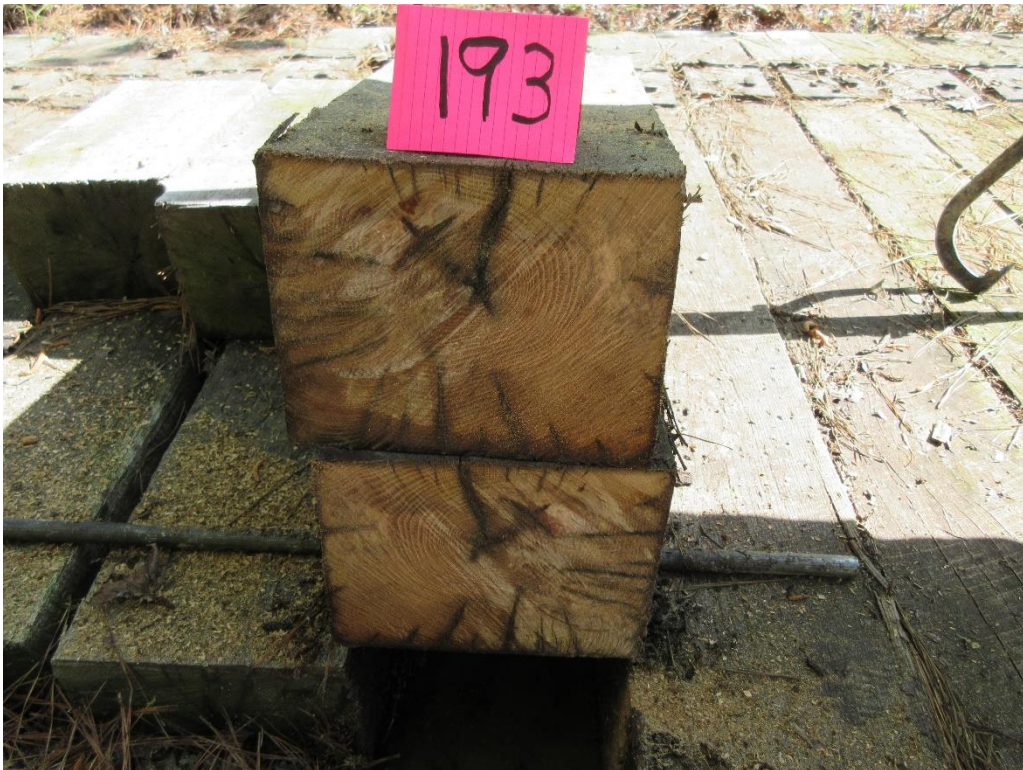
Figure 42- Tie #193 white oak/ACZA/ET (Lonza).

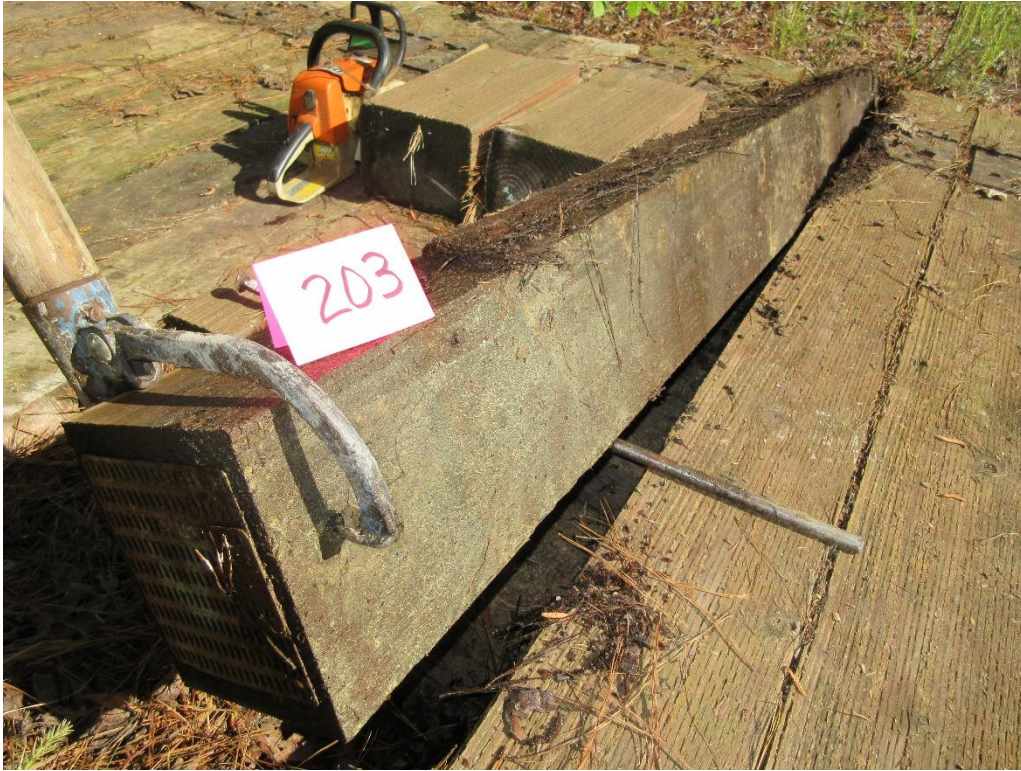
Figure 43 – Tie #203 Douglas fir/ACZA/DOT/ET (Lonza).

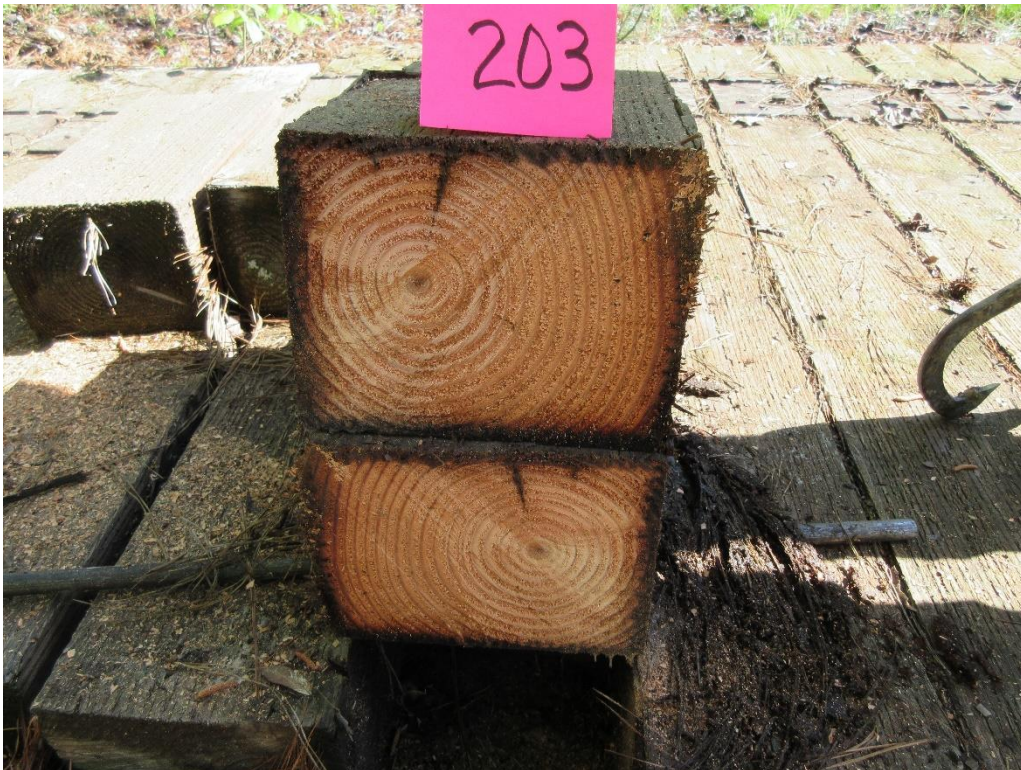
Figure 44 - Tie #203 Douglas fir/ACZA/DOT/ET (Lonza).

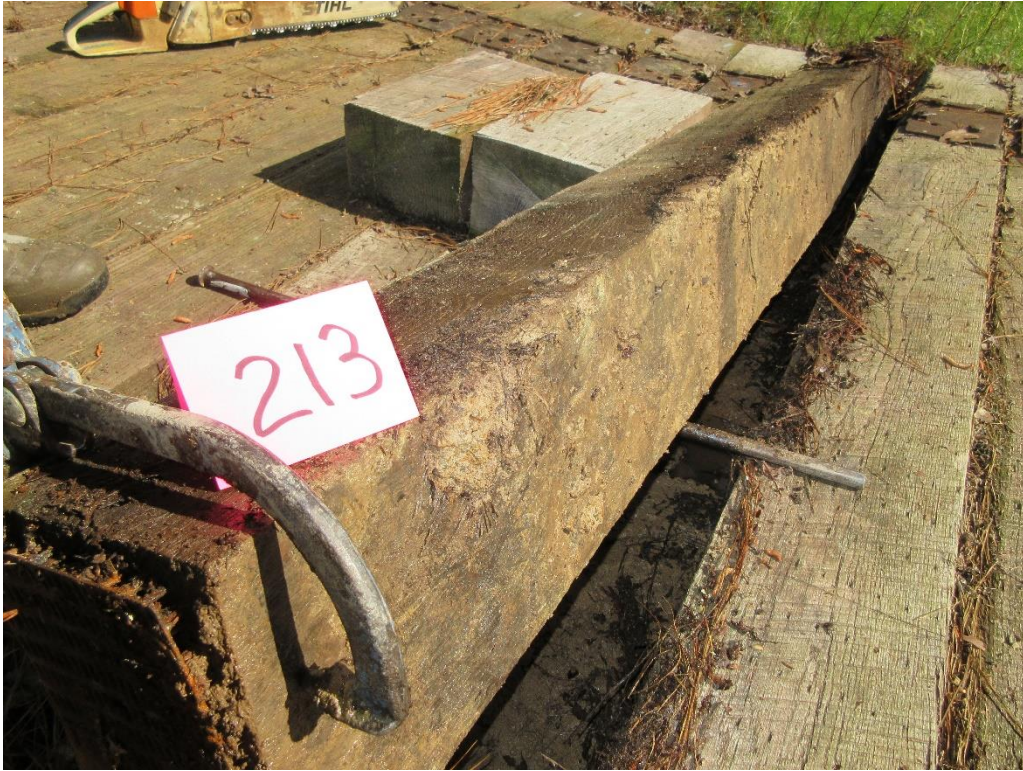
Figure 45 – Tie #213 red oak/ACZA/ET (Lonza).

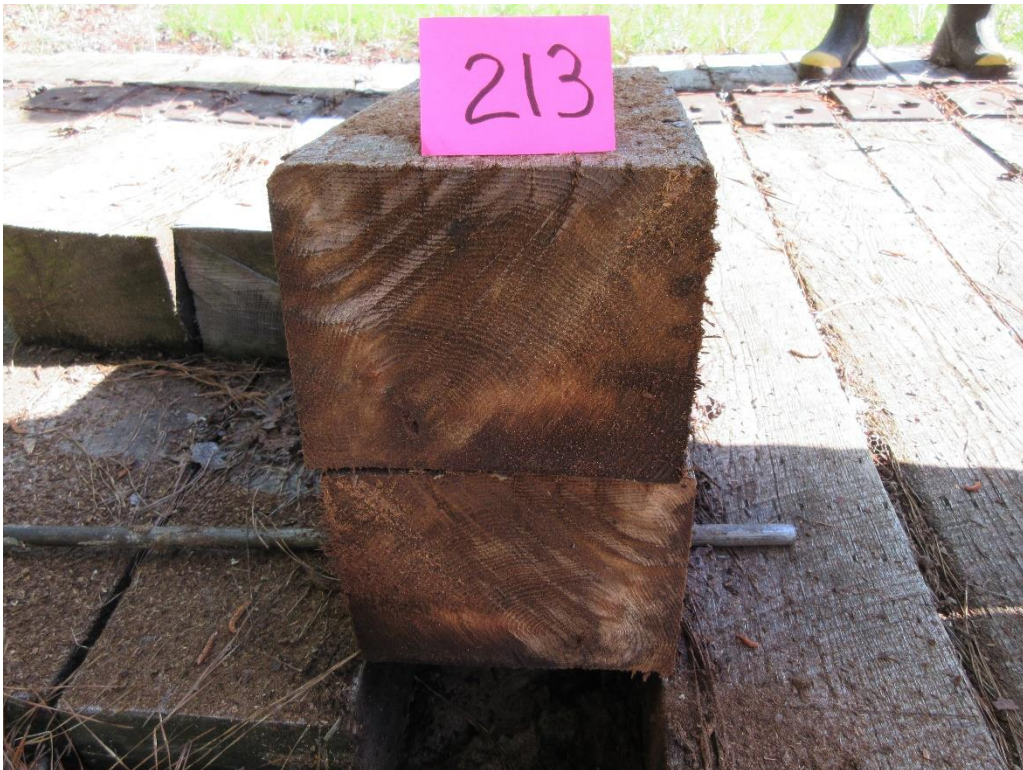
Figure 46 – Tie #213 red oak/ACZA/ET (Lonza).

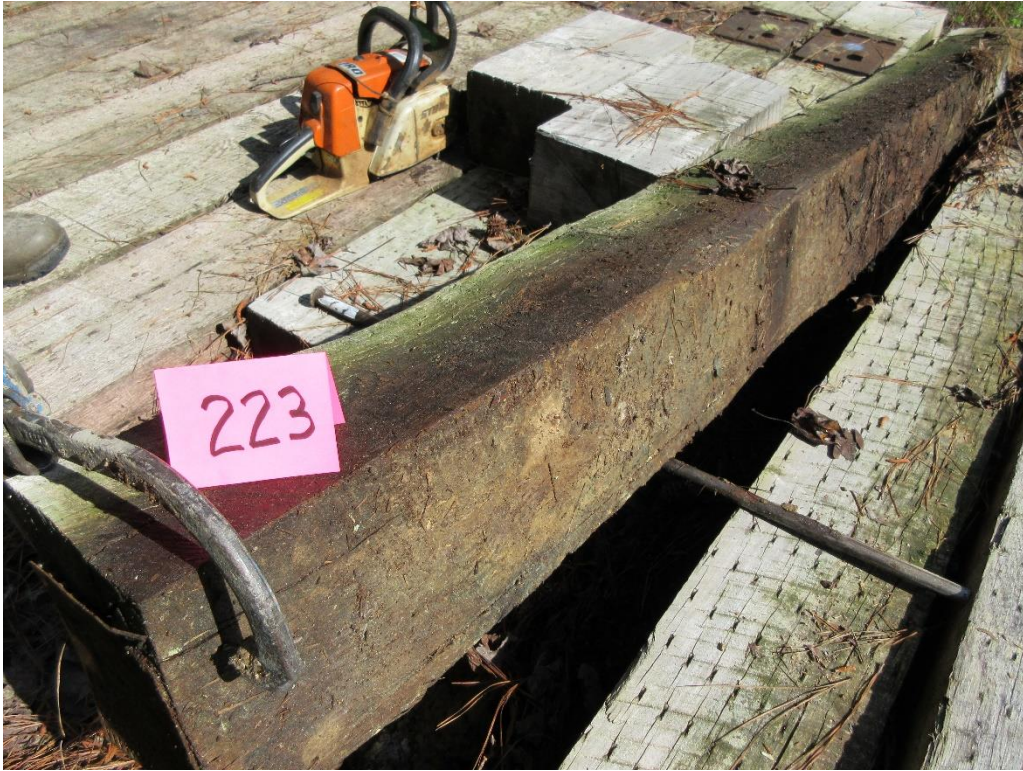
Figure 47 – Tie #223 white oak/ACZA/DOT (Lonza).
